Development Workshop

EARTHQUAKE DAMAGE ANALYSIS
Guinea, Koumbia earthquake

USAID

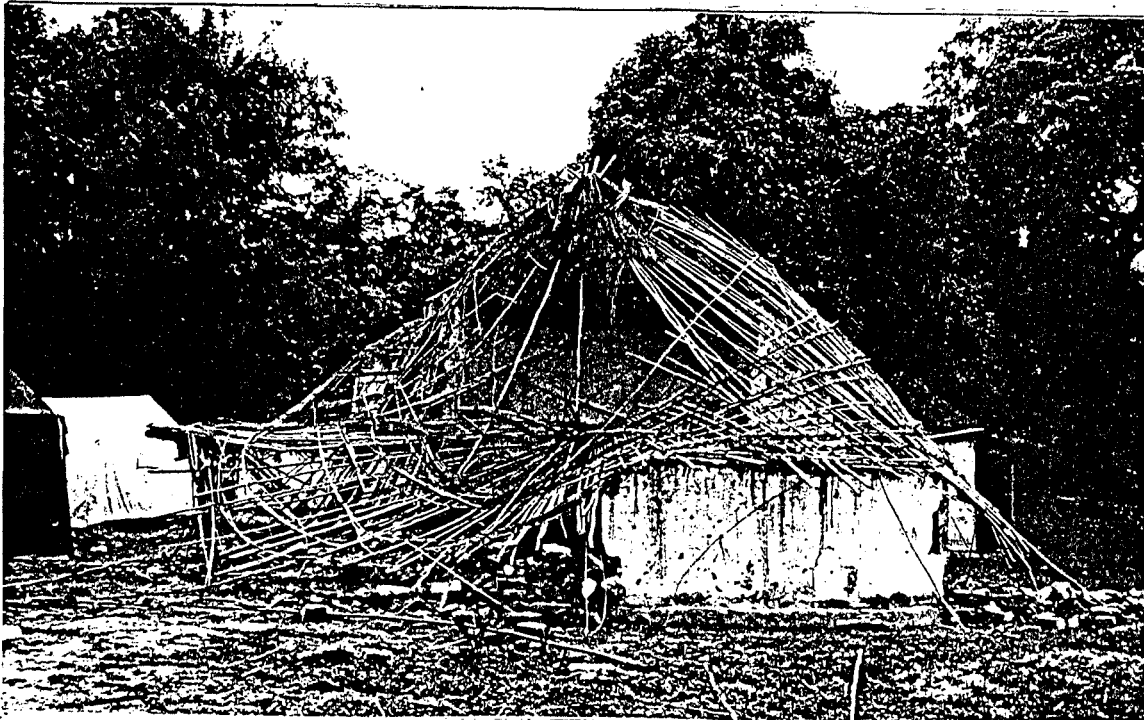
Damaged round house, Koumbia

Identifiable weaknesses were: instability of tall thin walls in all types of construction; poor lintels; lack of horizontal ties.

Recent trends towards the use of mud block walls in local material construction, and poor technique and shortage of materials in reinforced concrete construction increased the severity of damage sustained. Older, traditional construction, using timber lattice and mud plaster was quite resistant.

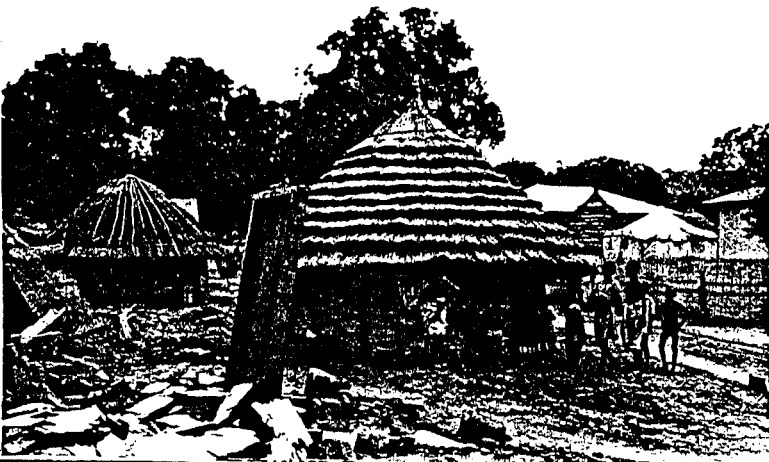
Temporary shelter behind collapsed house, Koumbia
