**A STRATEGY FOR DEVELOPING
INDIGENOUS BUILDING
IN EARTHQUAKE REGIONS**

**TIMBER REINFORCING
FOR EARTHQUAKE RESISTANCE**

**CASE STUDIES OF THE
BANDAR ABBAS (1977) AND THE ZARAND
(1978) EARTHQUAKES**

Development Workshop

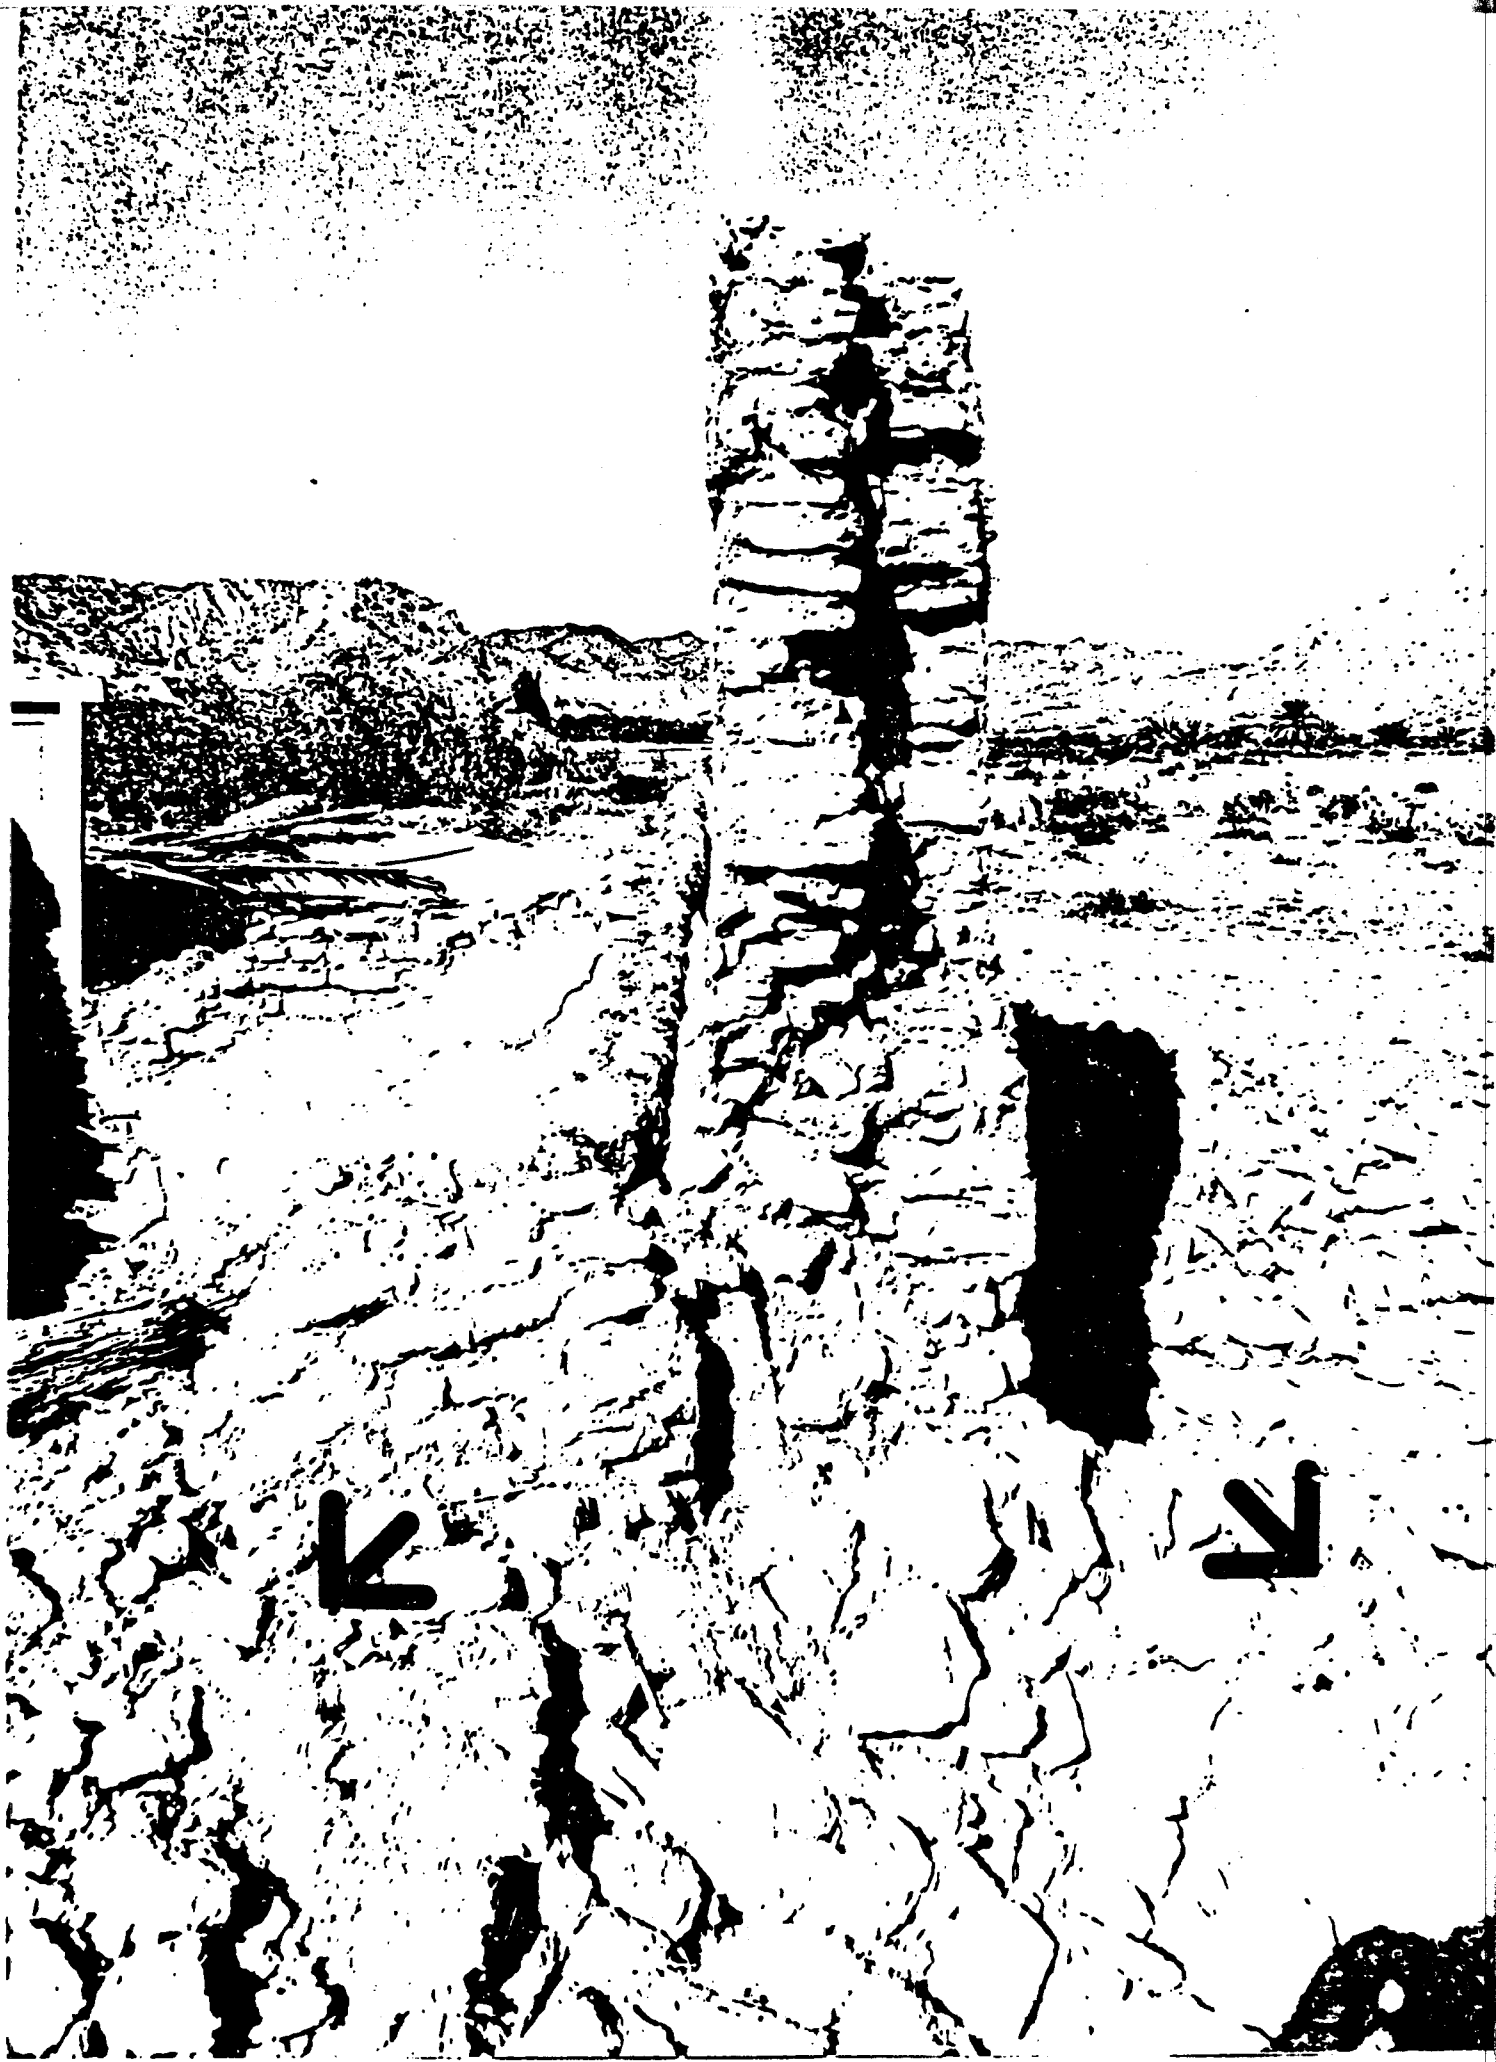
Examples of wall failure due to lack of internal bonding

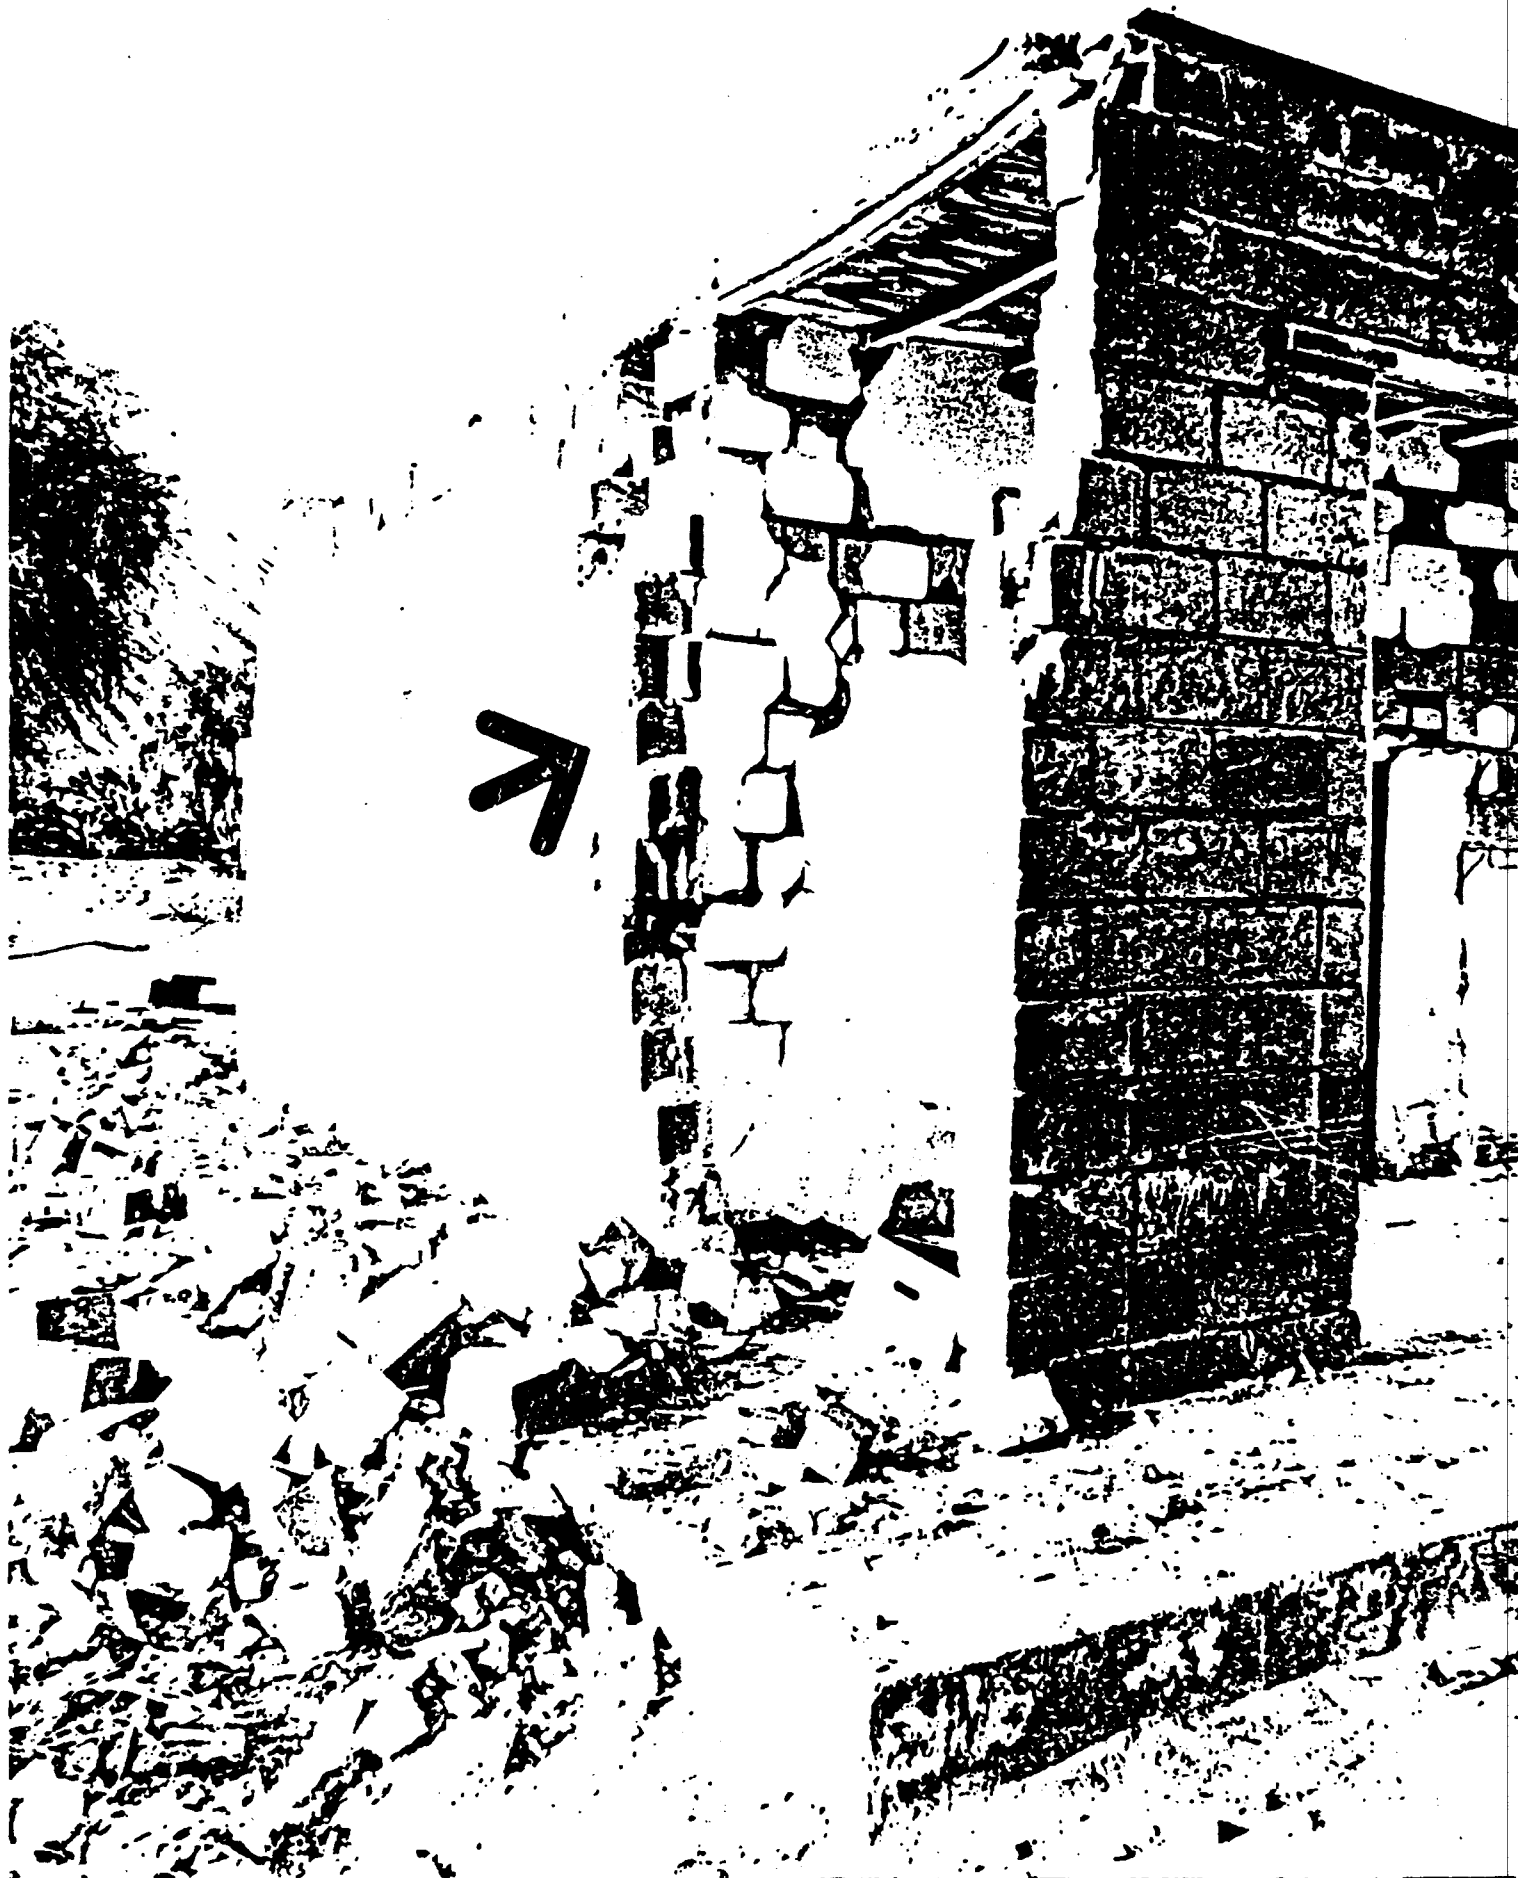
Corner failure
and collapse of concrete

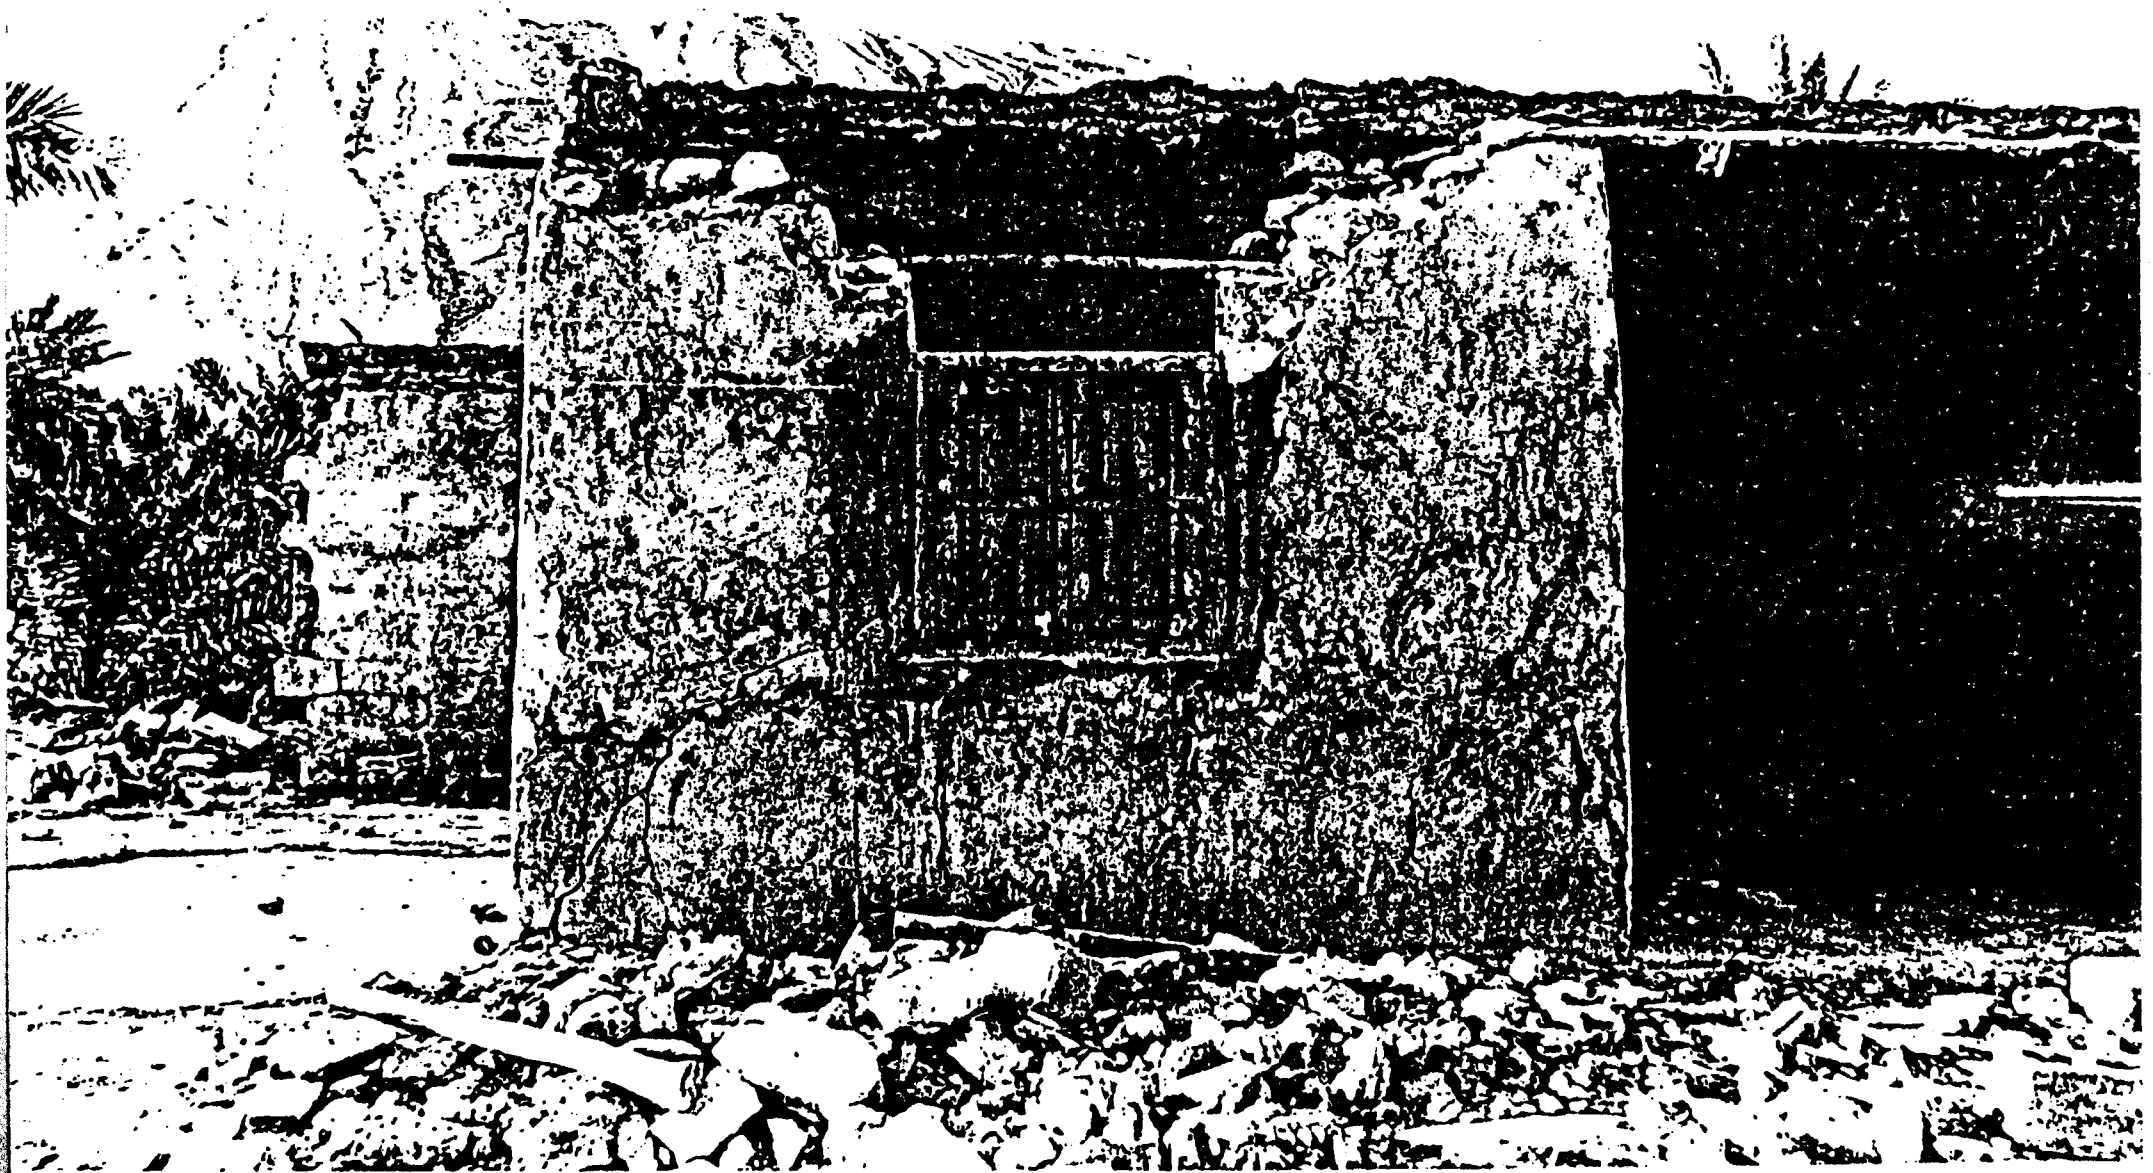
Nearly all the openings had been spanned with timber lintels. Because in most cases the lintels projected only a small amount into the wall on either side, the timber pulled out and the structure above collapsed. Even where the projection was sufficient, severe cracking on either side of the opening occurred.

Lintels over doors and windows were not embedded deep enough into wall.

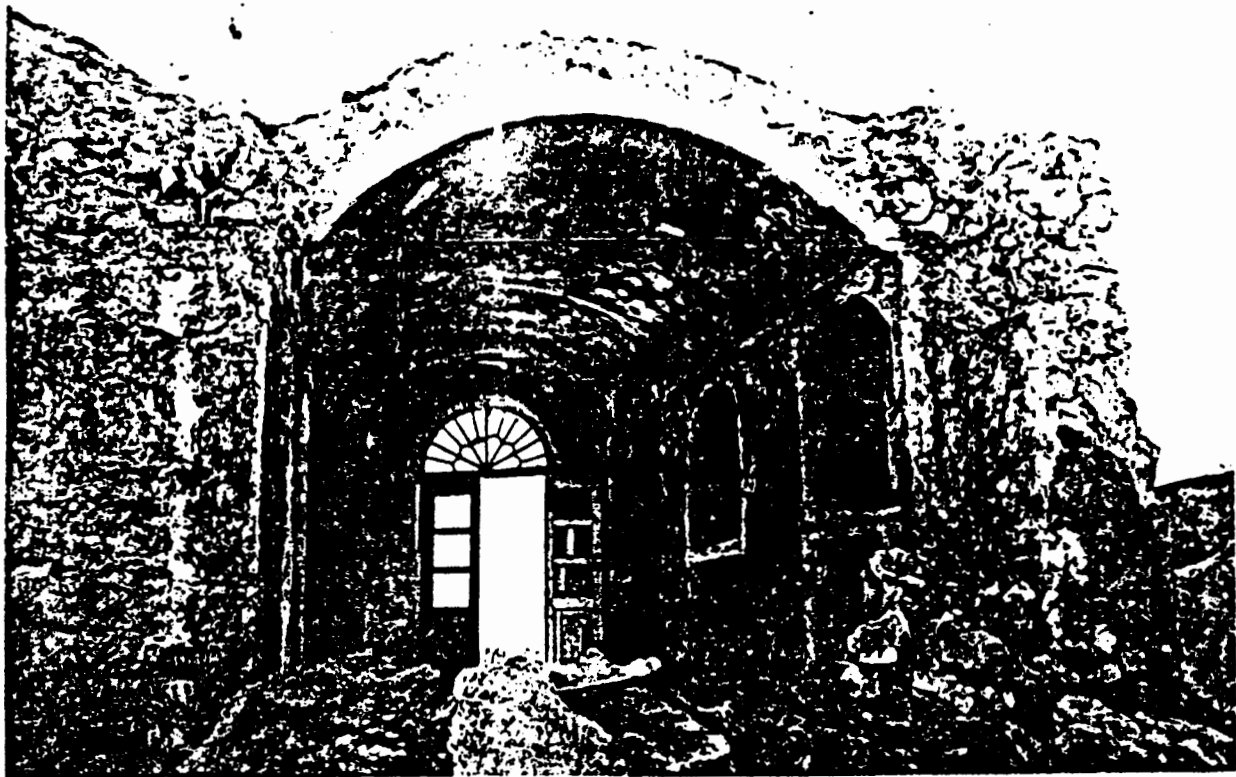
Gisk Village:

Metal tie rods anchored into reinforced horizontal beam at top of wall have prevented vault collapse. Horizontal timber beam set in cement mortar.

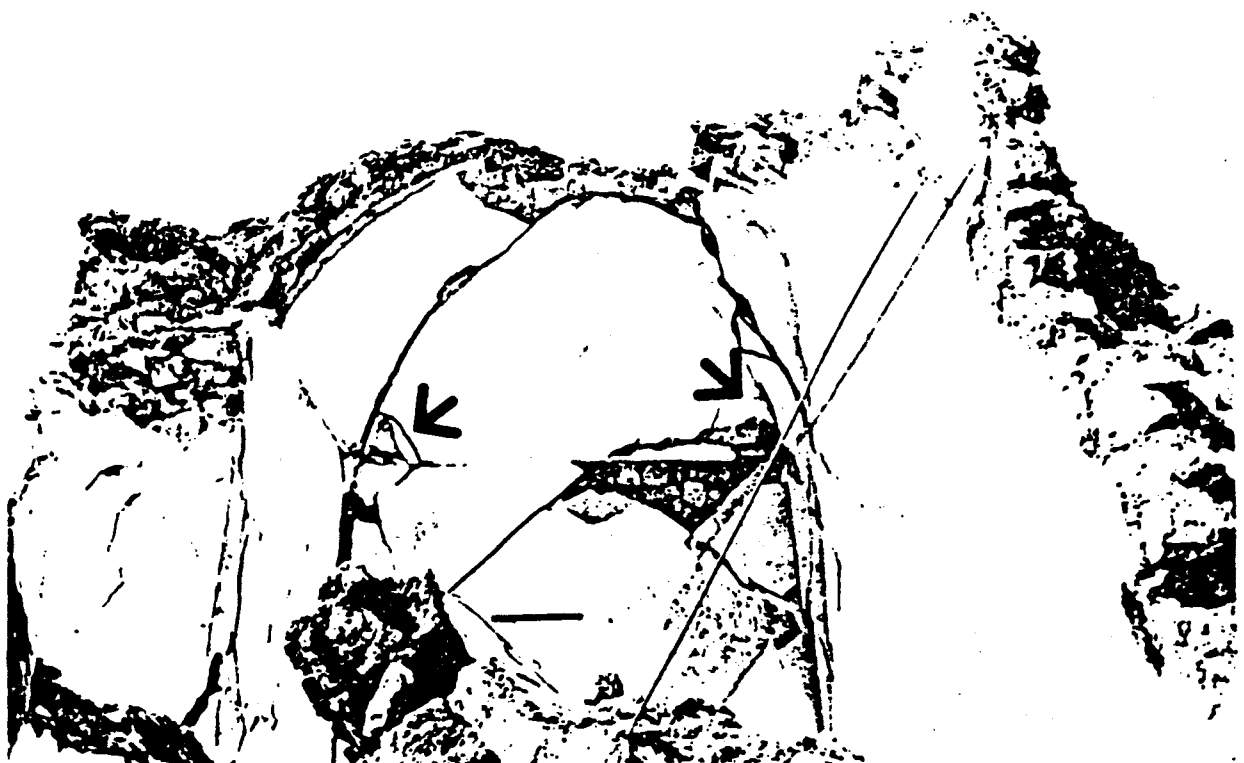
Sar Bagh:

Corner failure due to stress
concentration.

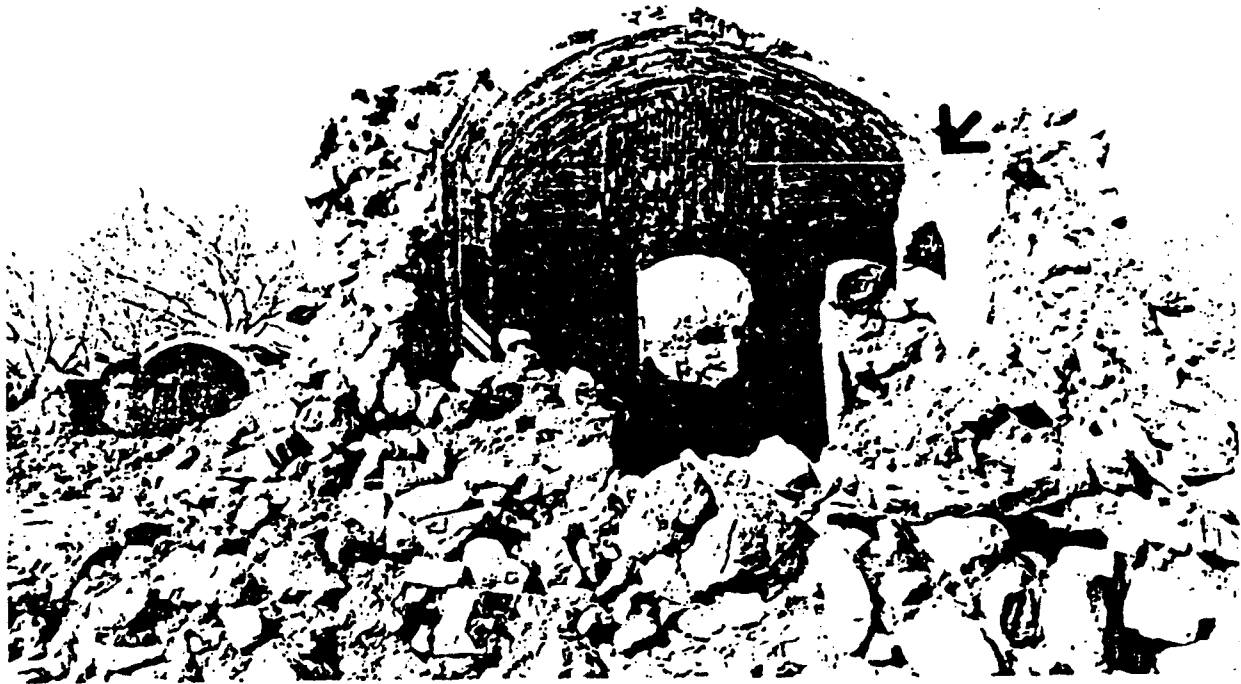
Sar Bagh Village:

Brick vault collapse. Note metal tie rods are not anchored by continuous horizontal wall ties.

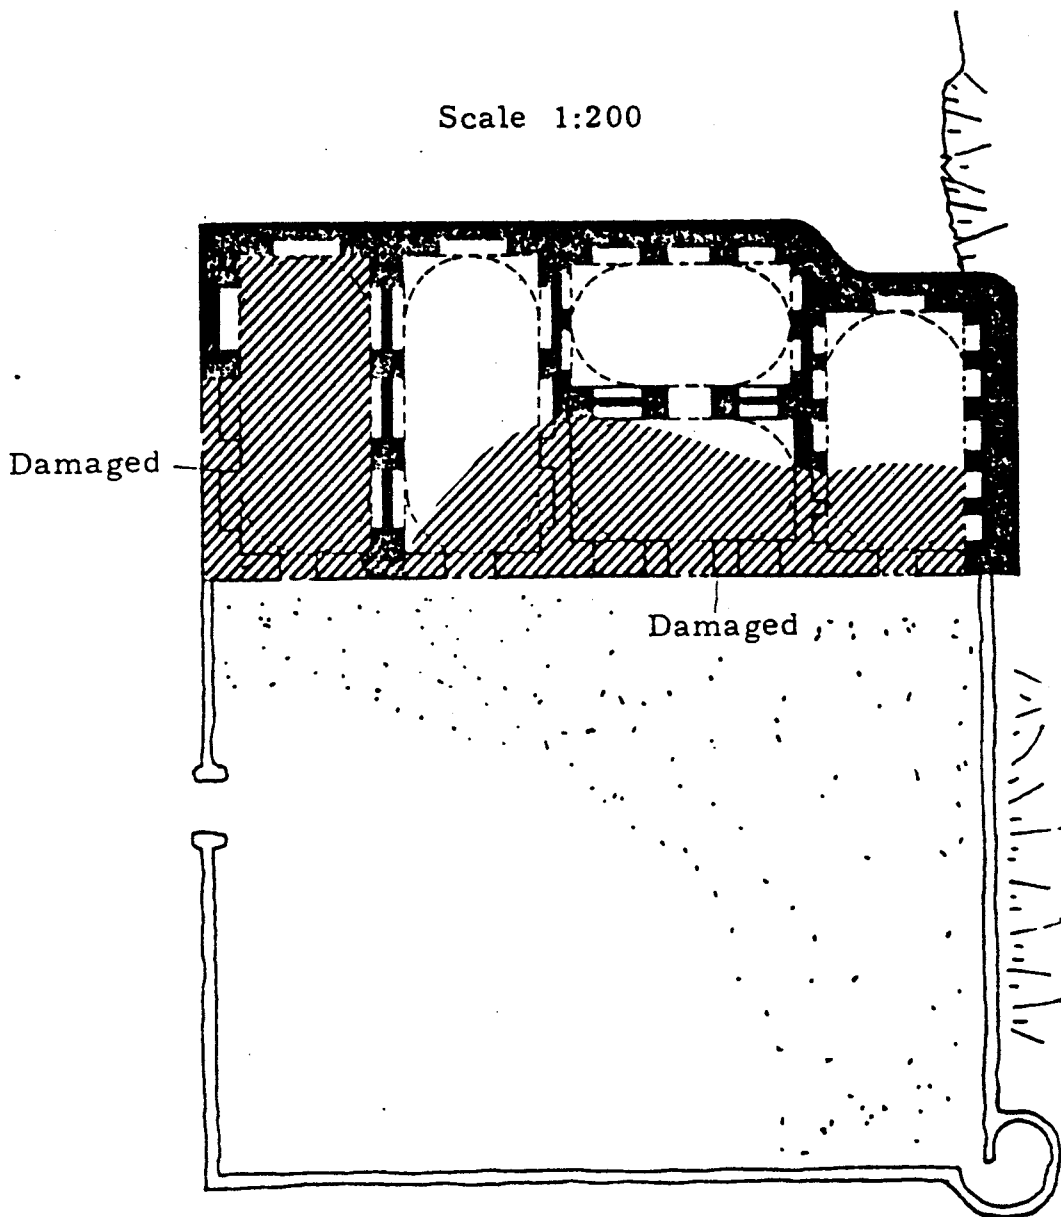
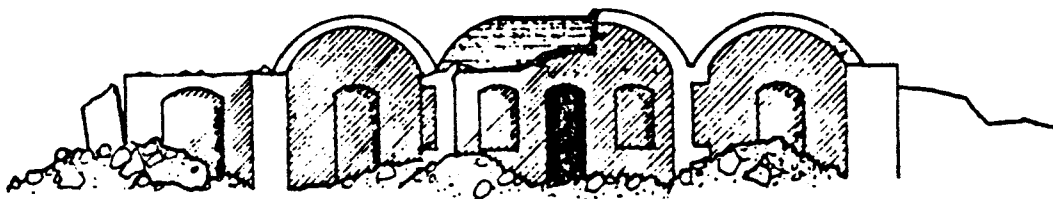
HOUSE AT SAR BUGH VILLAGE

Built of rubble stone walls with mud mortar and stone roof vaults with gypsum mortar. Total collapse of end room and major damage to other rooms

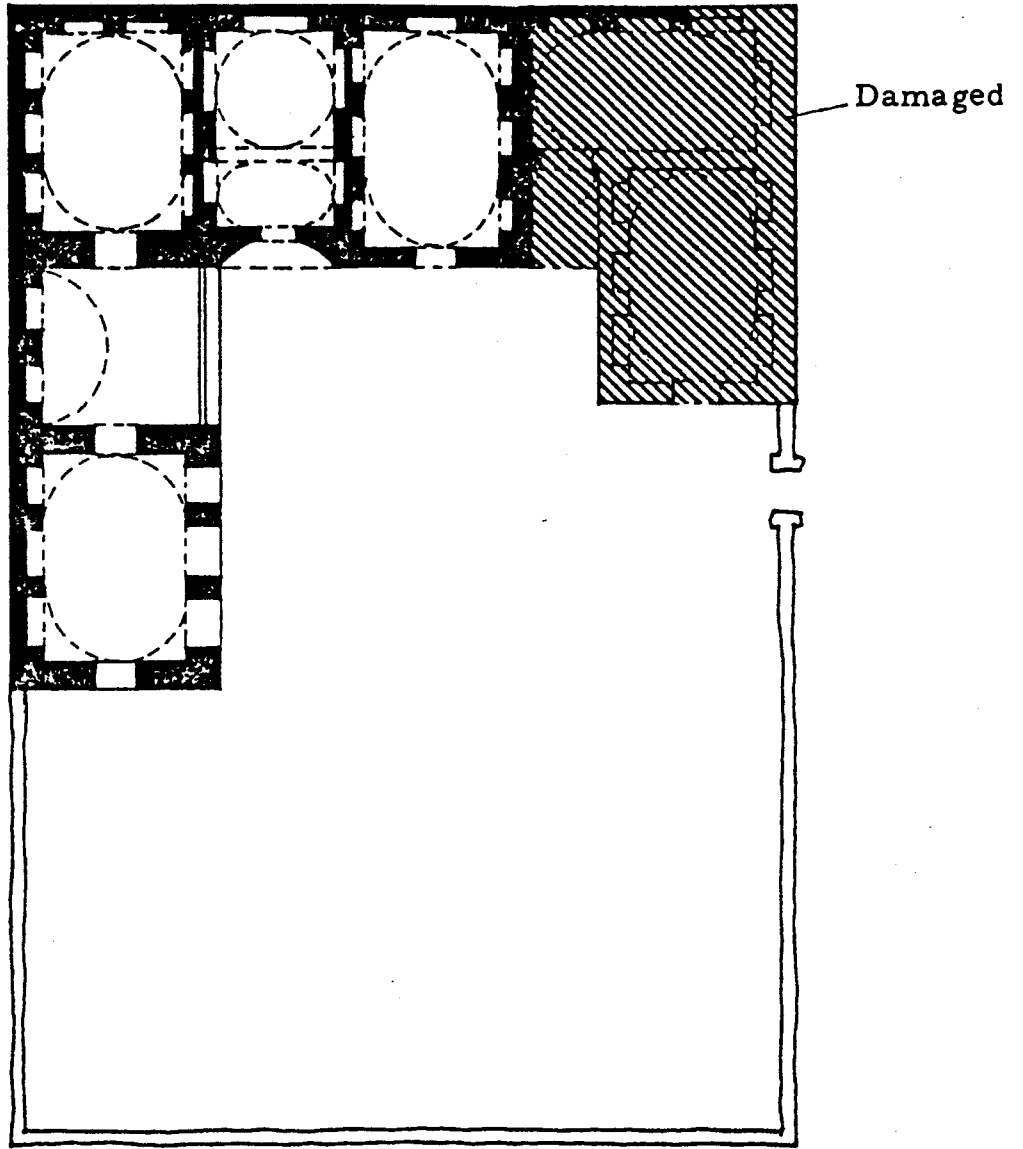
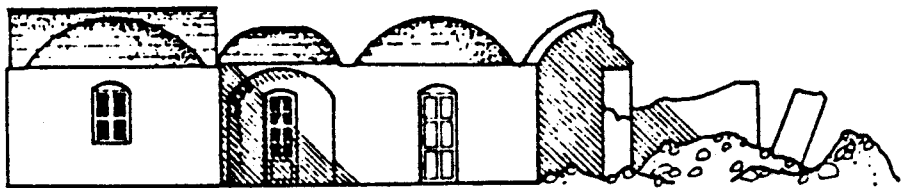
HOUSE AT SAR BAGH VILLAGE

Stone and mud construction.
Stress concentration in end rooms
caused collapse.

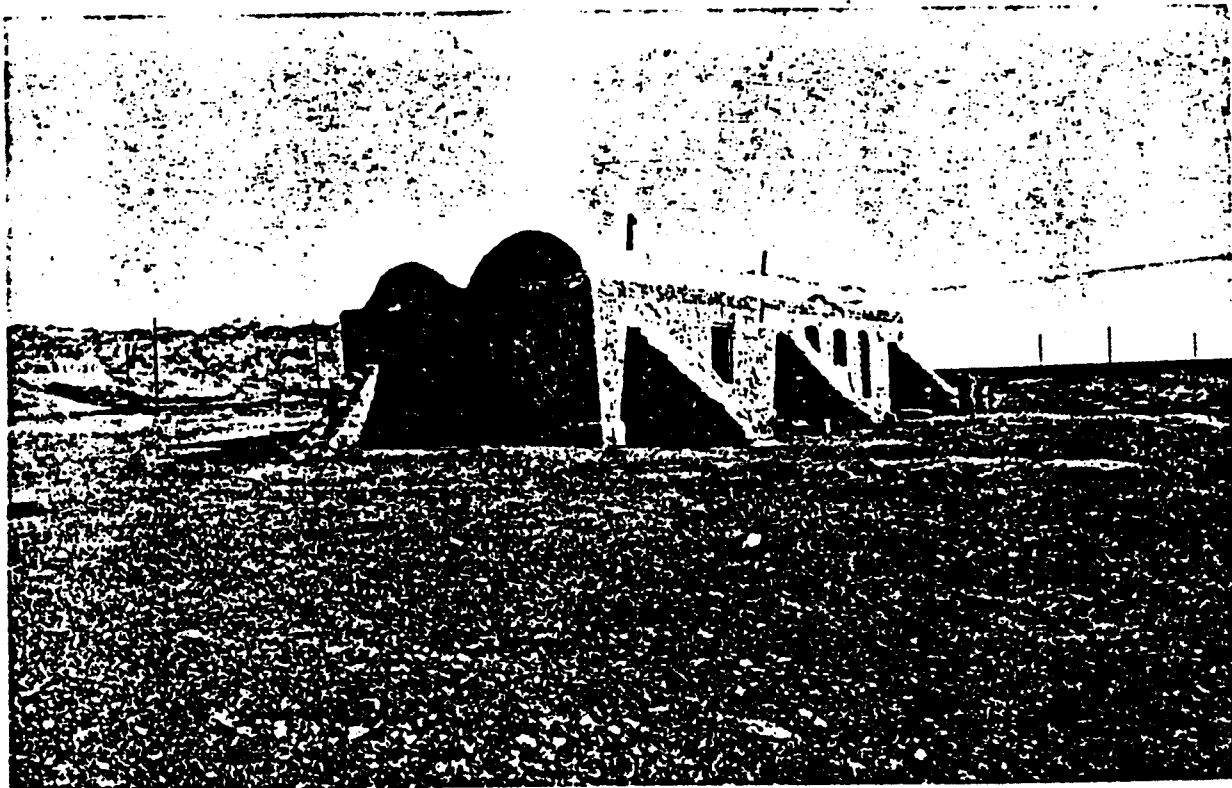
Workshop building south of Sar Bagh.
(See accompanying drawing).

WORKSHOP BUILDING SOUTH OF SAR BAGH
Stone walls in lime mortar and fired brick
vaults. External buttresses assisted building
to withstand major earthquake damage.

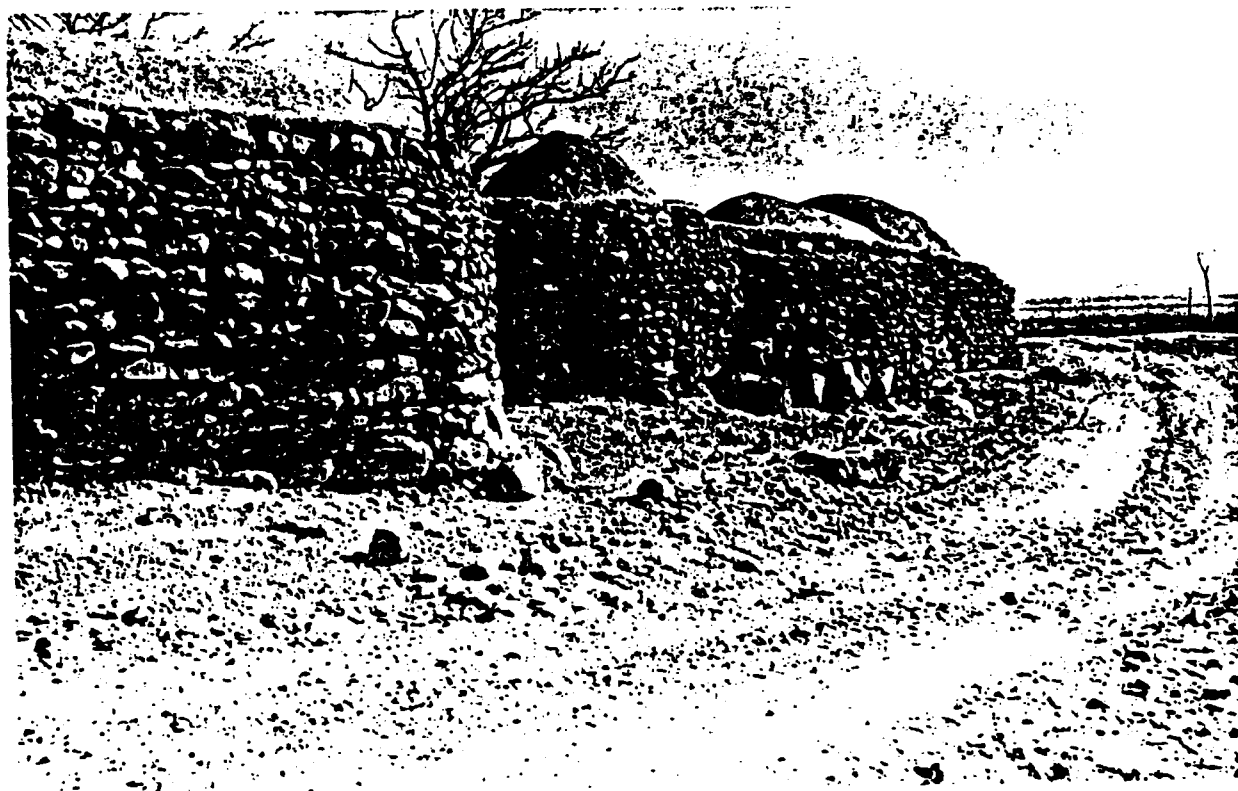
House south of Sar Bagh:
Rounded corners tend to disperse
load which would otherwise be
concentrated and cause damage.

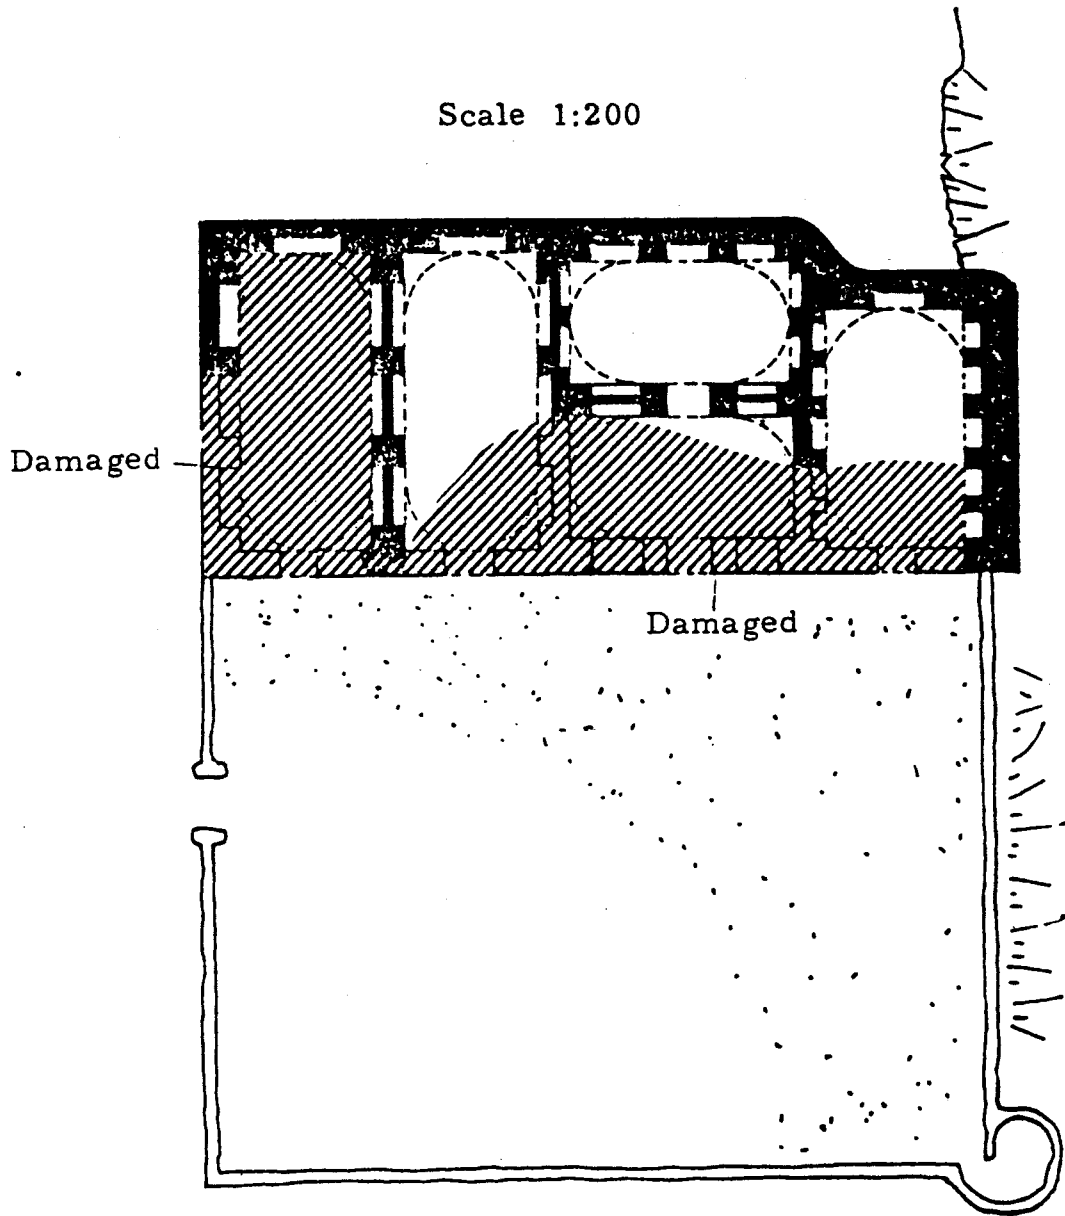
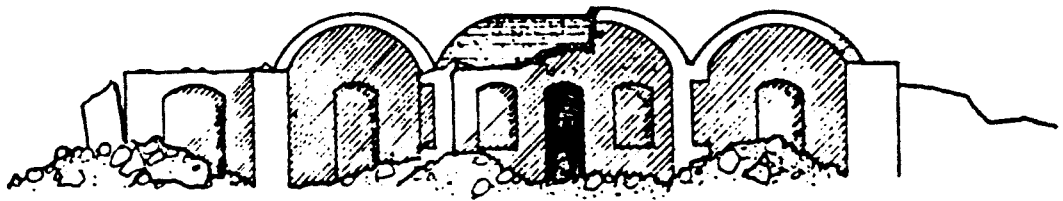
HOUSE AT SAR B/ GH VILLAGE

Built of rubble stone walls with mud mortar and stone roof vaults with gypsum mortar. Total collapse of end room and major damage to other rooms

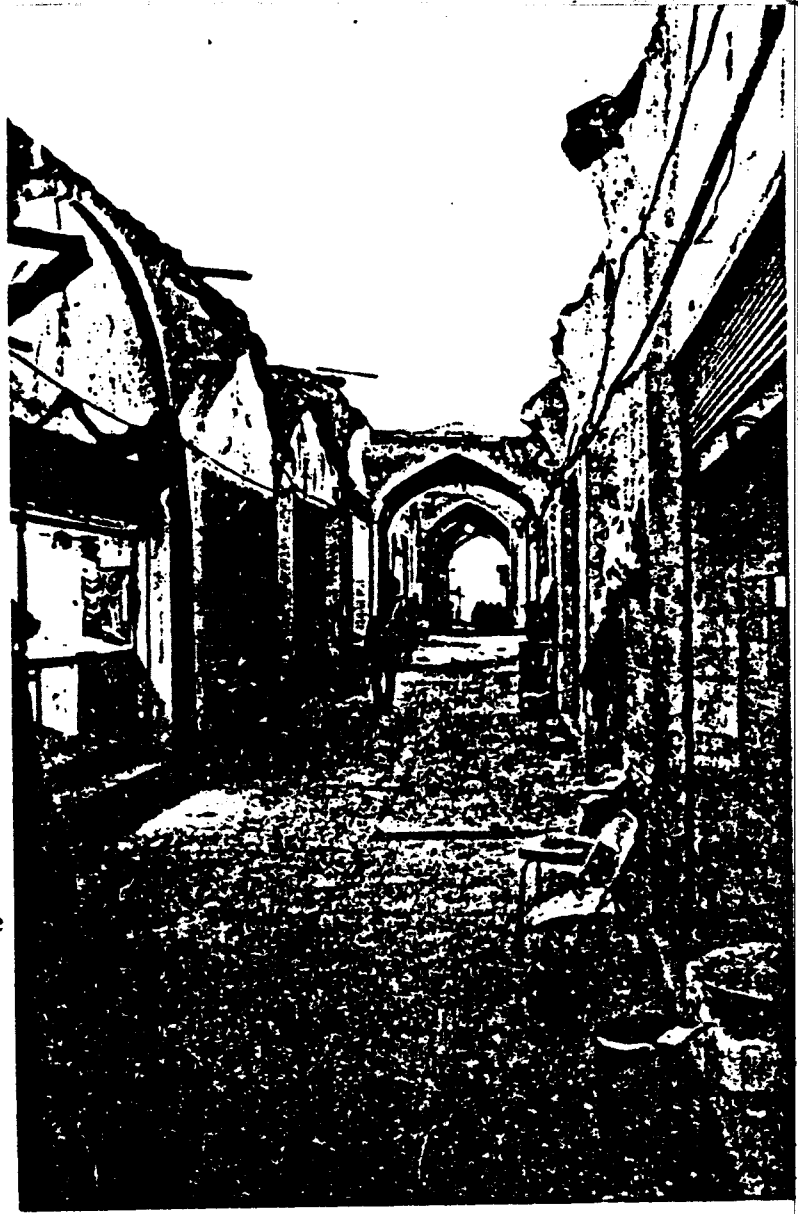
1

Zarand - Bazaar:

Collapse of bazaar roof probably due to poor repair.

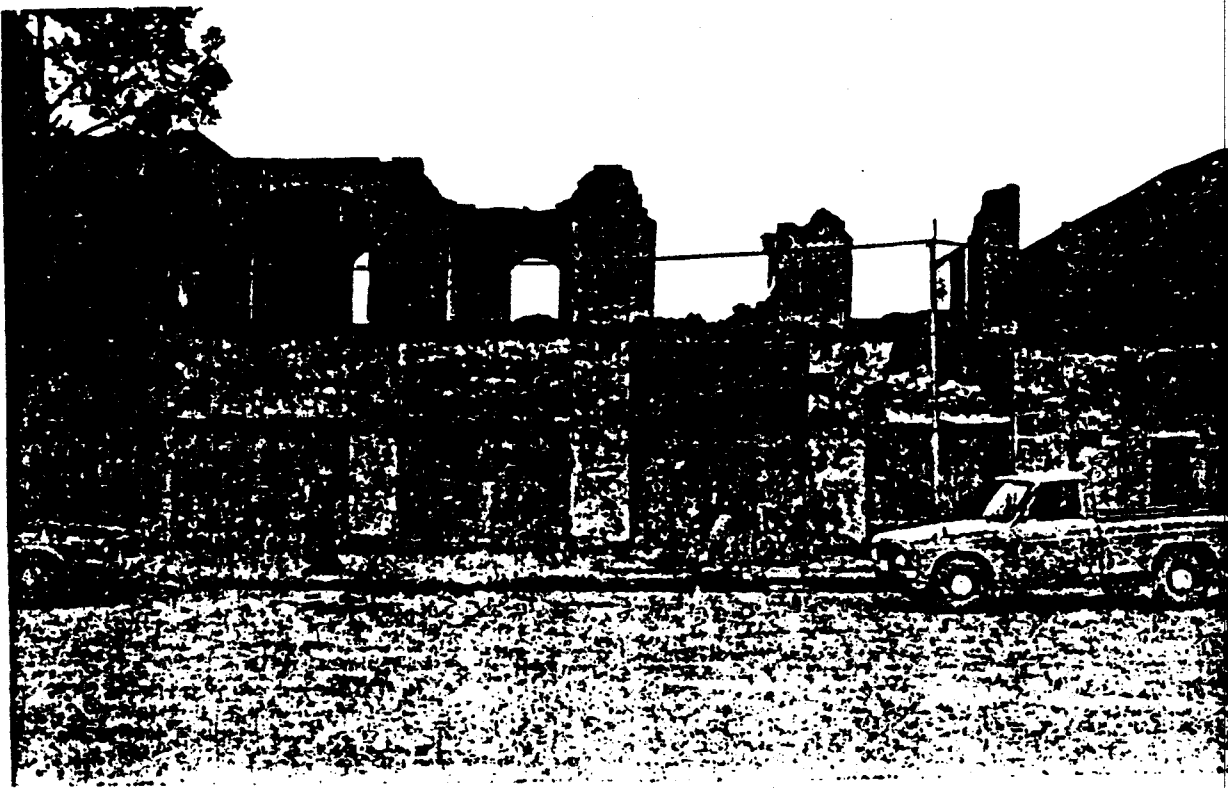
2

Zarand -

Vaults built side by side show progressively greater damage toward ends.

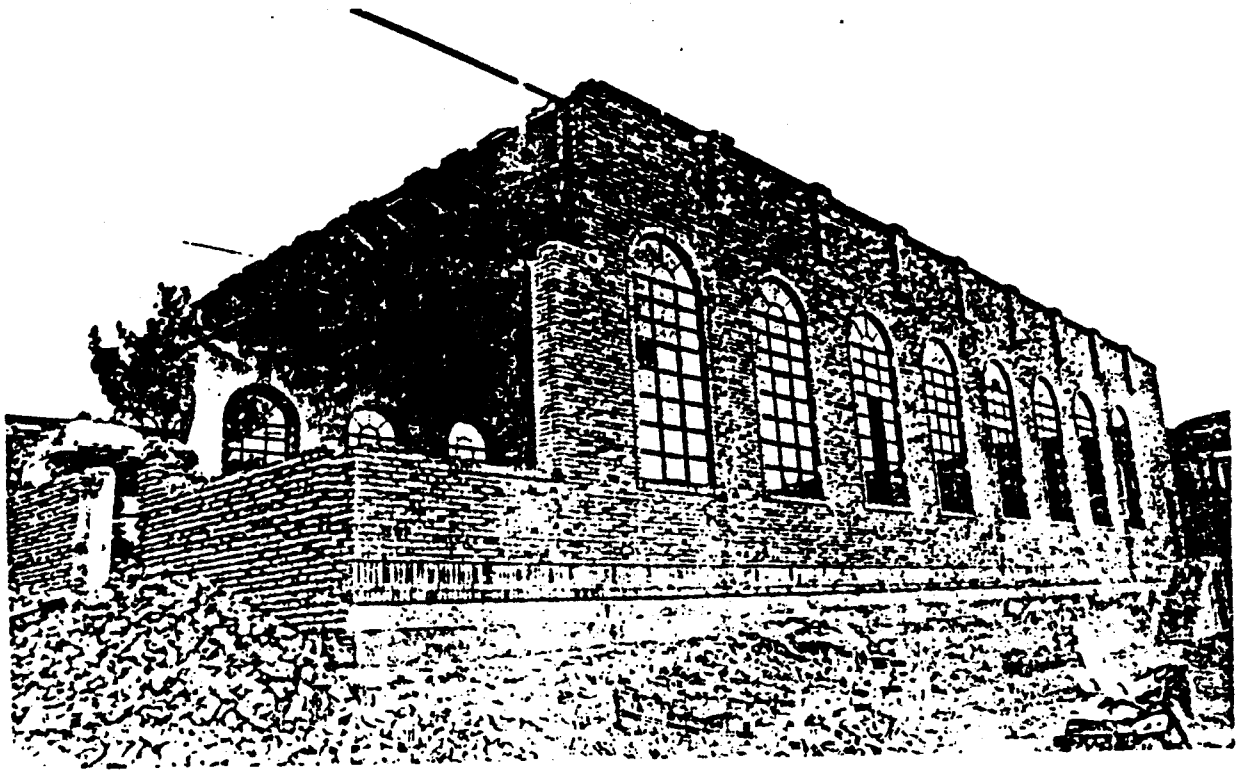
3 Zarand:

Recently built school failure due to improper steel framing, especially at corners.

Roof constructed of steel I beams and brick, supported by trusses.

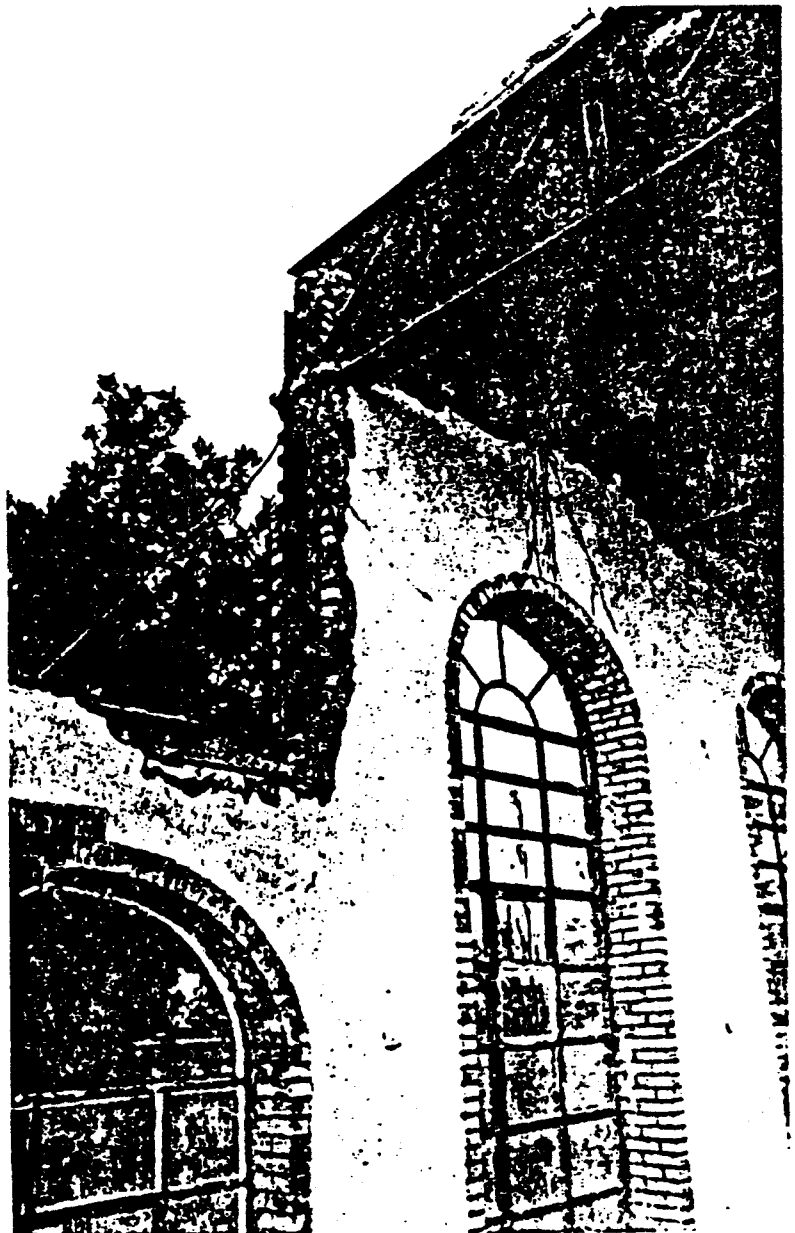
Detail of corners showing lack of steel framing.
