**A STRATEGY FOR DEVELOPING  
INDIGENOUS BUILDING  
IN EARTHQUAKE REGIONS**

**TIMBER REINFORCING  
FOR EARTHQUAKE RESISTANCE**

**CASE STUDIES OF THE  
BANDAR ABBAS (1977) AND THE ZARAND  
(1978) EARTHQUAKES**

**Development Workshop**

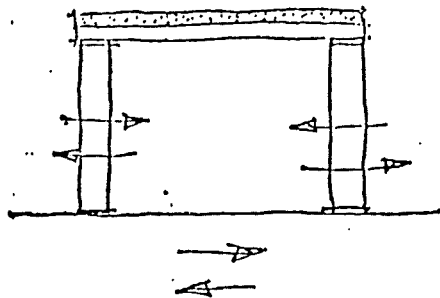
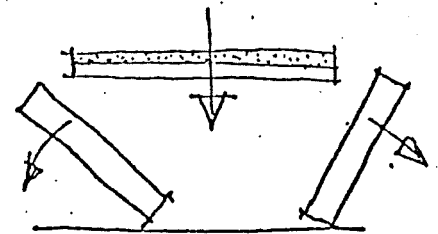
If walls are supporting heavy roofs, the sideways sway gathers momentum and walls fall outward causing the roof to collapse.

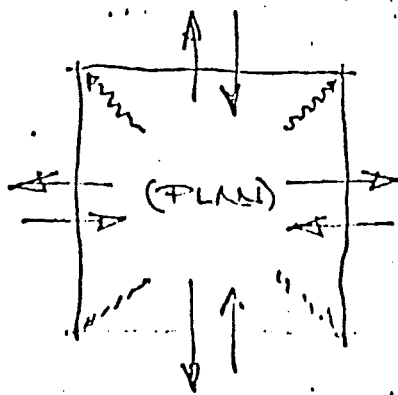
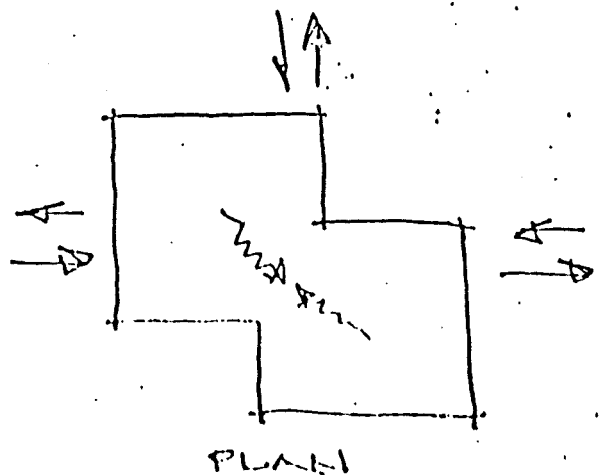
Stress due to earthquake movement is known to concentrate at the corners of a building or at joints between building elements. These areas need special design and construction attention.

stress at corners

stress at joints

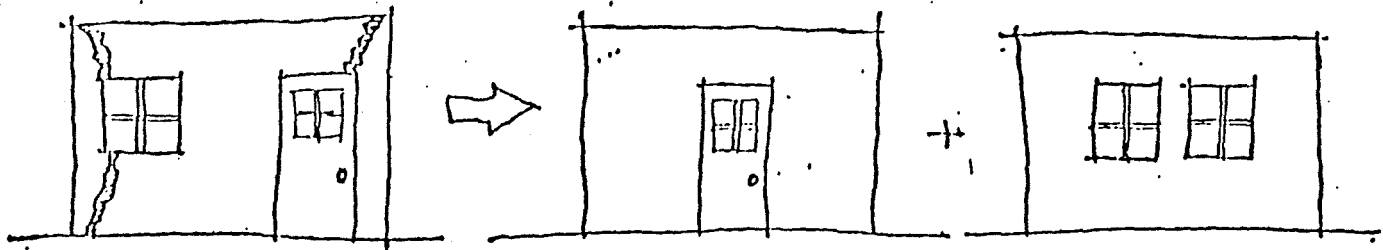
Because of stress concentration, openings should be avoided near corners of buildings.

Therefore it is better to position openings centrally on the walls.

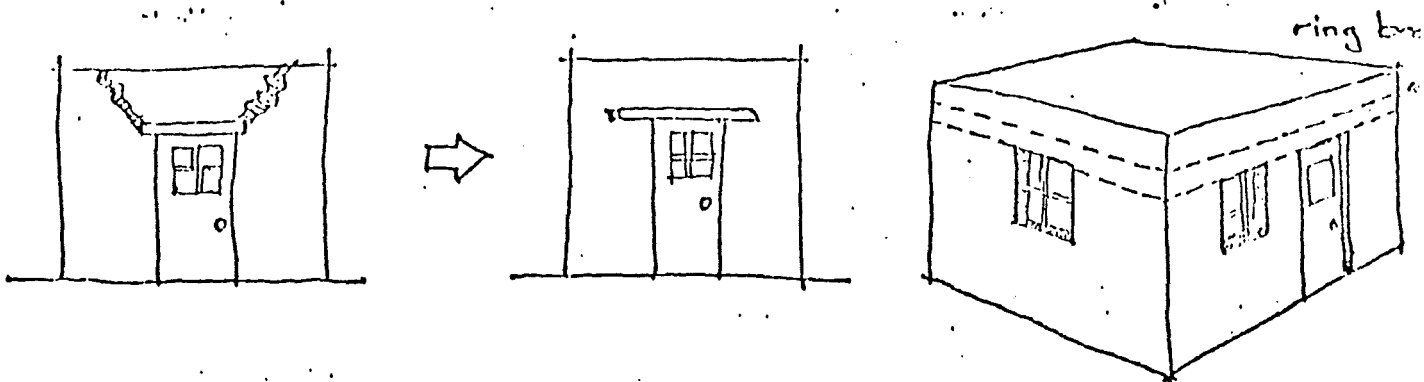
Cracking and failure often occurs above door and window openings. These areas can be strengthened by extending lintels deep into walls or by using continuous reinforced ring beams as a common lintel above all openings, with extra reinforcing at corners.

Such ring beams serve a double function in tying walls together to prevent movement which could cause roof collapse.

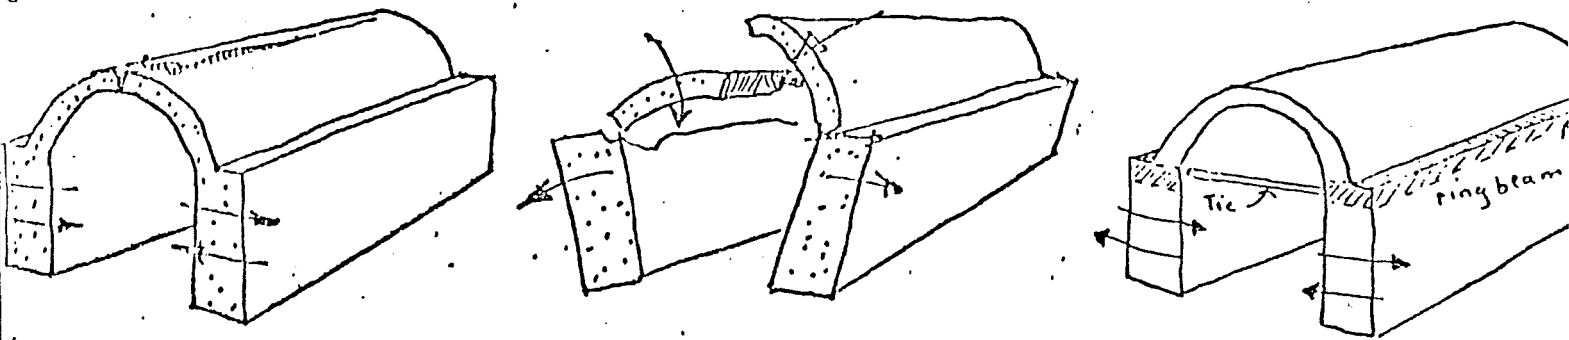
Vaults are much more susceptible to earthquake damage than domes. Any movement of walls upon which the vault rests will cause cracking in and failure of the roof.

A tie rod connecting the two side walls, which should have a continuous ring beam at the base of the vaults, will resist earthquake damage.

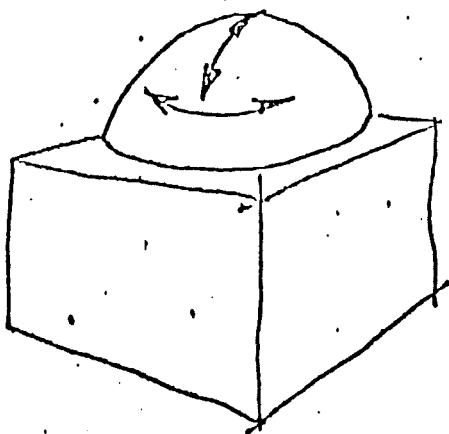
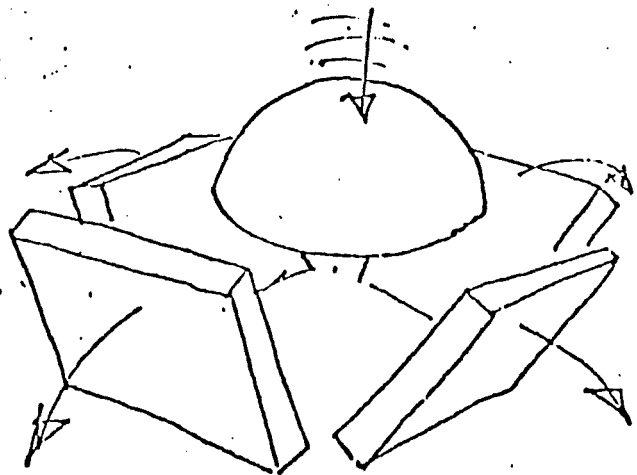
Domes, unlike vaults, have a double curvature and are able to withstand forces and movement much more easily. In many cases where walls have collapsed due to earthquakes, domed roofs have simply fallen intact.

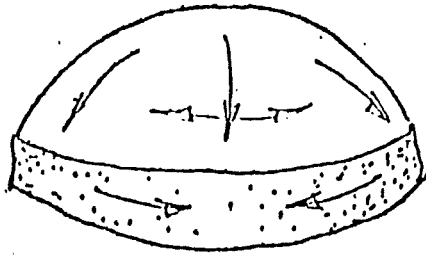
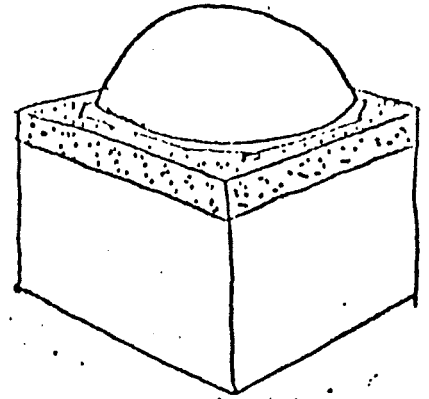
## Ring Beam Reinforcing for Domed Roofs

tension ring

continuous beam  
ties walls together

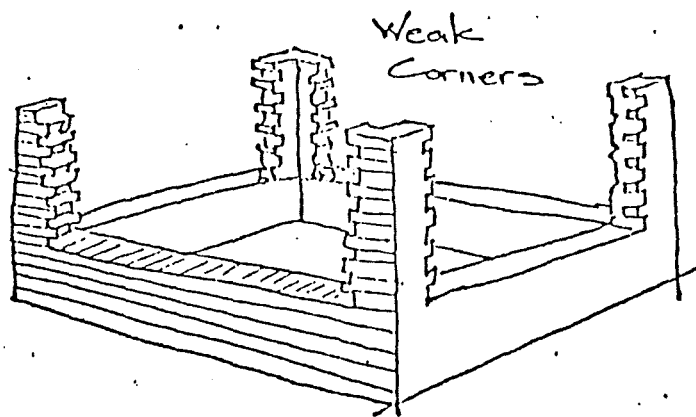
Bonding Corners: it is common practice in Iran to build up corners before infilling the wall. This is done to simplify the problems of lining up and levelling. This practice produces badly bonded and weak corners.

Since corners are critical stress areas, this practice should be discontinued. Brick courses should be laid continuously and wall building should progress evenly.

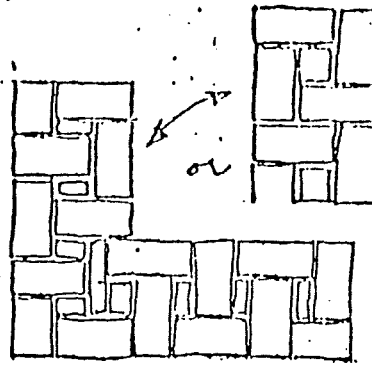
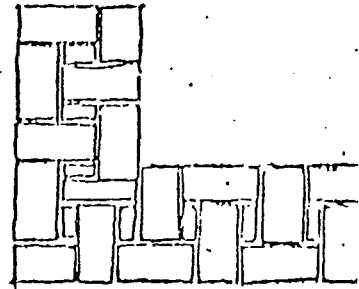
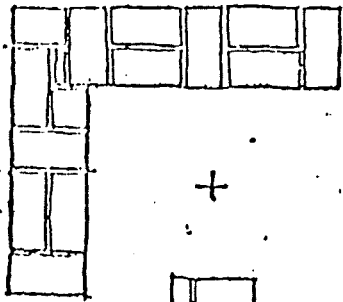
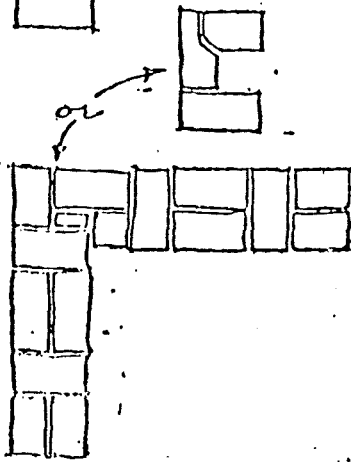
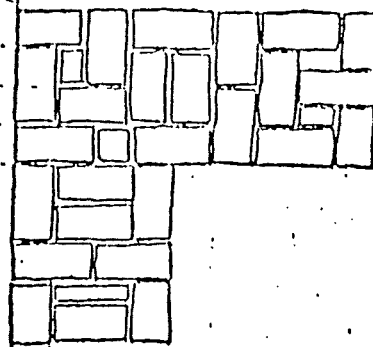
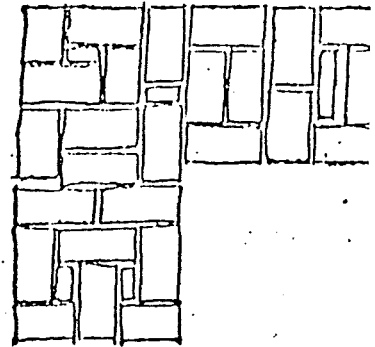
Proper Bonding: suggested bonding for brick walls of various dimensions.

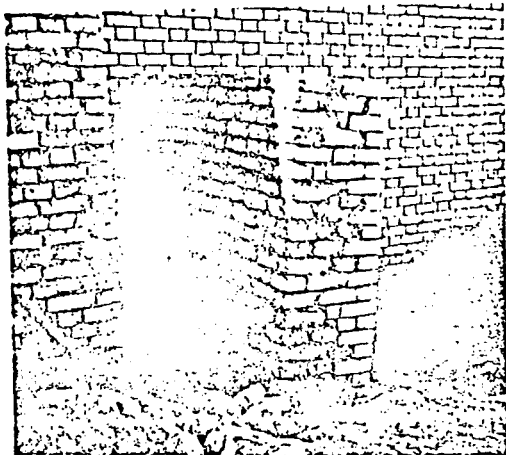
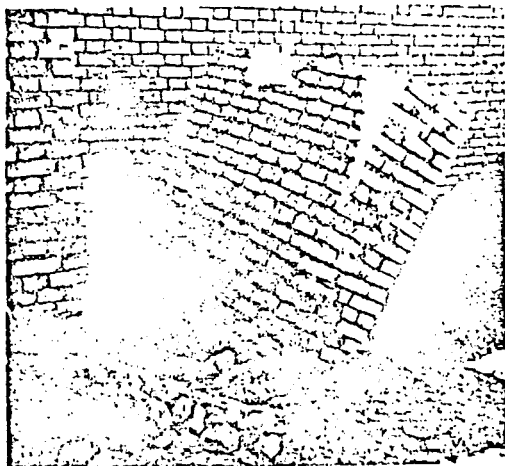
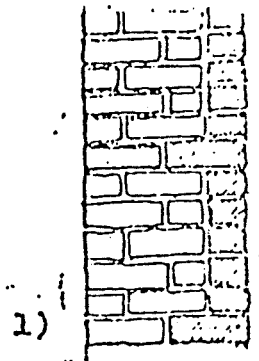
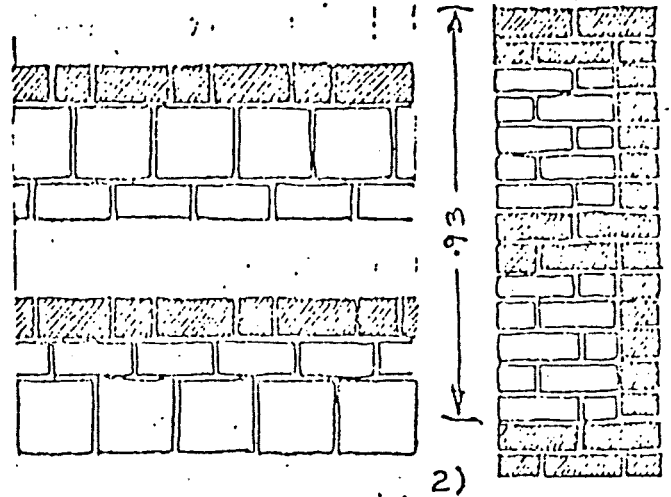
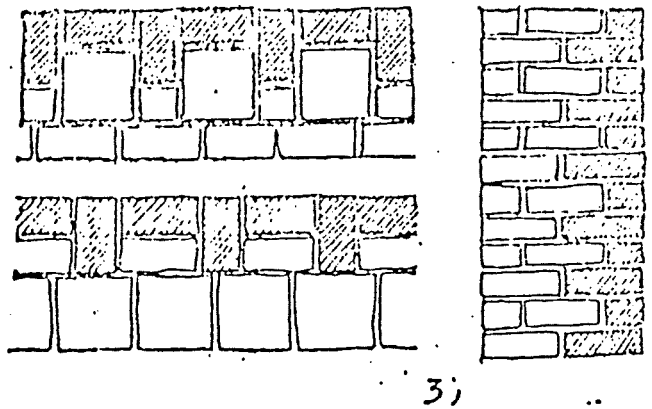
### From Bonding Experiments

- 1) poor bonding
- 2) good bonding
- 3) good bonding

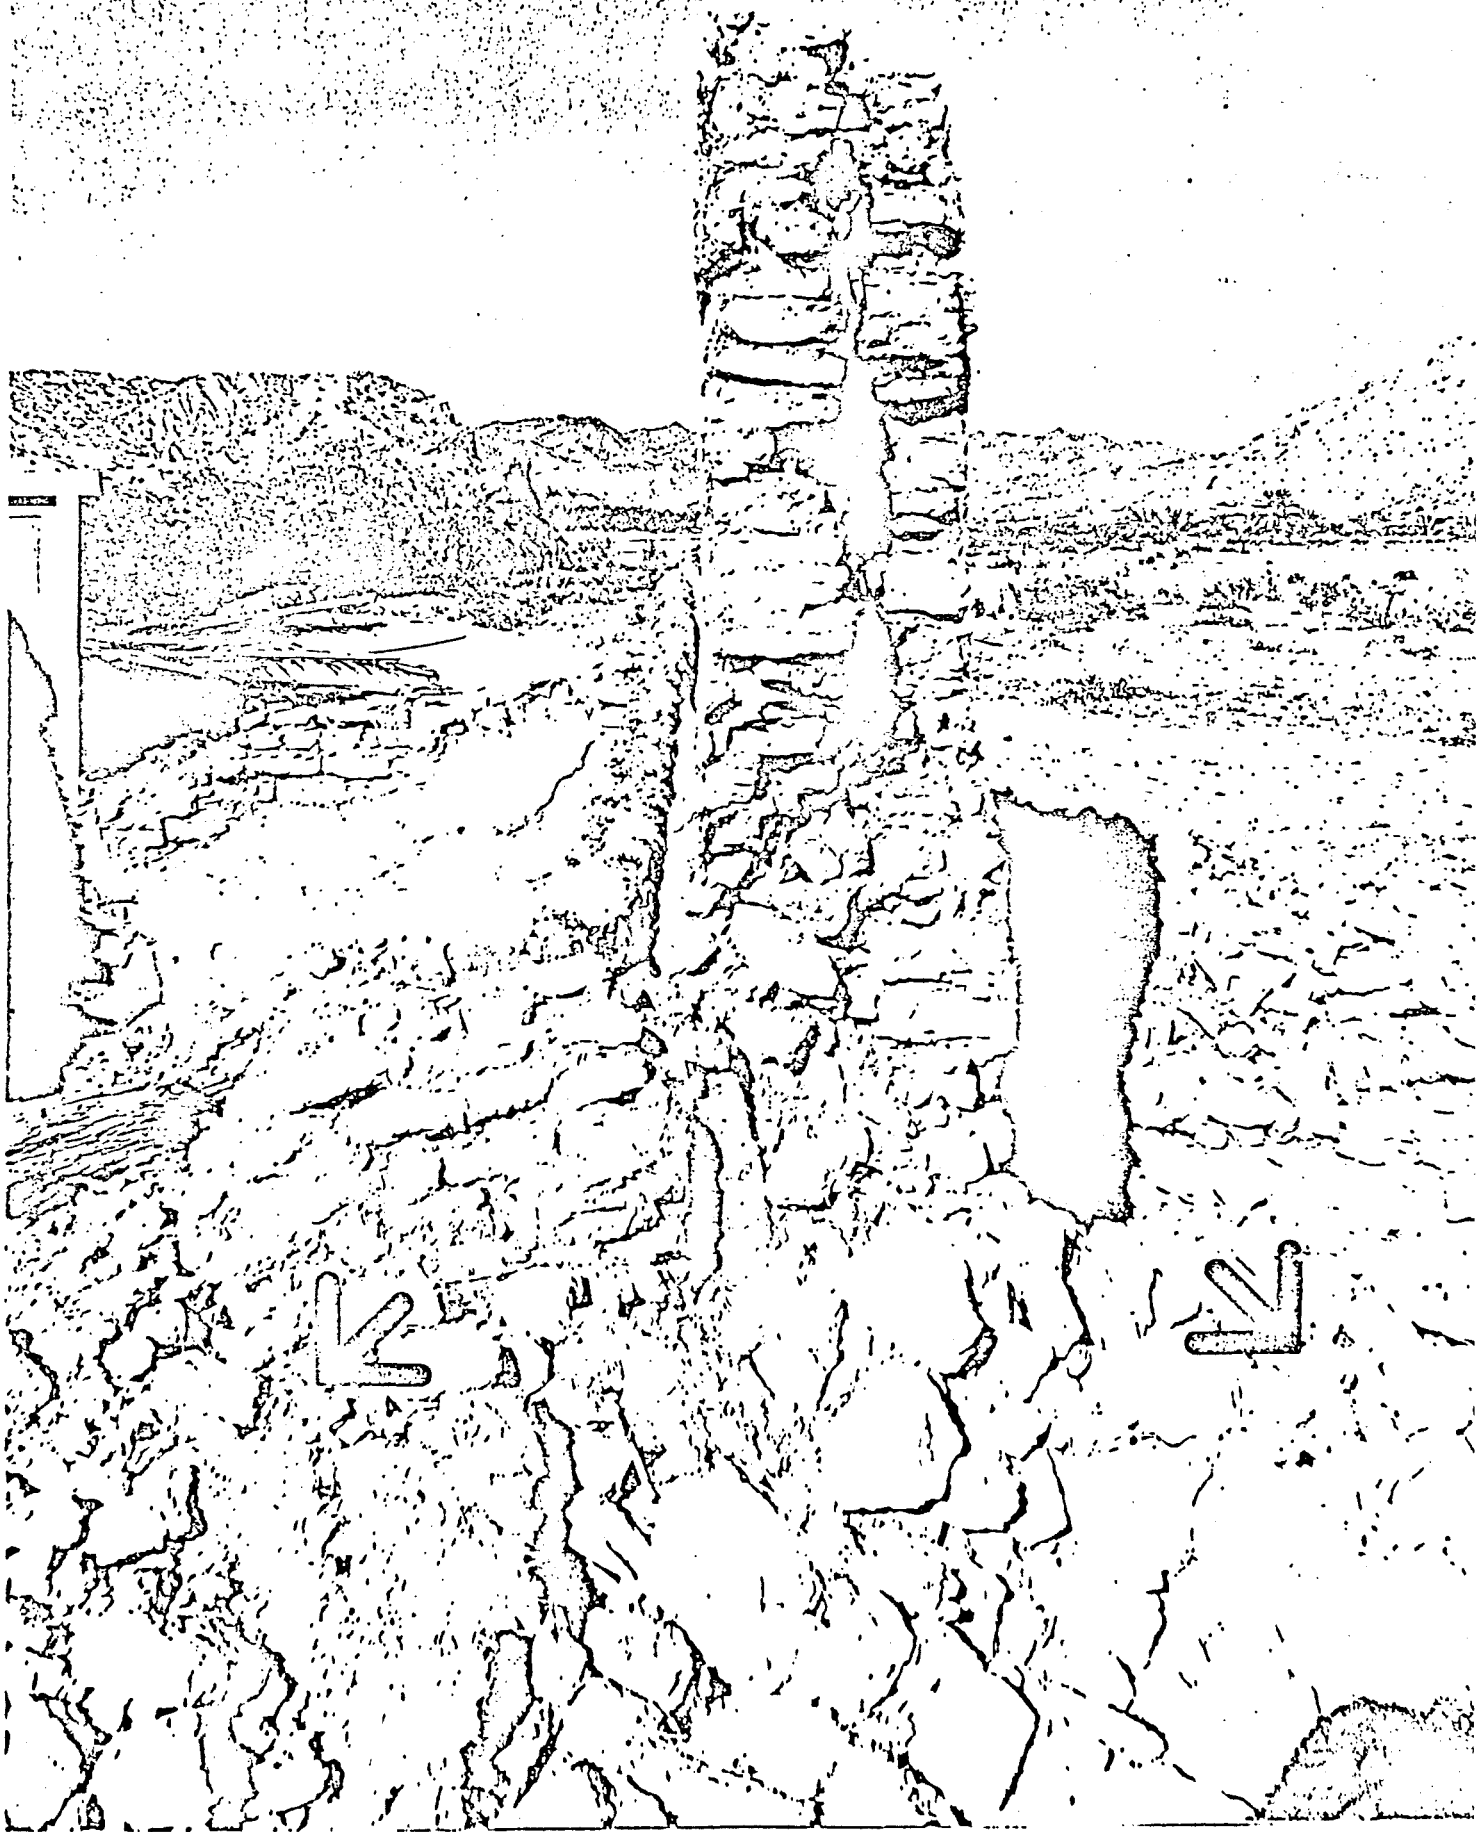
Examples of wall failure due to lack of internal bonding

The failure of these walls was facilitated by the lack of bonding through the width of the wall. Walls were built with an outer and inner course of bricks, with only the mortar to hold the two halves together. These two halves tended to separate during the tremors, so that neither half consequently was strong enough or thick enough to stand up on its own or to support its load, leading to collapse. In the absence of observing the actual collapse of these buildings, it is not possible to state accurately which part collapsed first or exactly how; however, the lack of bonding would facilitate the total disintegration of the wall. There was also evidence that the strength of the walls had been reduced by termite bore holes, which seemed particularly the case for the mud mortar used between the bricks, which may have been prepared with less care than the mud bricks themselves. Similarly, where timber had been embedded into the walls (basically a good practice in reinforcing and framing the walls of a building for earthquake protection), it had been attacked by subterranean termites and substantially weakened. There were some instances where walls had fallen intact as a result of the movement. Examples of this were particularly apparent where existing openings had been filled in at a later date with no bond to the sides of the opening and with nothing to resist the collapse of the added wall, which in several cases was seen lying almost intact on the ground.

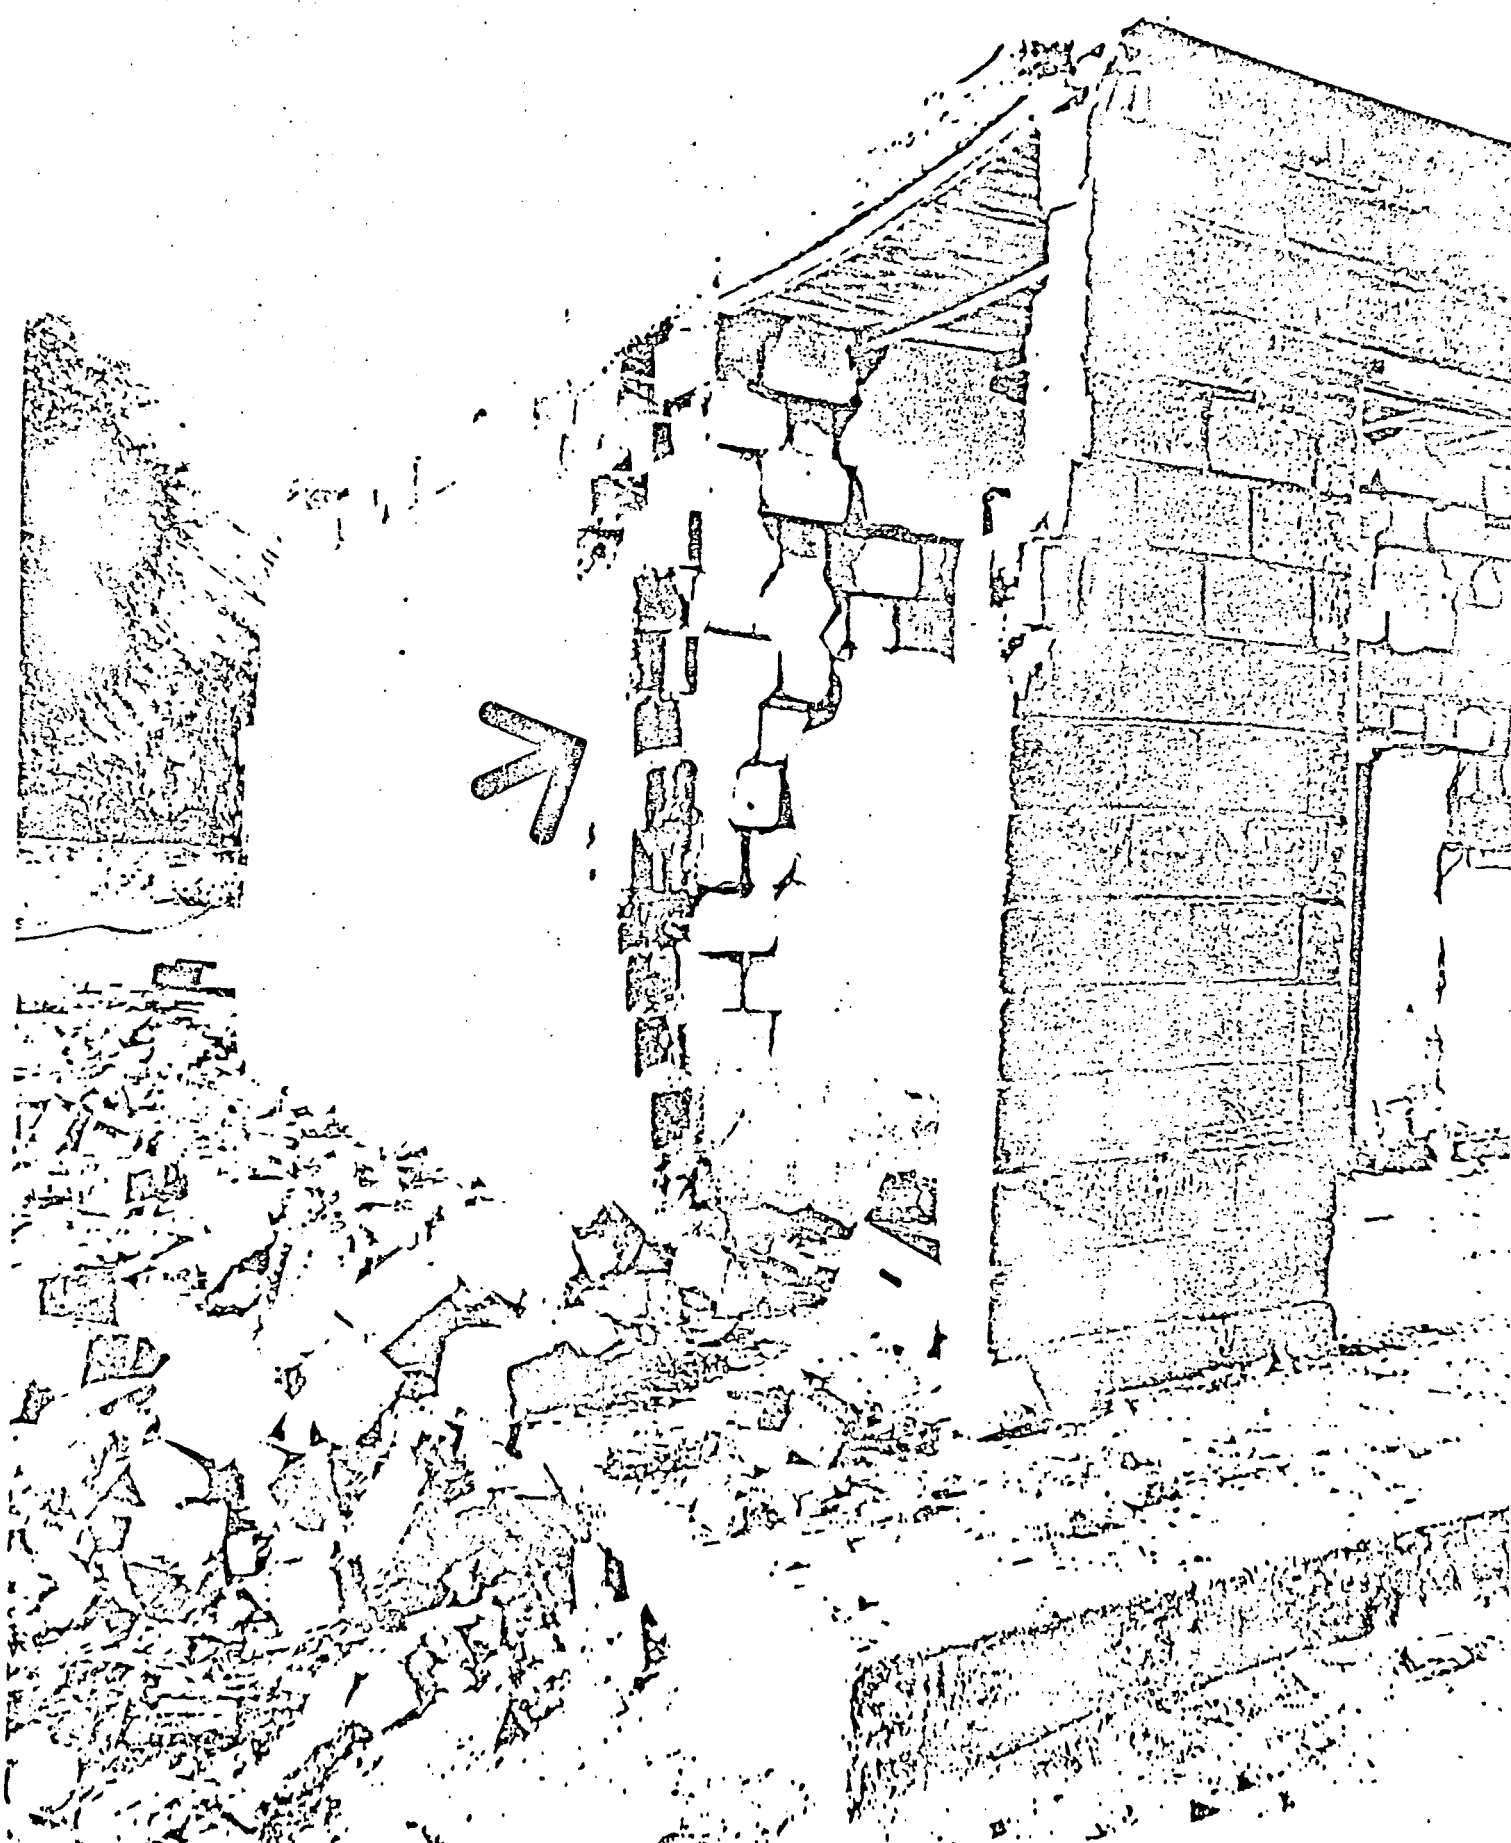
Corner failure  
and collapse of concrete

Only one building, a school, was seen during the visit that used materials and techniques not readily available in the area. The walls were of concrete block and the roof made of steel I beams with brick jack arches. There was a sheet of chicken wire mesh under the roof structure onto which the plaster had been applied. All the walls were cracked and one of the loadbearing walls had totally collapsed. The roof had collapsed.

The steel I beams had not been tied together and overall the building had suffered from insufficient, and in parts non-existent framing. With the movement of the steel, the jack arches had also collapsed.

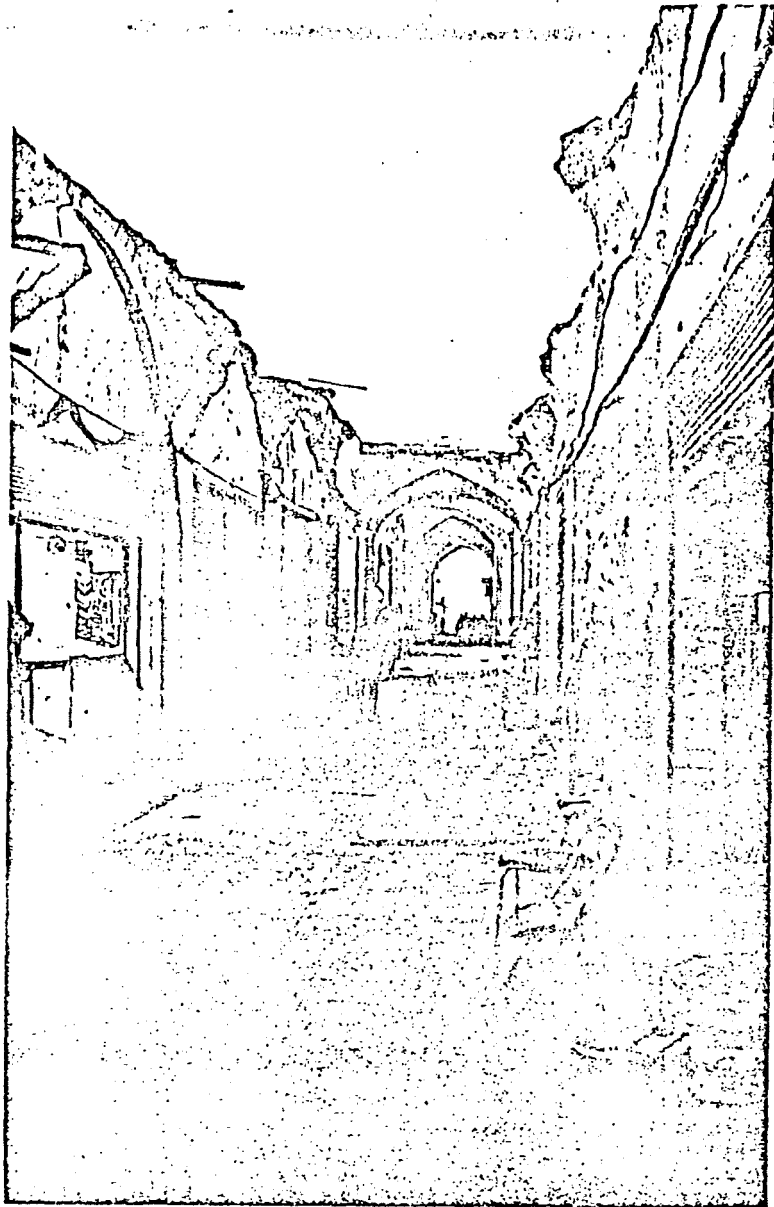
Zarand - Bazaar:

Collapse of bazaar roof probably due to poor repair.

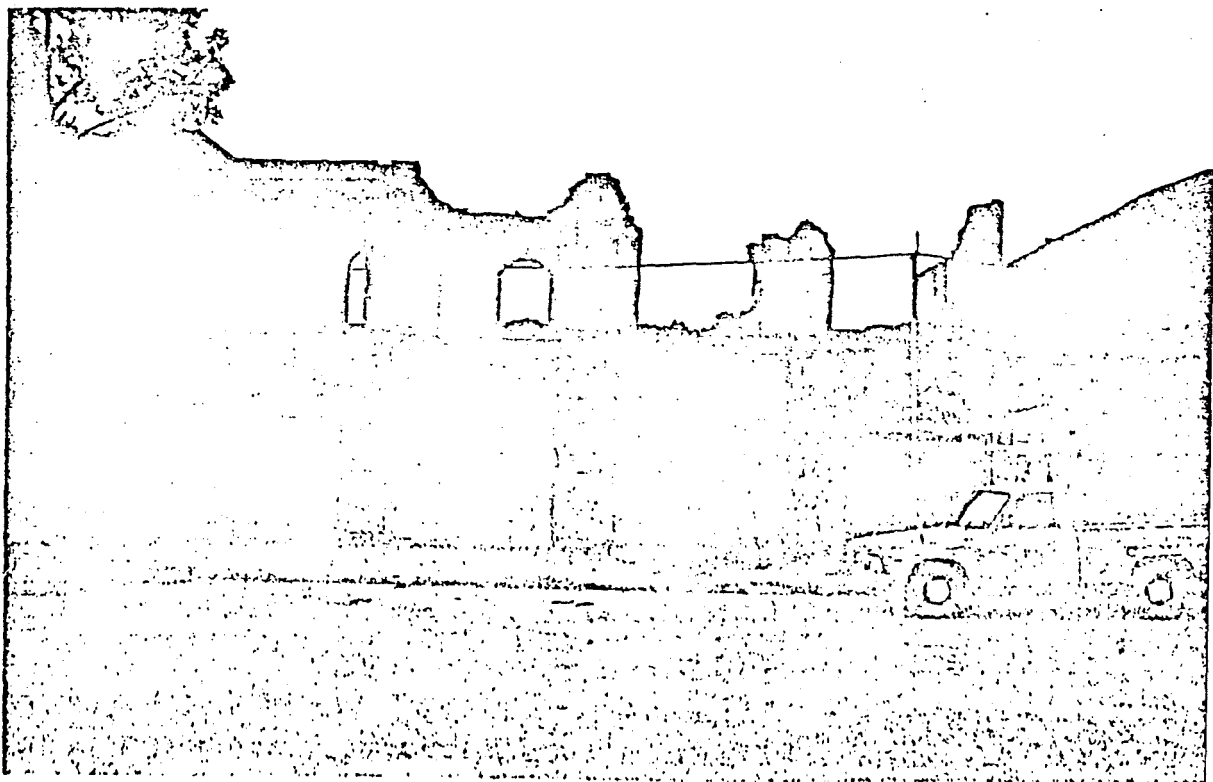
2 Zarand -

Vaults built side by side show progressively greater damage toward ends.

It was observed that mud-brick domes withstood the earthquake better than the vaults. This is due to the double curvature of the domes distributing the thrusts in all directions. The vaults which were tied with reinforcing bars sufficiently anchored into the side walls proved to be much safer structures. In a series of vaults built side by side, the end vaults, if not properly tied, had collapsed and the internal vaults showed progressively less damage. In the internal vaults the opposing thrusts balance each other, while stresses are concentrated toward the end vaults, causing their collapse; thus, if the end vaults are strengthened, it would improve the resistance of the whole series of vaults.

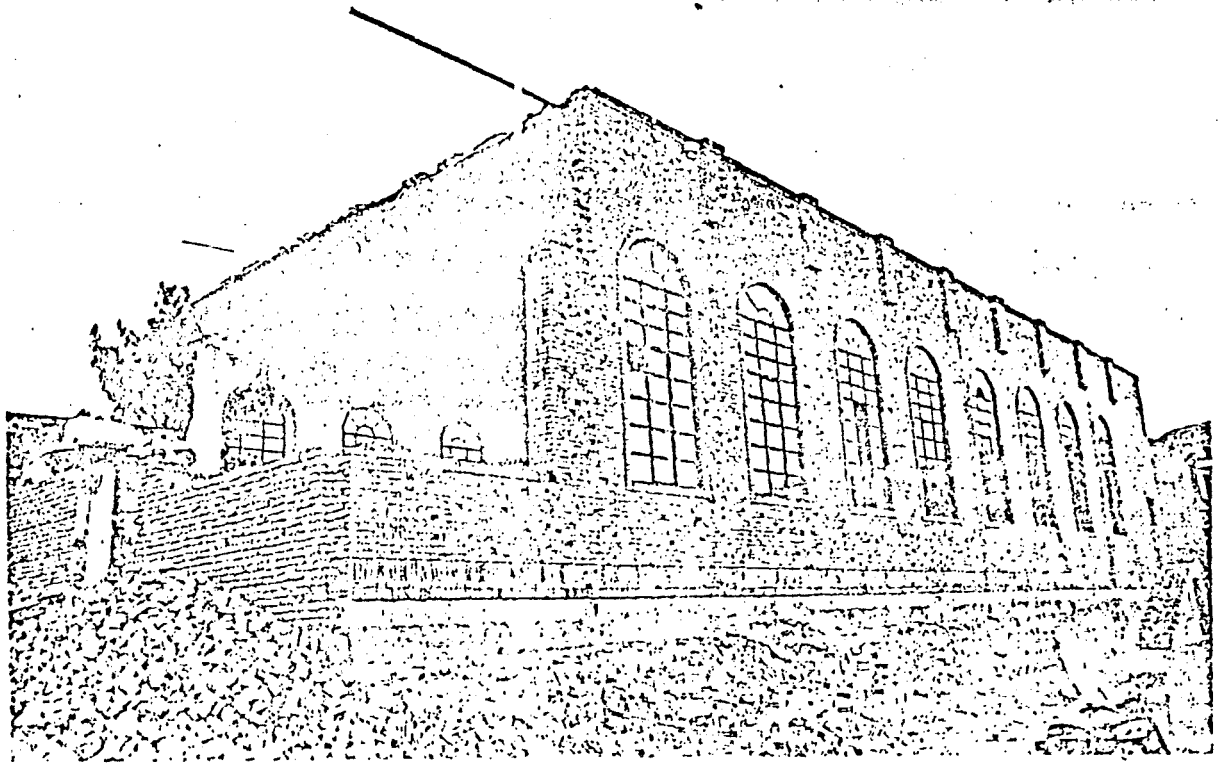
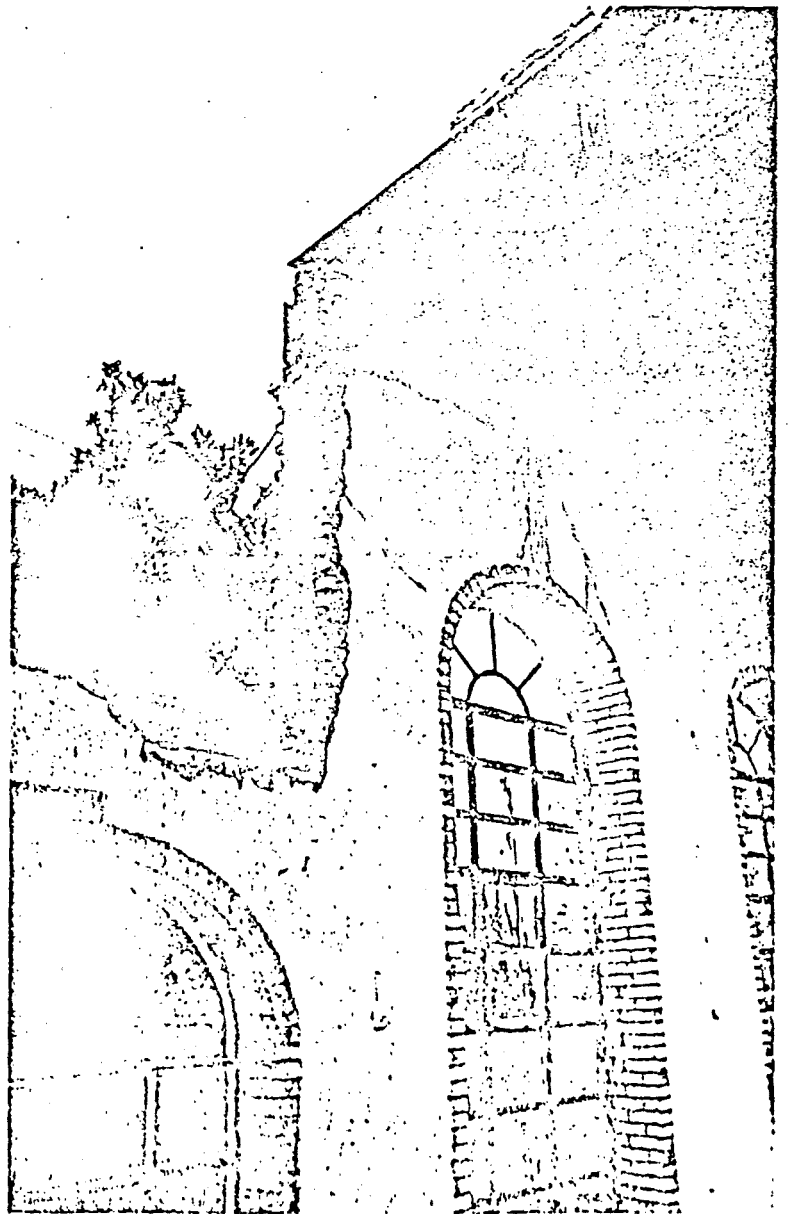
**3 Zarand:**

Recently built school failure due to improper steel framing, especially at corners.

Roof constructed of steel I beams and brick, supported by trusses.

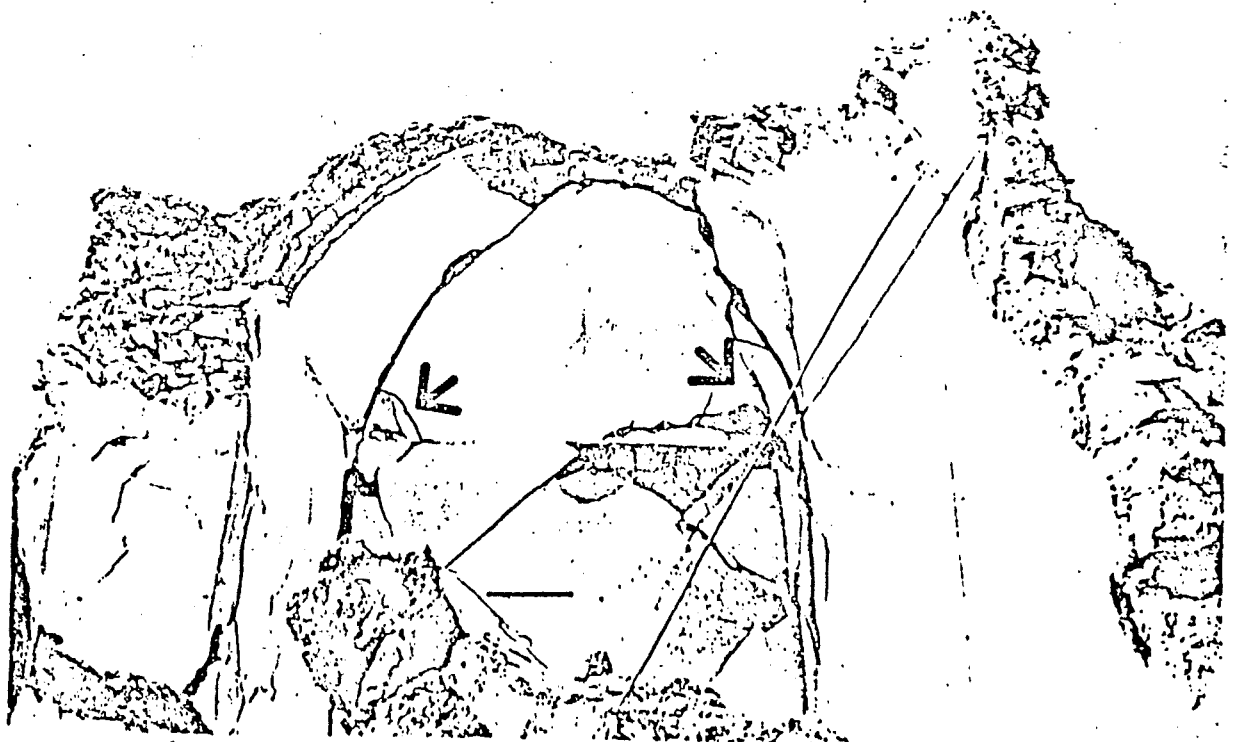
Dar Tang Gol:

Rubble wall failure due to lack  
of internal bonding.

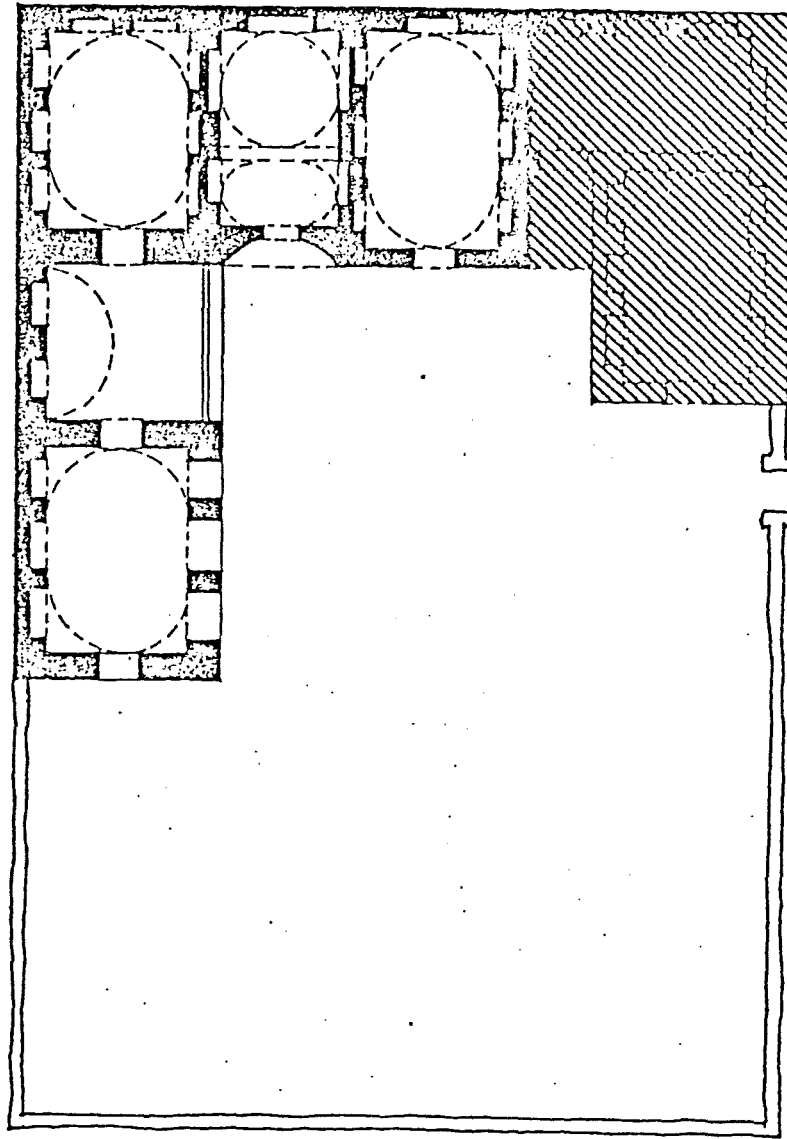
Sar Bagh:

Corner failure due to stress  
concentration.

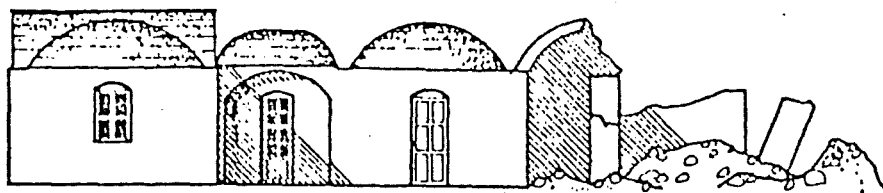
HOUSE AT SAR BAGH VILLAGE .

Stone and mud construction.  
Stress concentration in end rooms  
caused collapse.

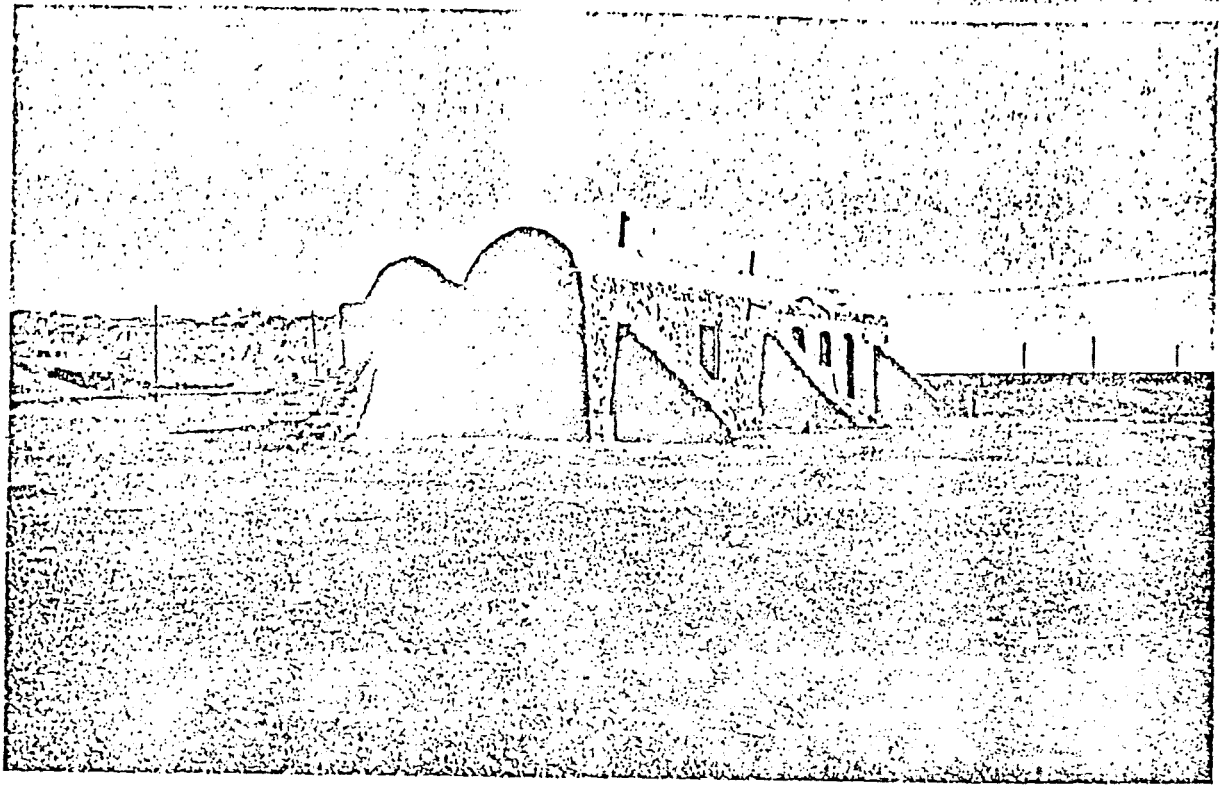
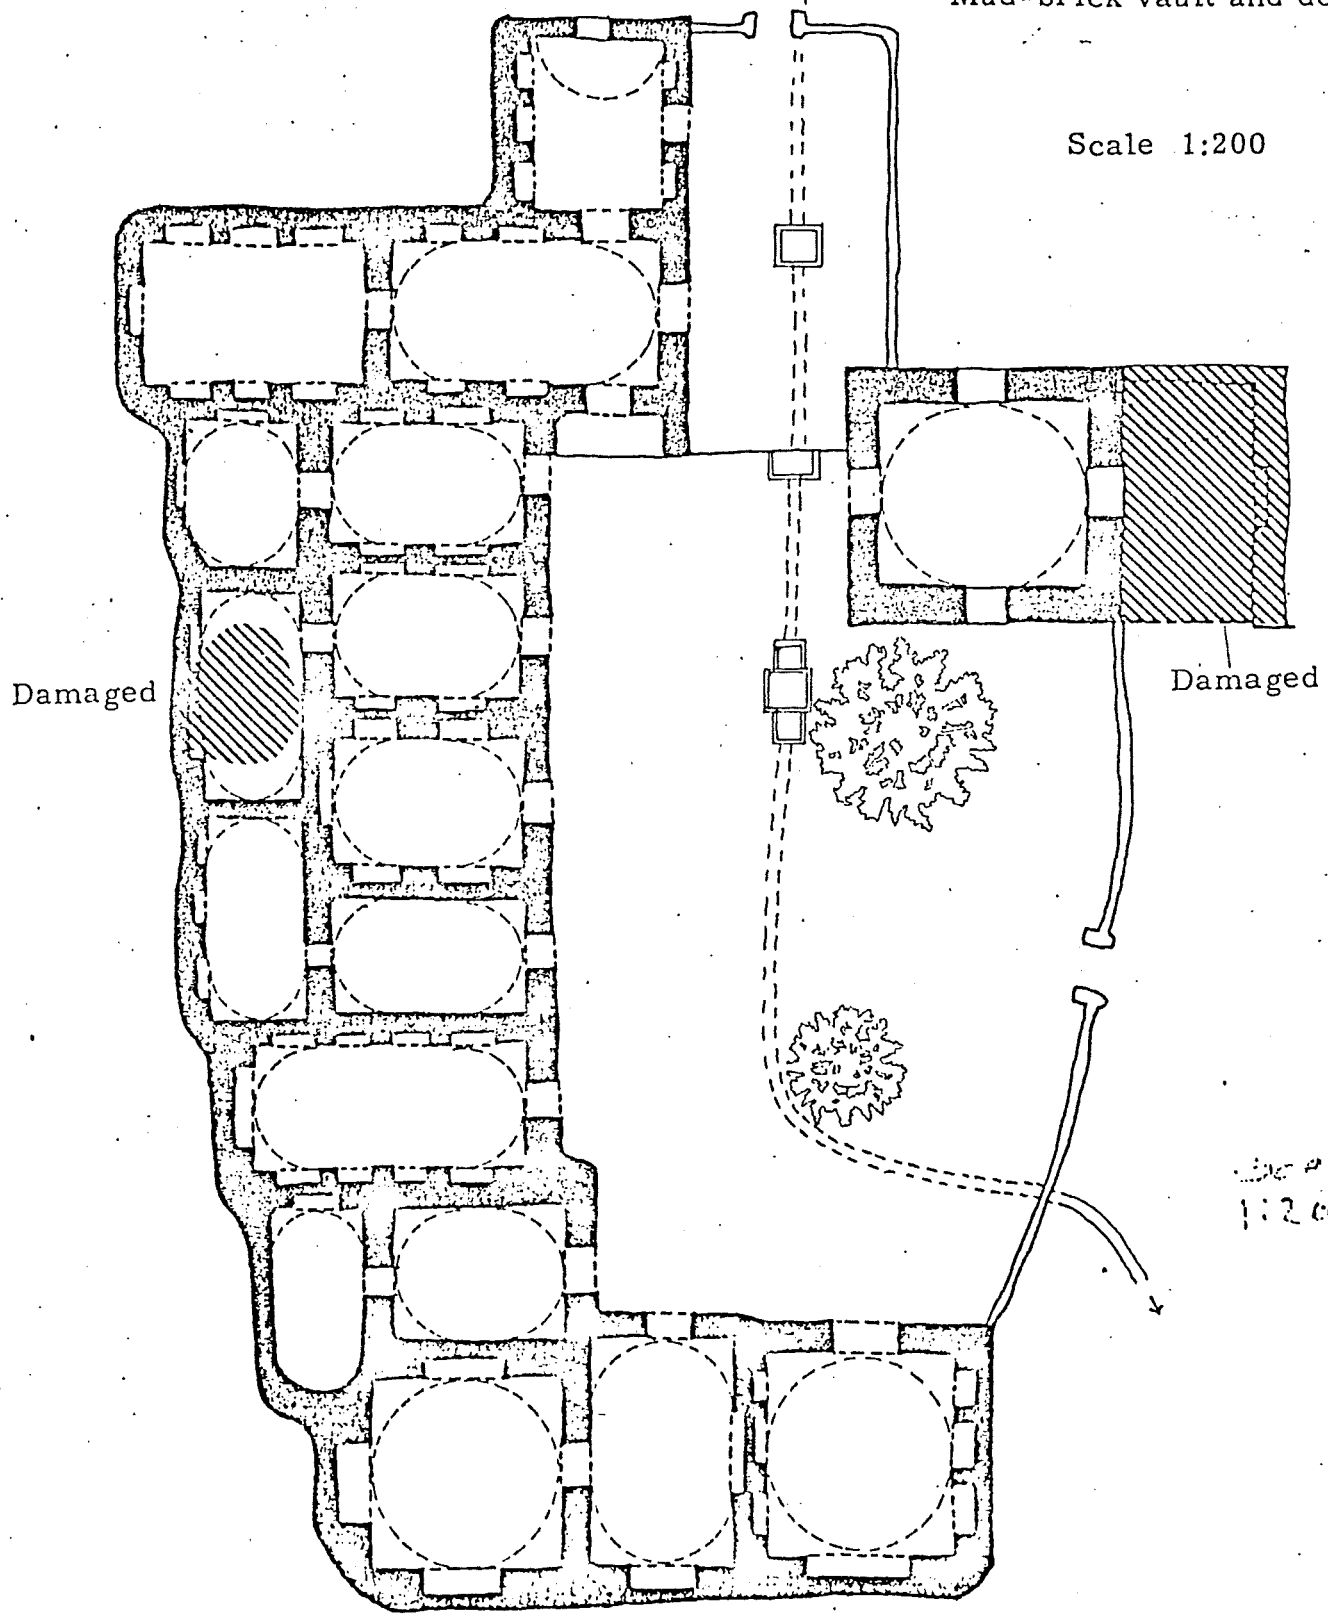
### WORKSHOP BUILDING SOUTH OF SAR BAGH

Workshop building south of Sar Bagh.  
(See accompanying drawing).

Stone walls in lime mortar and fired brick vaults. External buttresses assisted building to withstand major earthquake damage.

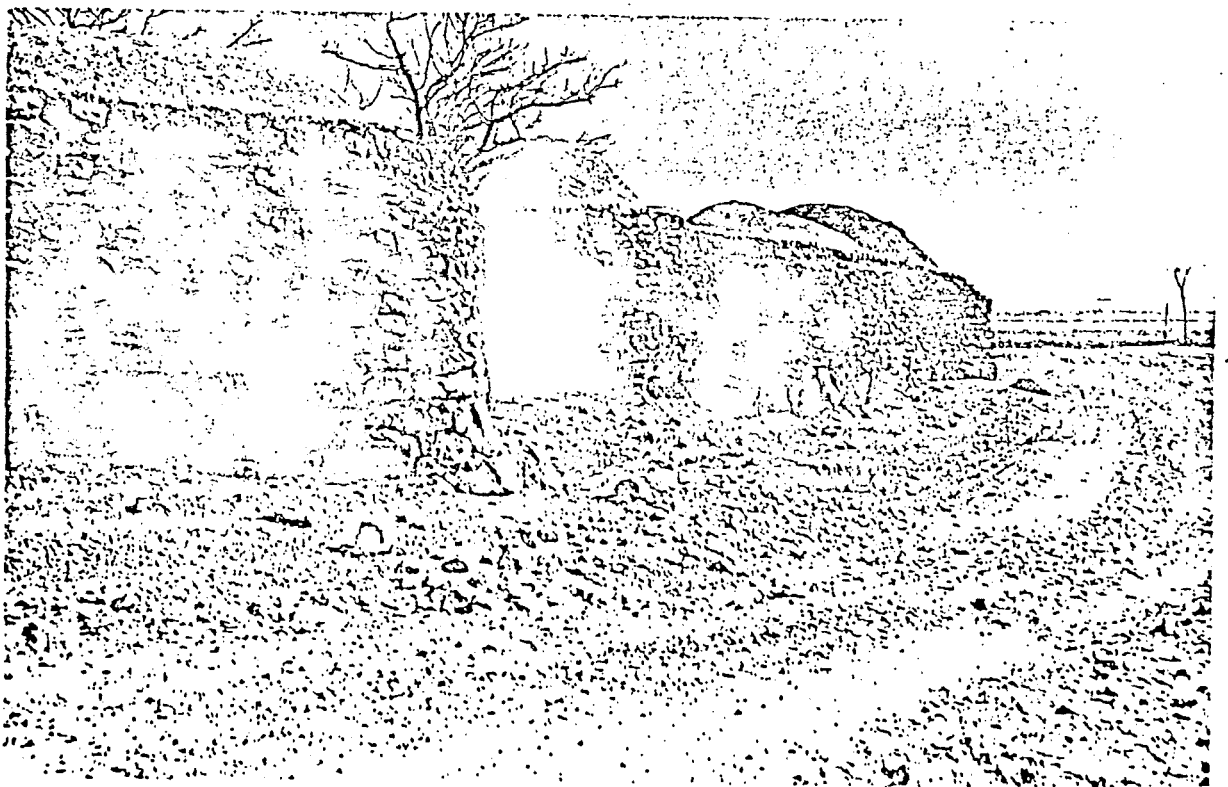
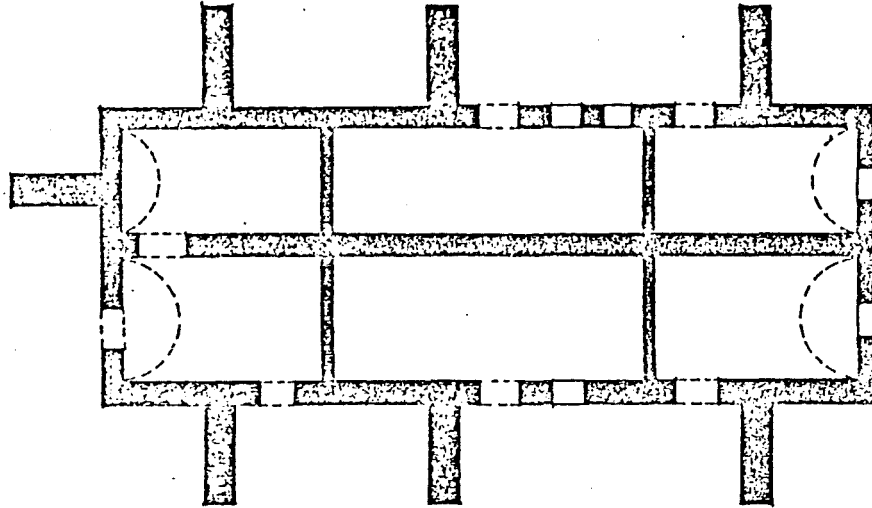
House south of Sar Bagh:

Rounded corners tend to disperse  
load which would otherwise be  
concentrated and cause damage.

HOUSE SOUTH OF SAR BAGH  
Stone walls  
Mud-brick vault and dome roofs.
