**A STRATEGY FOR DEVELOPING  
INDIGENOUS BUILDING  
IN EARTHQUAKE REGIONS**

**TIMBER REINFORCING  
FOR EARTHQUAKE RESISTANCE**

**CASE STUDIES OF THE  
BANDAR ABBAS (1977) AND THE ZARAND  
(1978) EARTHQUAKES**

**Development Workshop**

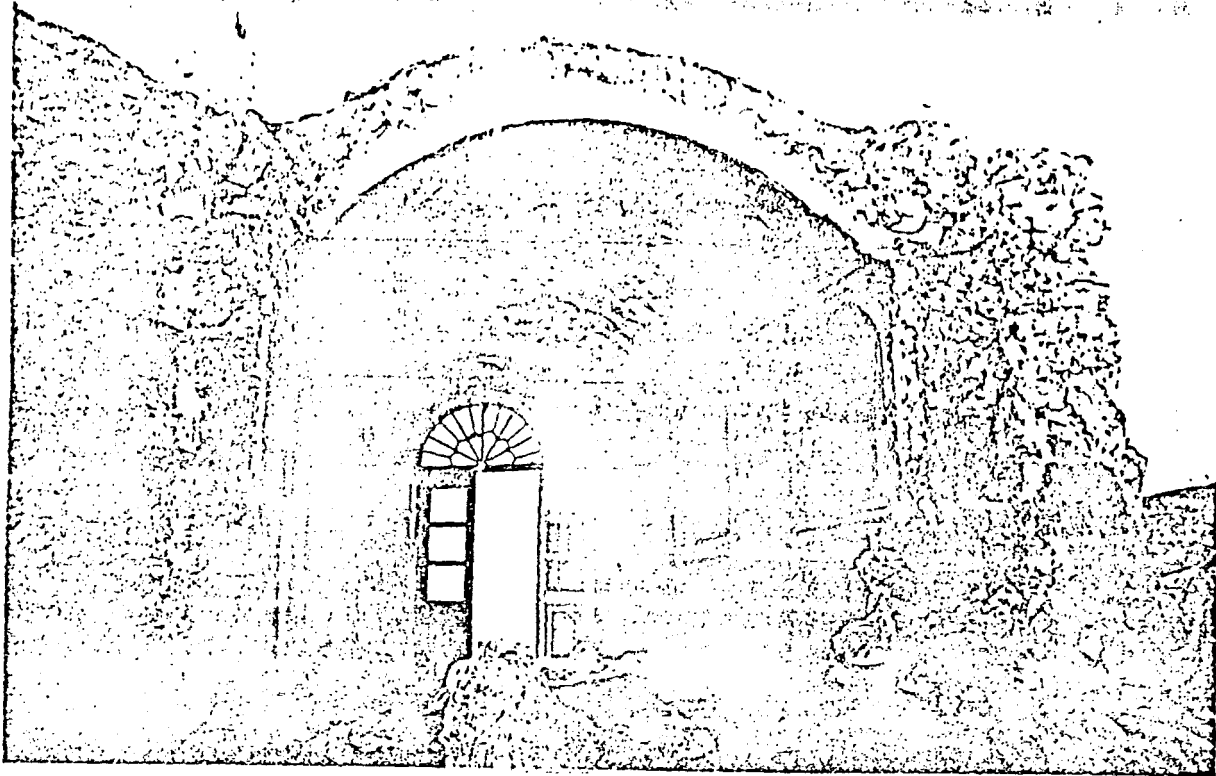
Gisk Village:

Metal tie rods anchored into reinforced horizontal beam at top of wall have prevented vault collapse. Horizontal timber beam set in cement mortar.
