**The Introduction of
earthquake resistant building techniques
in Koumbia,
North West Guinea**

Final Report

**John Norton
Development Workshop**

September 1985

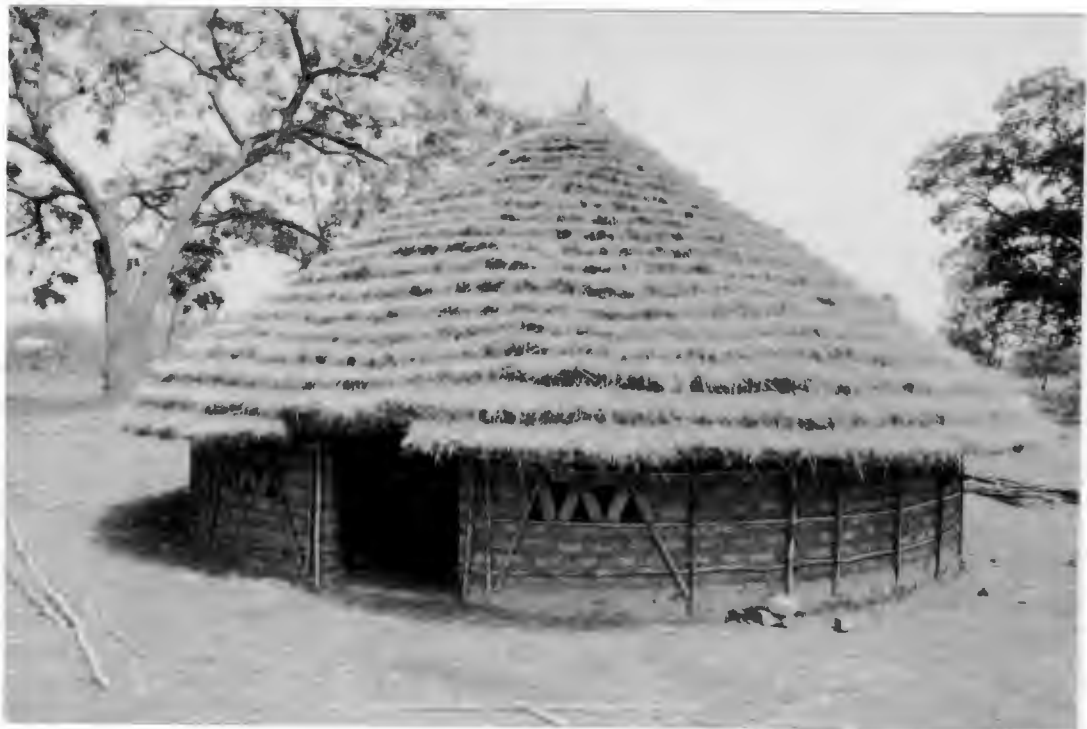
COMPLETED DEMONSTRATION ROUND HOUSE AT WOUPIRDE

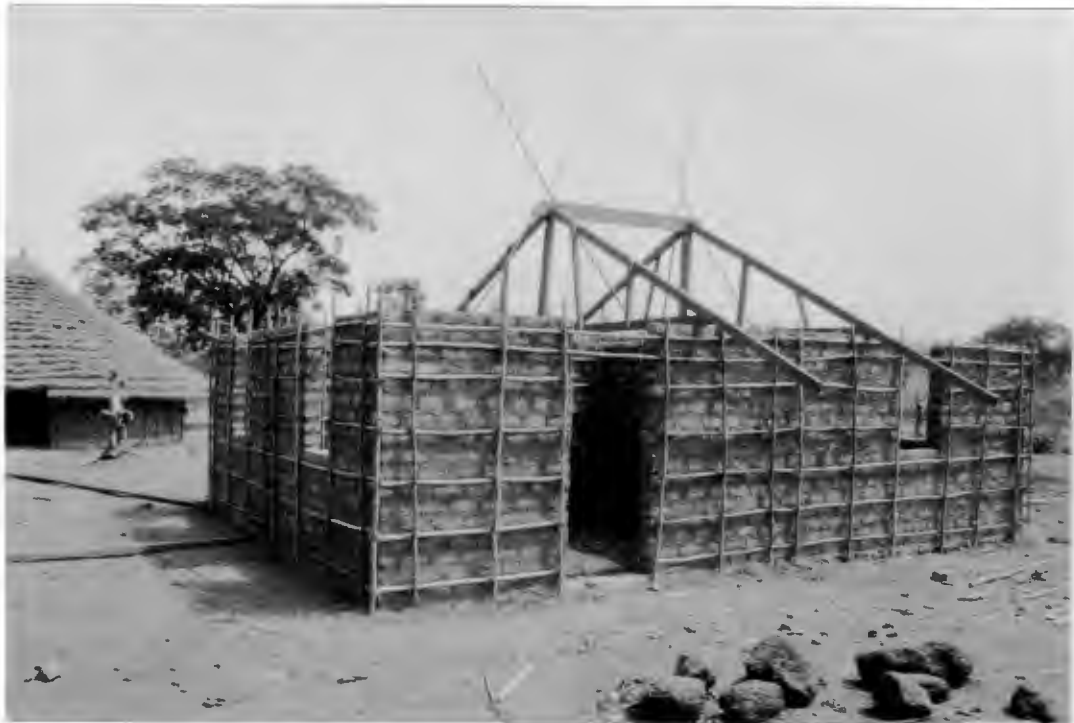
DEMONSTRATION RECTANGULAR HOUSE (LOCAL MATERIALS) READY FOR ROOFING.

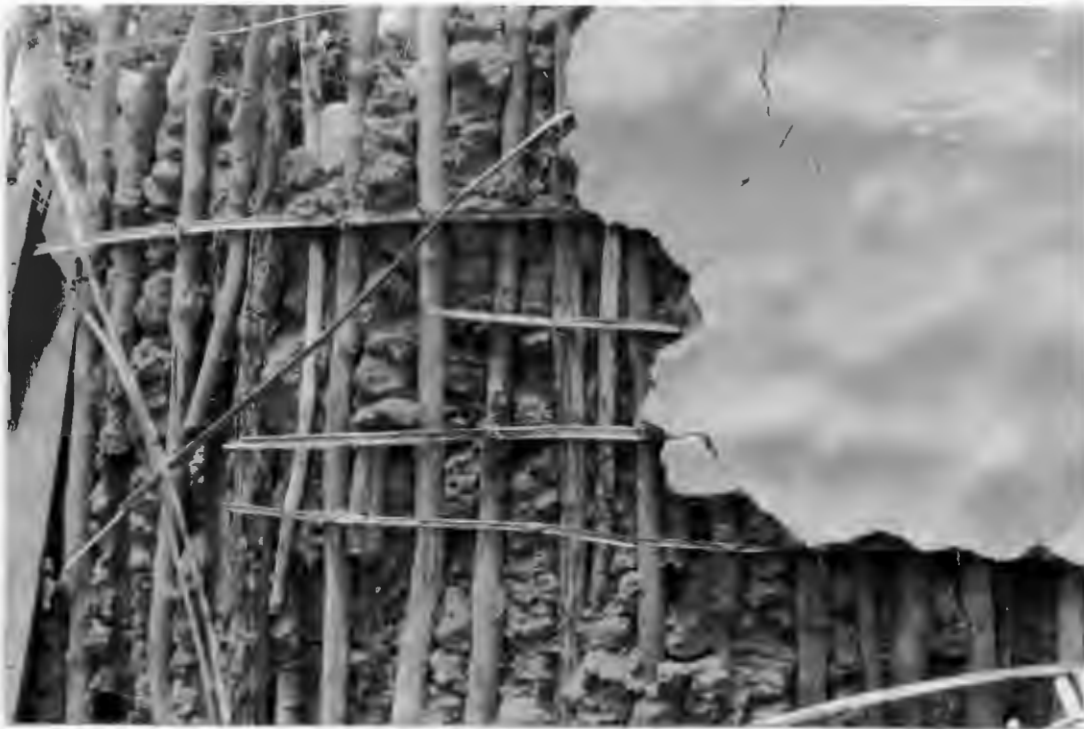
FIG.6. TRADITIONAL WALL WITH WOOD AND BAMBOO FRAME
COVERED BY MUD PLASTER

In Section 4.2 'The Traditional Round House', two types of traditional wall construction were noted: (a) walls made of mud plastered over a wood and bamboo lattice (Fig.6); and (b) walls made of mud blocks. Method (a) provided greater resistance to movement and damage caused by the earthquake, but it has the major drawback that the structure of the wall is made of organic material, and therefore easily destroyed by termites. This leaves the wall structurally weak even though the outer coating of mud plaster may show little sign of deterioration. Method (b), using mud blocks, is not subject to termite attack, but has little resistance to movement and shaking caused by an earthquake. In normal circumstances, when no movement occurs, this type of wall, if protected from moisture, will last a very long time, certainly in comparison to the lattice wall (a).

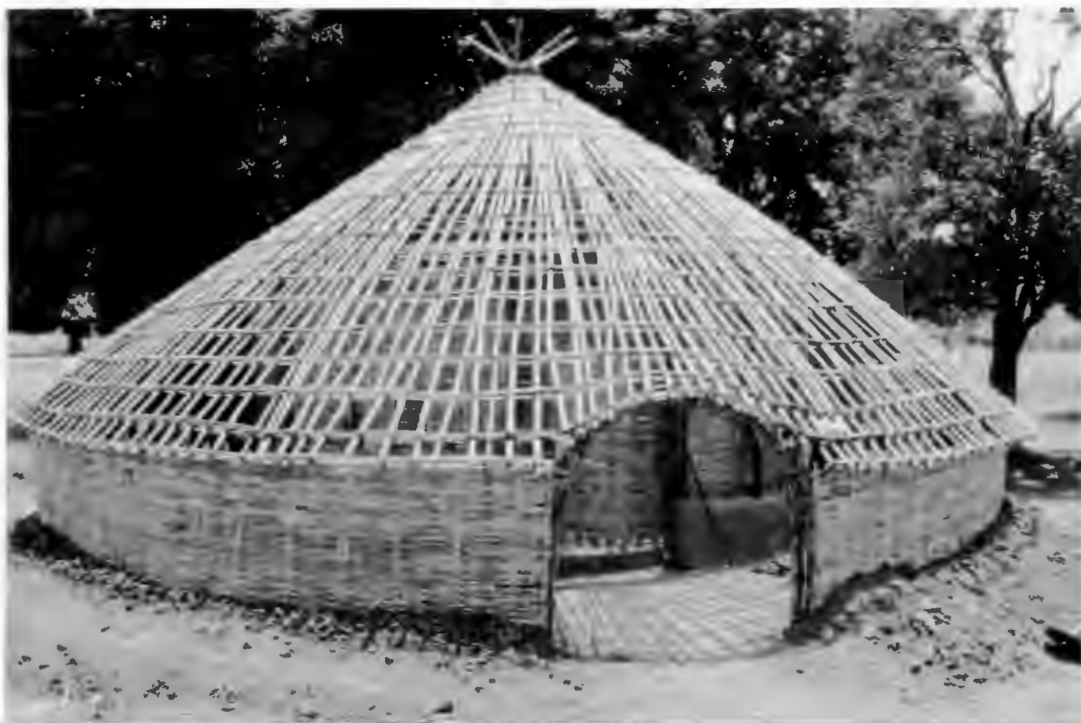
FIG.7. ROOF FRAME READY FOR THATCHING ON TEMPORARY HOUSE
NEAR KAMELE

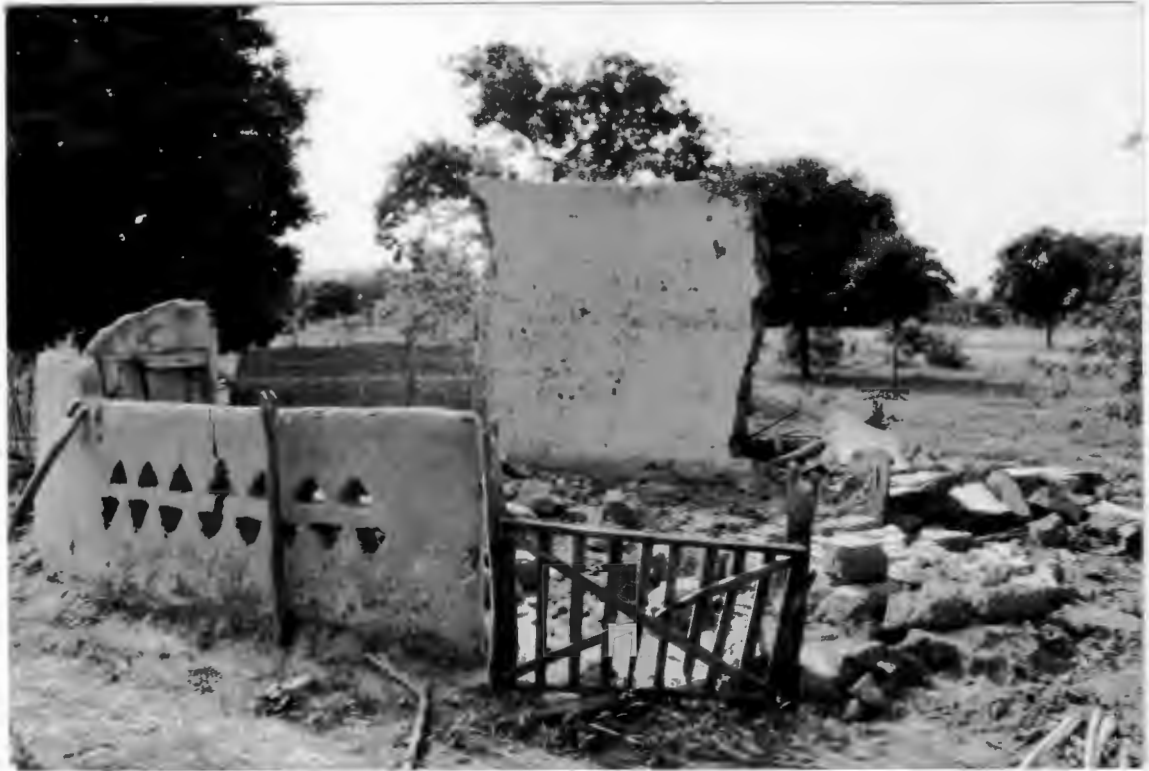
FIG.10. TALL SEGMENT OF WALL REMAINING ON ROUND HOUSE INNER WALL, AFTER COLLAPSE OF LINTEL AND MOST OF INNER WALL.

(i) The traditional round house: In traditional round houses, constructed from mud, bamboo, timber, and thatch, most injury and loss of life occurred because of the collapse of mud block walls. Rescue operations were made more difficult by roofs that had also collapsed. Although almost all the buildings in the earthquake area were damaged, a good number in fact remained standing. The thinness of the mud-block walls was blamed for the failure in most traditional round houses, but in fact the most common cause of failure was the collapse of lintels over openings in the circular wall of the inner room. This resulted from the lintel being too short and not projecting far enough into the wall on either side of the opening. The concentration of stress at openings and the general shaking during an earthquake lead to the collapse of the lintel and the subsequent collapse of the wall above it. This had several effects: the continuity of the circular inner wall was removed, leaving tall, thin, unstable segments of wall which could easily fall (Fig.10); the collapse of the lintel allowed the roof structure to sag at that point, (Fig 11) thus applying an outward thrust on the remaining wall on either side of the opening, and on the lower perimeter wall, both of which were pushed over by this thrust. Supporting forked posts were also pushed over by this effect.

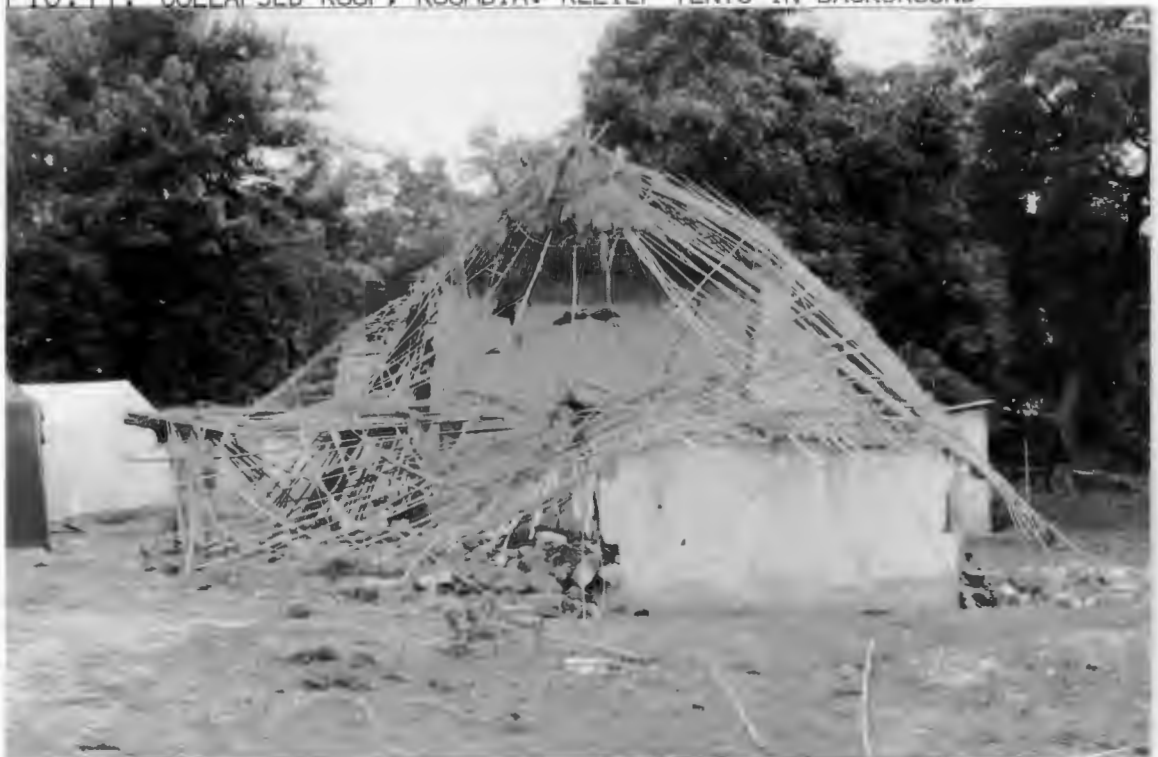
FIG.11. COLLAPSED ROOF, KOUMBIA. RELIEF TENTS IN BACKGROUND

Newly erected roof frameworks are structurally rigid, and rest principally on their perimeter supports. With age, however, the framework tends to sag

as a result of termite attacks to the binding and the horizontal rings which hold the roof together. During the earthquake, the degree to which roofs exerted downward and outward pressure depended to a large extent on their age and condition.

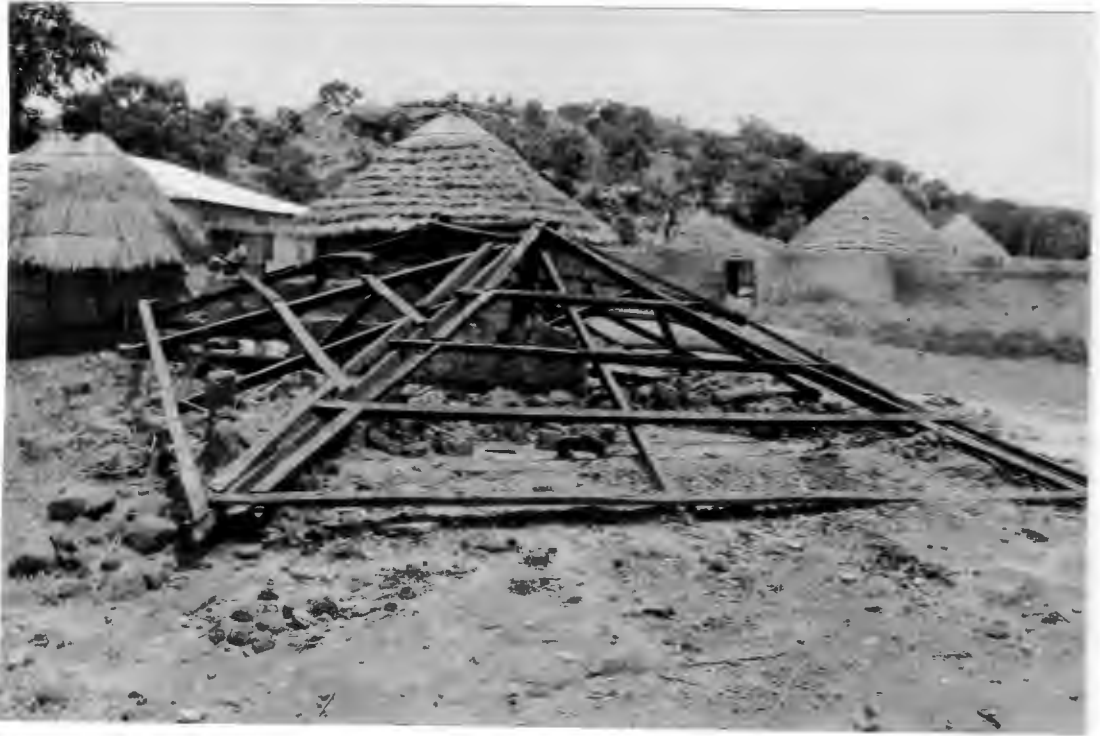
FIG. 12. RECTANGULAR HOUSE ROOF FRAME RESTING ON RUBBLE OF COLLAPSED WALLS. KOUMBIA

(ii) The traditional rectangular house: In Koumbia, a few examples of rectangular houses with mud block walls were noted, and in all cases they had collapsed completely, leaving the roof framework resting on rubble on the ground. (Fig.12) In Kamélé, one building of this type was found only partially destroyed, but all its corners had collapsed. (Fig.13)

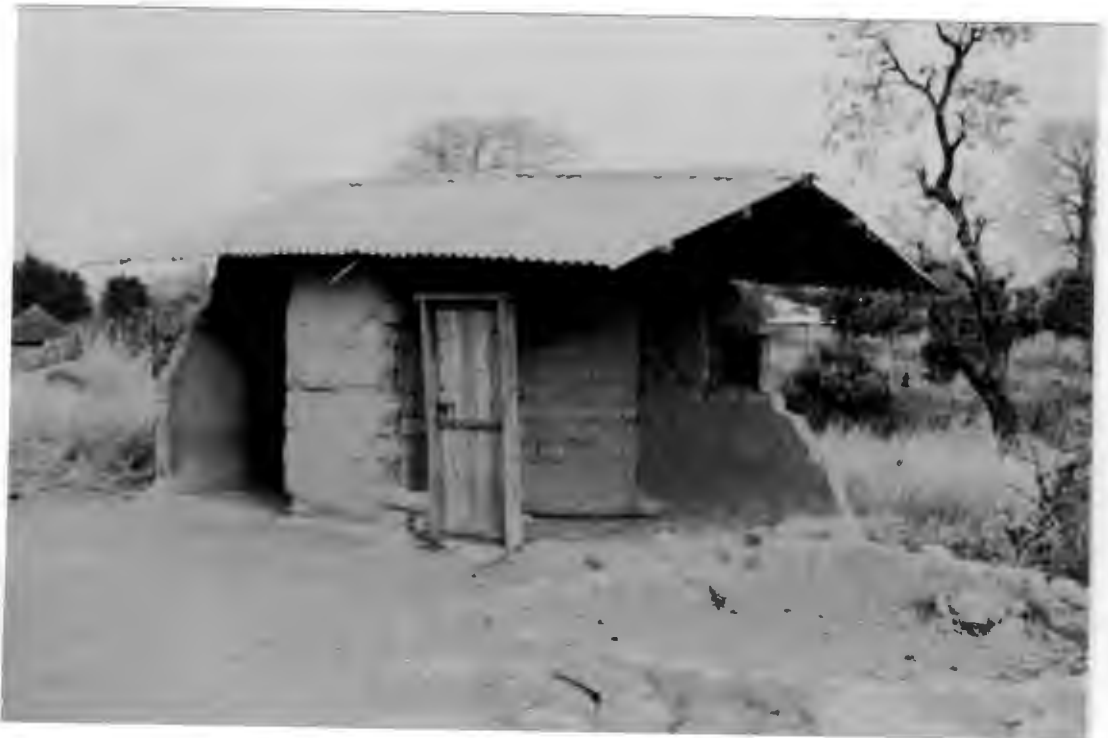
FIG. 13. COLLAPSED CORNERS ON SMALL RECTANGULAR HOUSE.

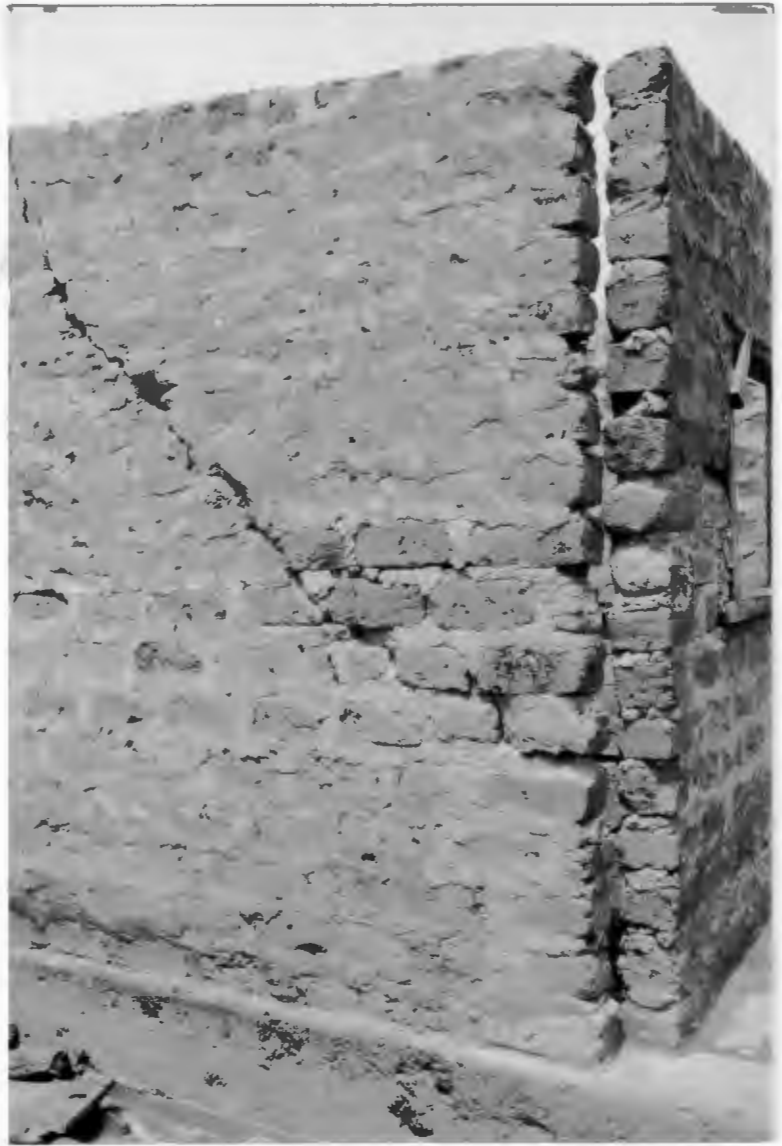
FIRE BRICK WALLS WITH NO BOND AT THE CORNER, AND WITH NO REALISTIC PROVISION FOR PUTTING IN CORNER COLUMN AND REINFORCEMENT.

NOTE DIAGONAL CRACK FROM TOP LEFT TO LOWER RIGHT.

The conflict of movement between two walls at corners caused considerable cracking. In some cases the corners collapsed. In nearly all cases the wall became separated from the corner column, often with cracking taking place through the bricks. (Fig.15) Both concrete blocks and fired bricks were of very poor quality. The concrete blocks had too little cement and could be crumbled by hand, and the fired bricks were sandy and were frequently cracked even

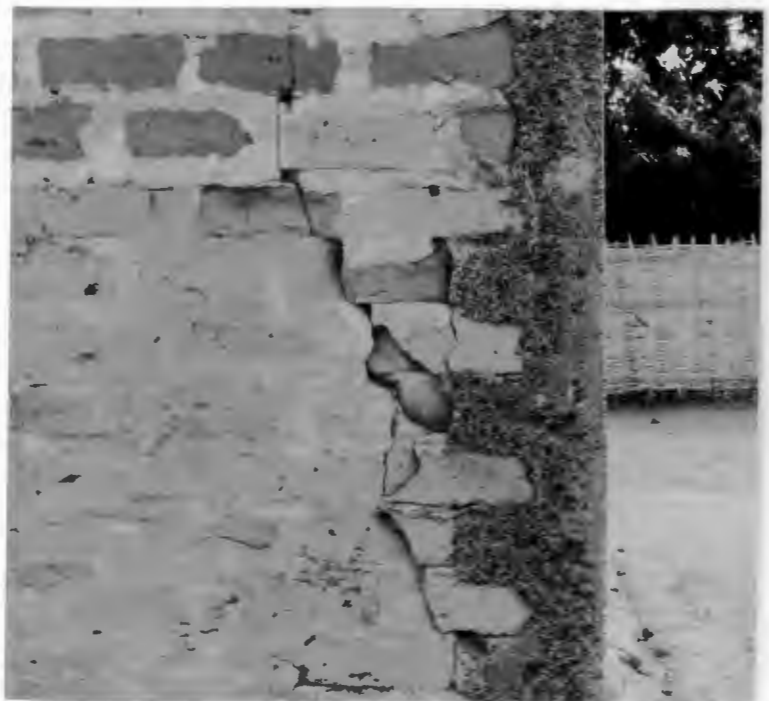
FIG. 15.

CRACKING THROUGH BRICKWORK CLOSE TO A REINFORCED COLUMN AT A CORNER.

BRICKS WEAKER THAN MORTAR.

before the earthquake, because of the way they were made. Bricks in the area are slop-moulded, which means that the mud is used wetter than for a sand-moulded brick, and the result is that there is more shrinking and cracking during the drying period. By contrast to the poor quality of blocks and bricks, the mortars were strong, using more cement than necessary in comparison to the masonry they were binding. Cracks occurred more often through a brick than through the joint between two bricks.

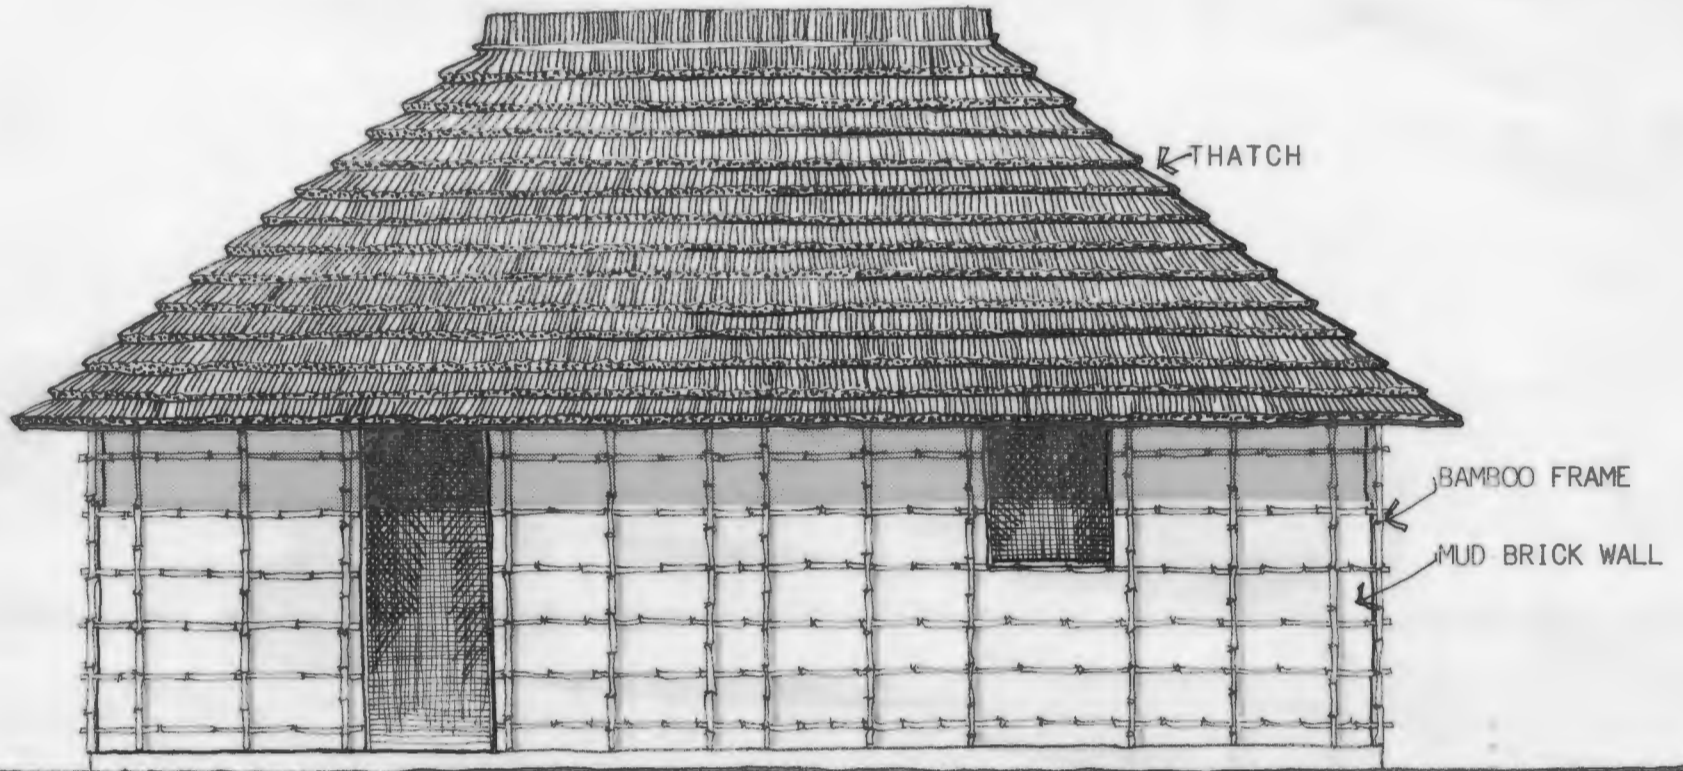
FIG. 17B.
DEMONSTRATION RECTANGULAR HOUSE ELEVATION.
LOCAL MATERIALS.
SCALE: 1:50

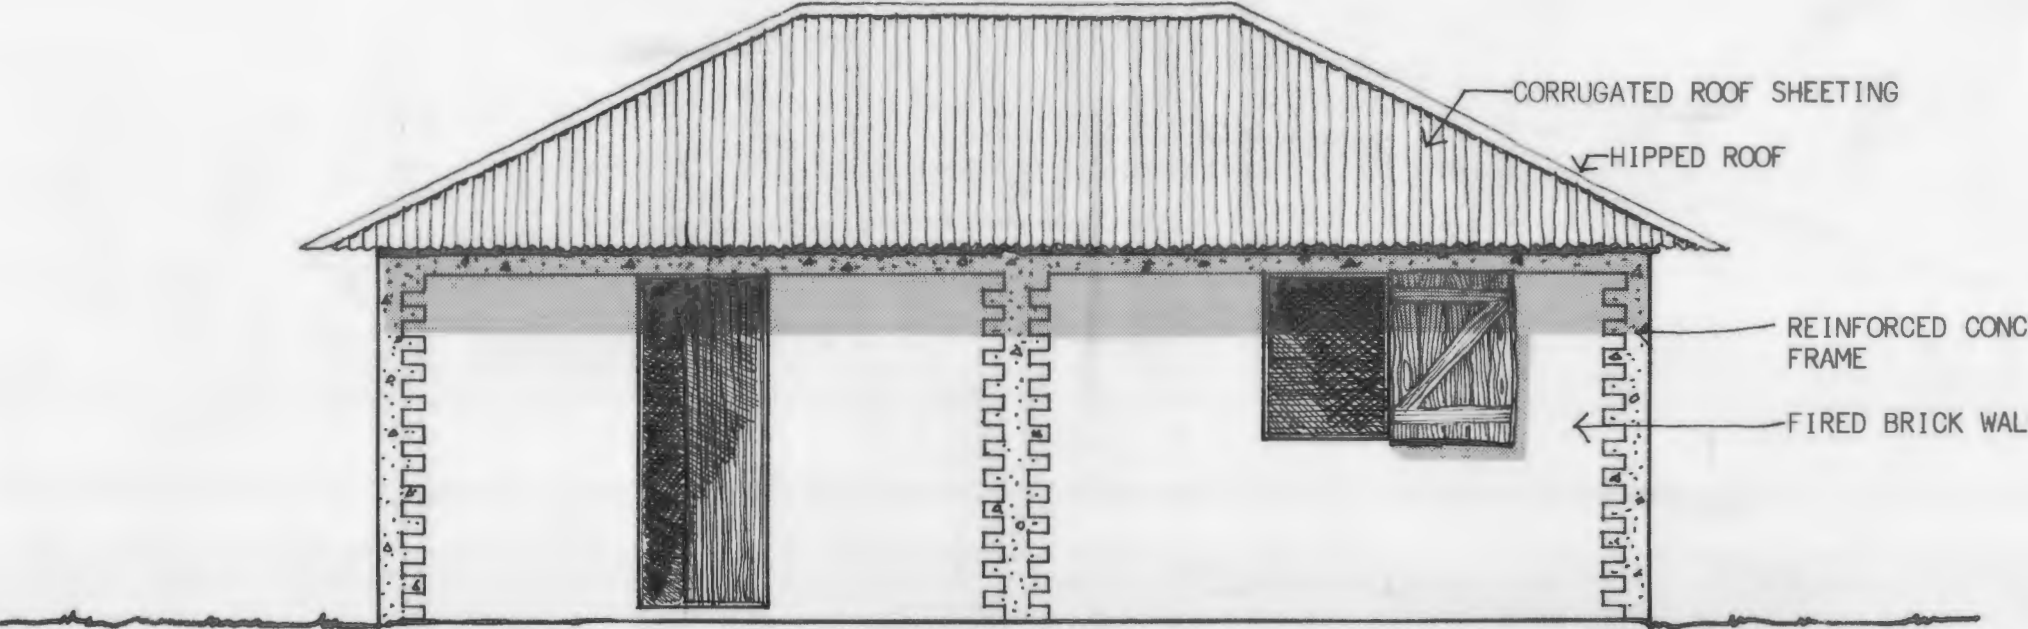
FIG. 18B
DEMONSTRATION RECTANGULAR HOUSE ELEVATION.
DURABLE MATERIALS
SCALE: 1:50

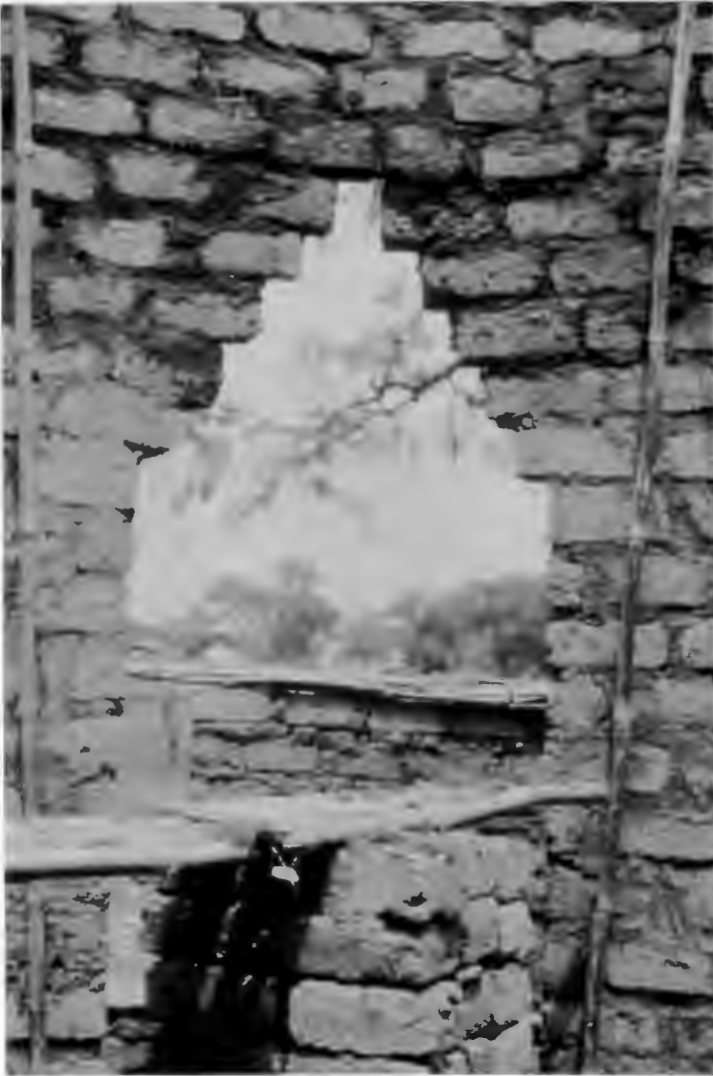
FIG. 21.
CORBEL ARCH OVER OPENING,
INNER CIRCLE WALL OF
ROUND HOUSE.
VERTICAL BAMBOOS ALREADY
IN PLACE.

(ii) Lintels: In order to avoid the problem of walls collapsing over openings following the failure of a lintel, the lintels have been completely eliminated in the low walls, so that the window and door openings are carried on up to the top of the wall. This applies to all openings in the rectangular house using local materials, and to all openings in the perimeter and partition walls of the round house (Fig.19) The framing is carried on across the top of the openings (Fig.20). For openings in the tall inner circle wall of the round house it was not practical to continue the opening up to the top of the wall.* Instead the stability of the tall inner wall was increased by maintaining a complete circle of brickwork at the top of the wall. In this instance, in order to avoid the vulnerability of lintels, corbel arches are used to close in the top of the opening. The corbel, formed by stepping out bricks from either side of the opening, takes the same form as that which would be created if bricks laid horizontally over an opening were allowed to fall i.e. an open triangle. (Fig.21)

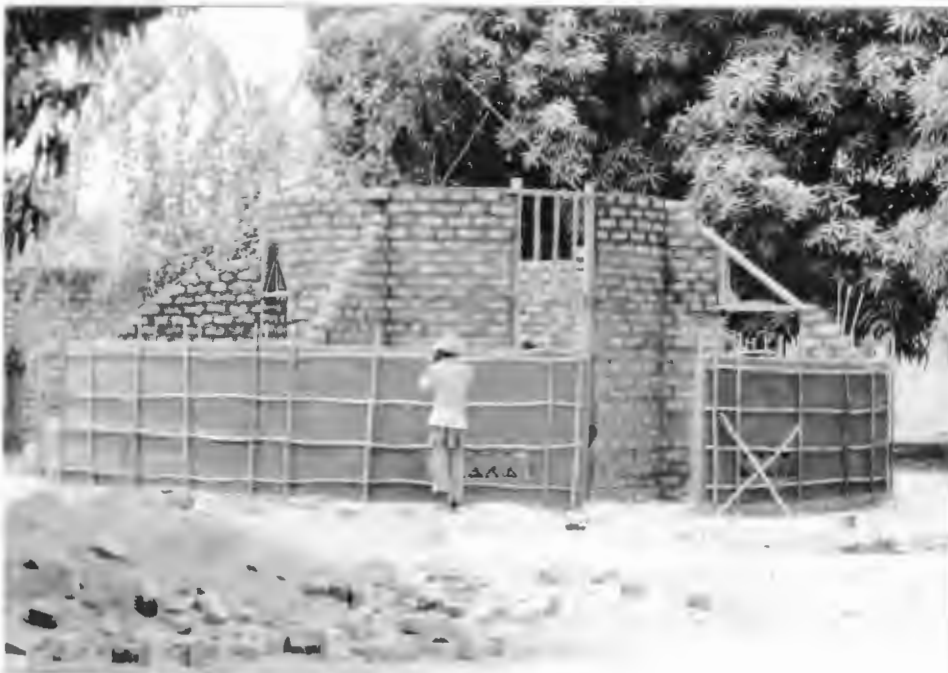
FIG. 22. OPENING IN TALL INNER WALL FRAMED UP TO TOP OF WALL - A VARIANT

* One prototype round house was built with the opening going up to the top and a wooden infill frame placed in-between. (Fig.22) It would be unrealistic, however, to expect people to have access to this much timber.

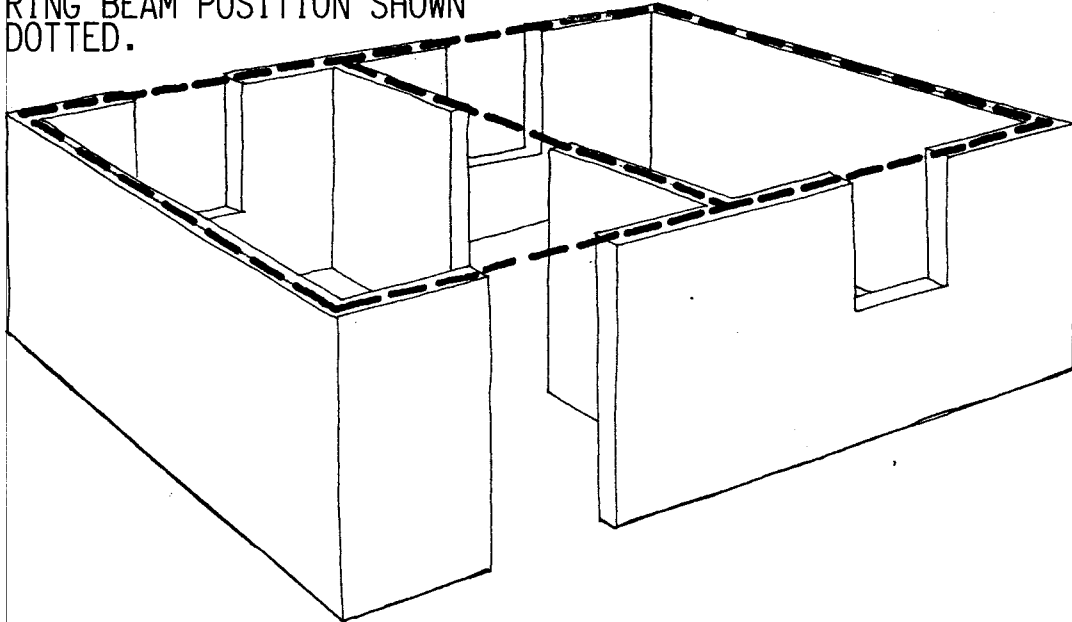
C'est la sablière qui tient le haut du bâtiment.

RING BEAM POSITION SHOWN DOTTED.

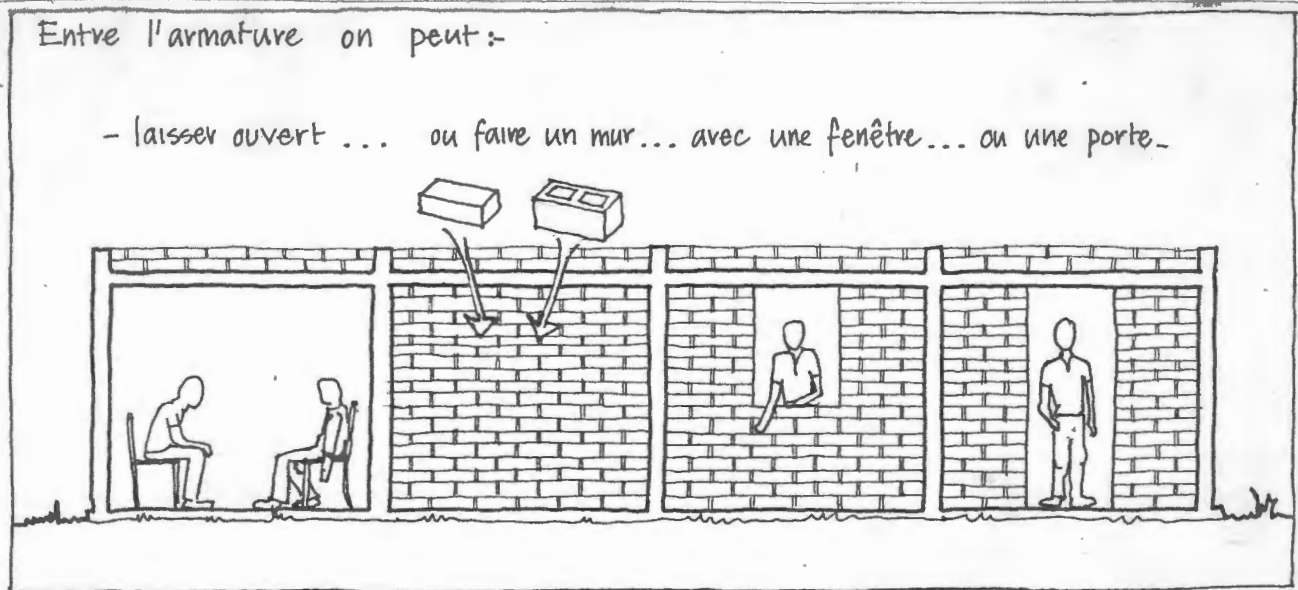
FIG. 25. BUILDING CONCEPT USING R.C. FRAME AND WALL INFILL OPTIONS.

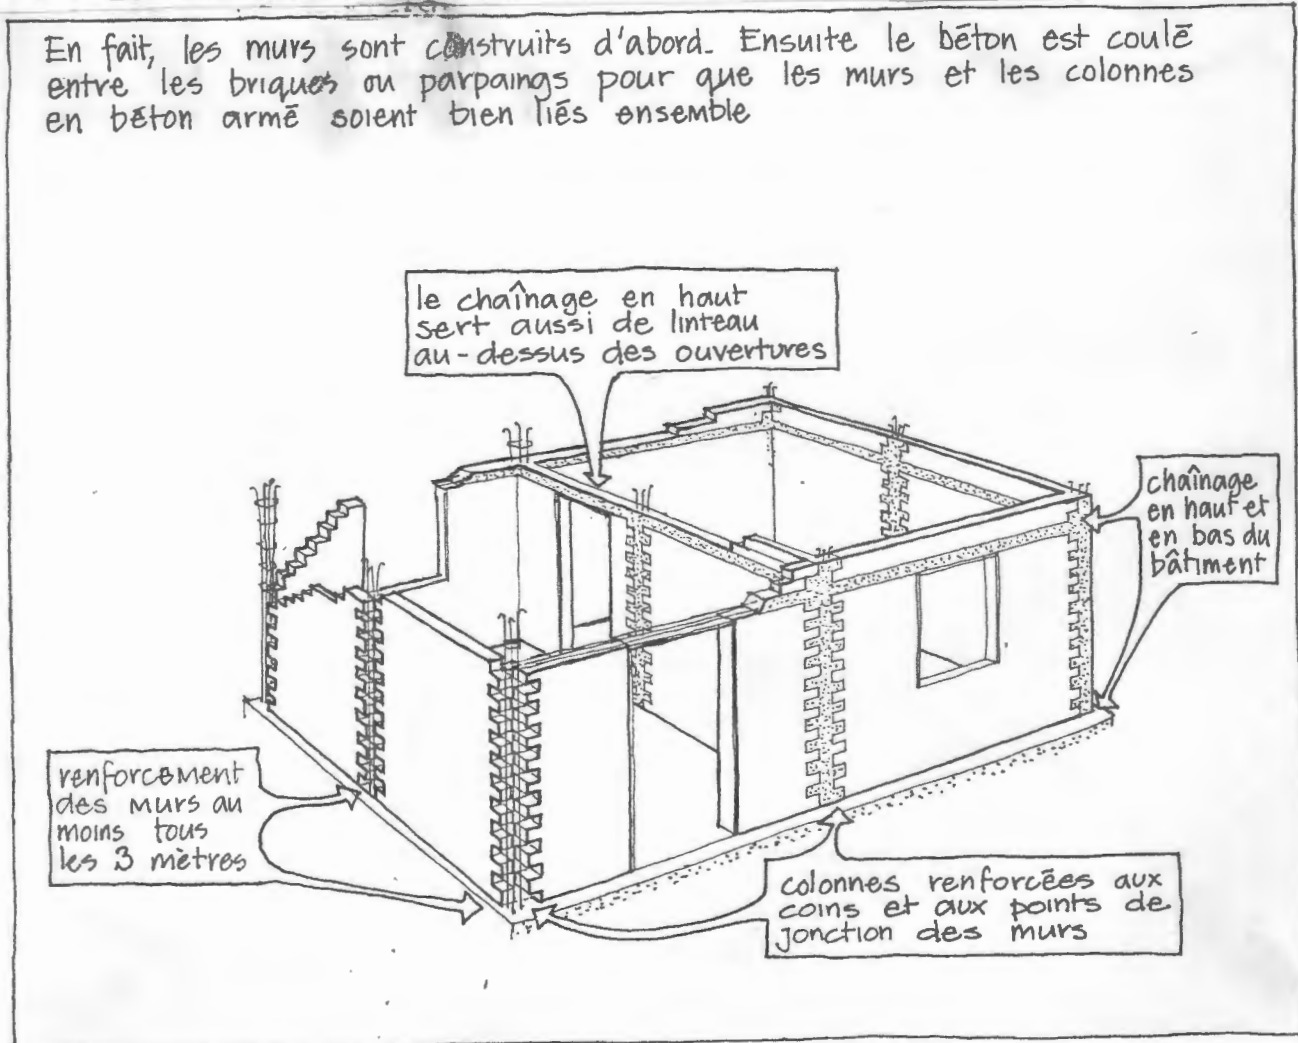
FIG. 26. PRACTICAL APPLICATION: WALLS USED FOR SHUTTERING COLUMNS.

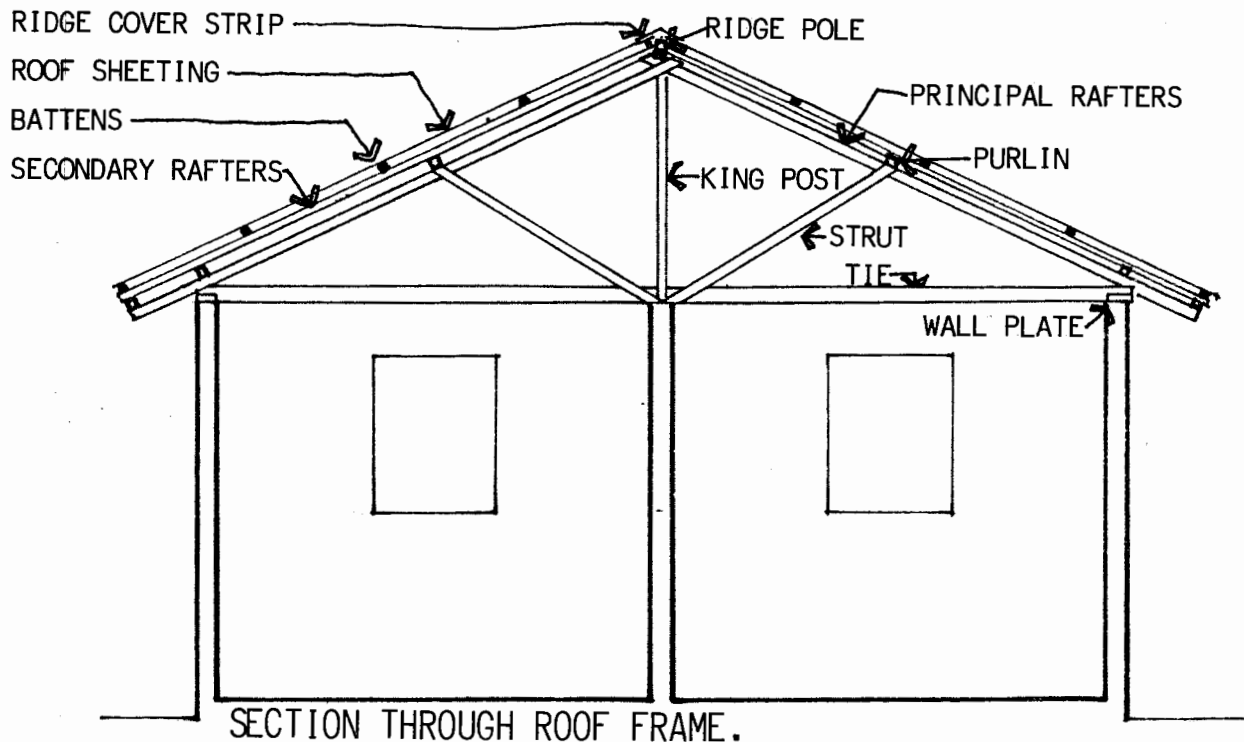
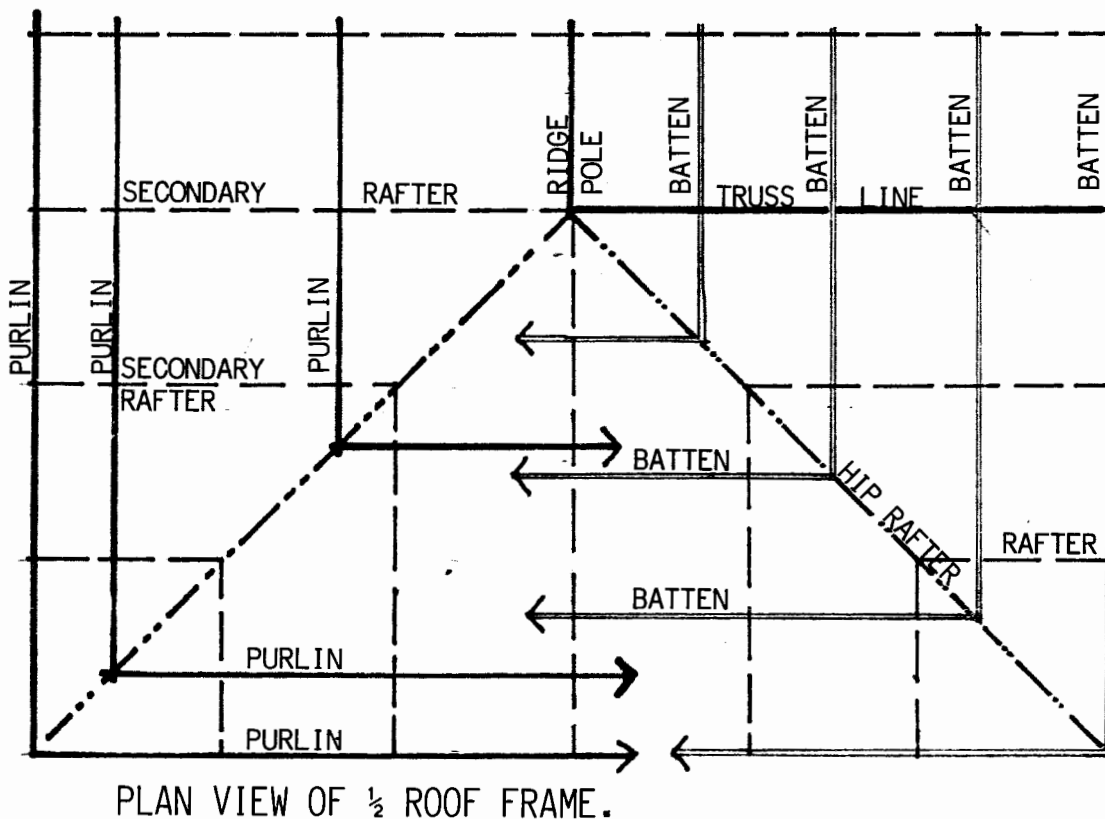
FIG. 24. B.
 DEMONSTRATION RECTANGULAR HOUSE WITH DURABLE MATERIALS.
 ROOF FRAME: SHOWING TRUSS, & PART PLAN VIEW OF ROOF ELEMENTS.
 SCALE: 1:50

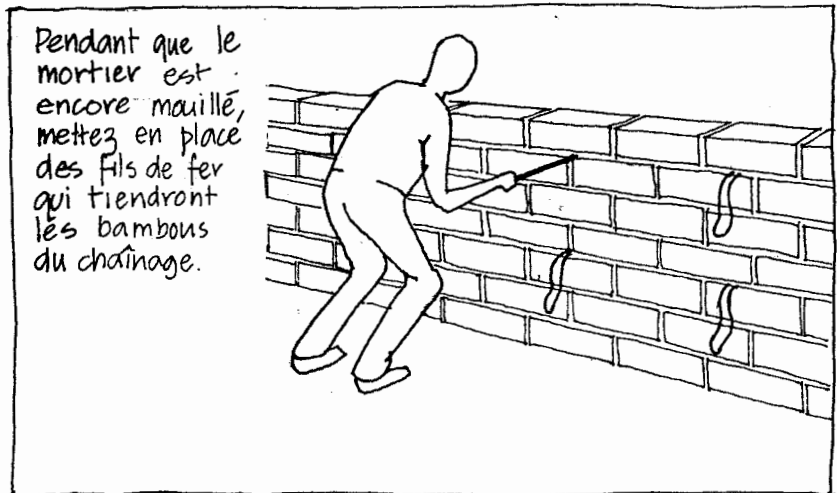
FIG. 29.
MAKING HOLES IN
THE BRICKWORK

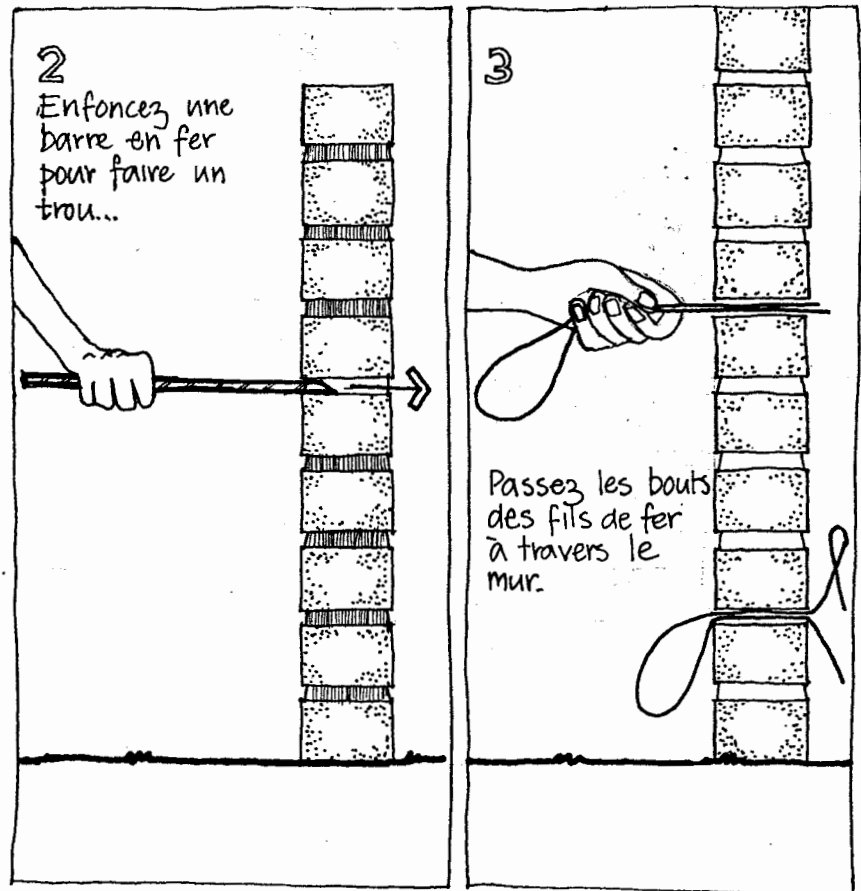
FIG. 30.
DETAIL OF PLACING
WIRES.

side of the wall - there is a loop large enough to pass a 4 centimetre diameter bamboo through, and on the other side there are two tails of wire, some 20 centimetres long, hanging out of the hole. (Fig.30) When the wall is finished it is plastered with mud.

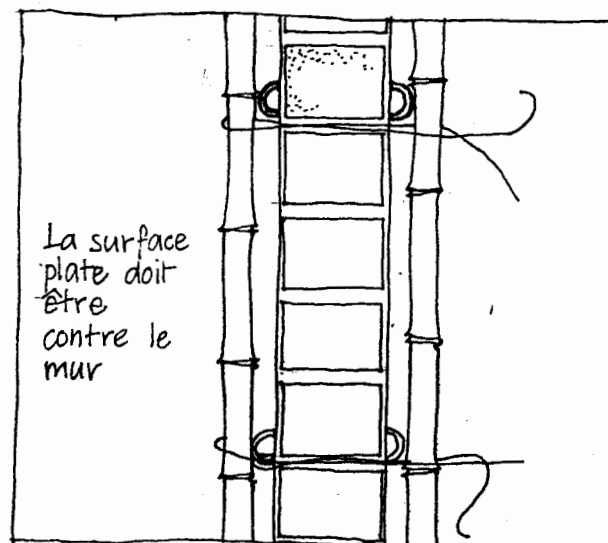
FIG. 31.

VERTICAL BAMBOOS
LOOSELY HELD BY
WIRES; SPLIT
HORIZONTAL BAMBOOS
PACED BETWEEN
MUD PLASTERED WALL
AND VERTICAL
BAMBOOS.

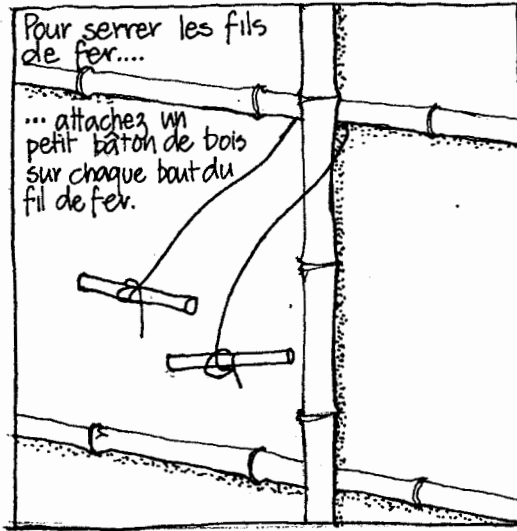
FIG. 32.

SHORT STICKS ATTACHED TO TIE WIRES.

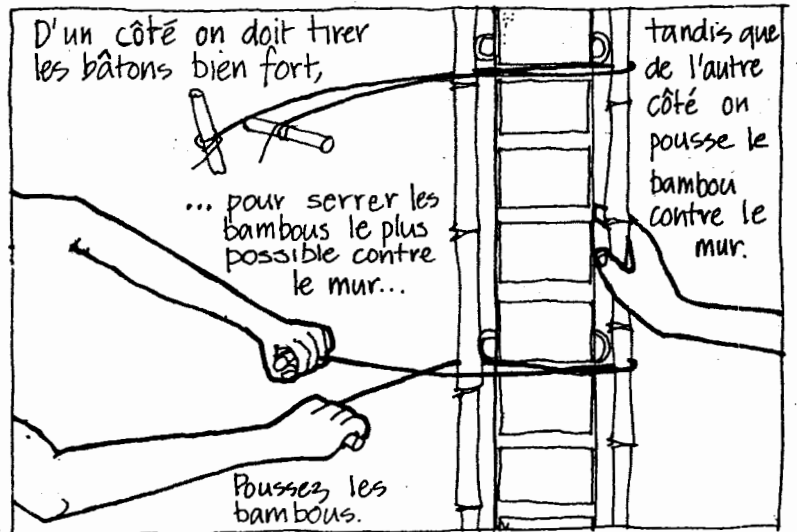
FIG. 33.

PULLING THE FRAME TOGETHER BY TIGHTENING THE WIRES.

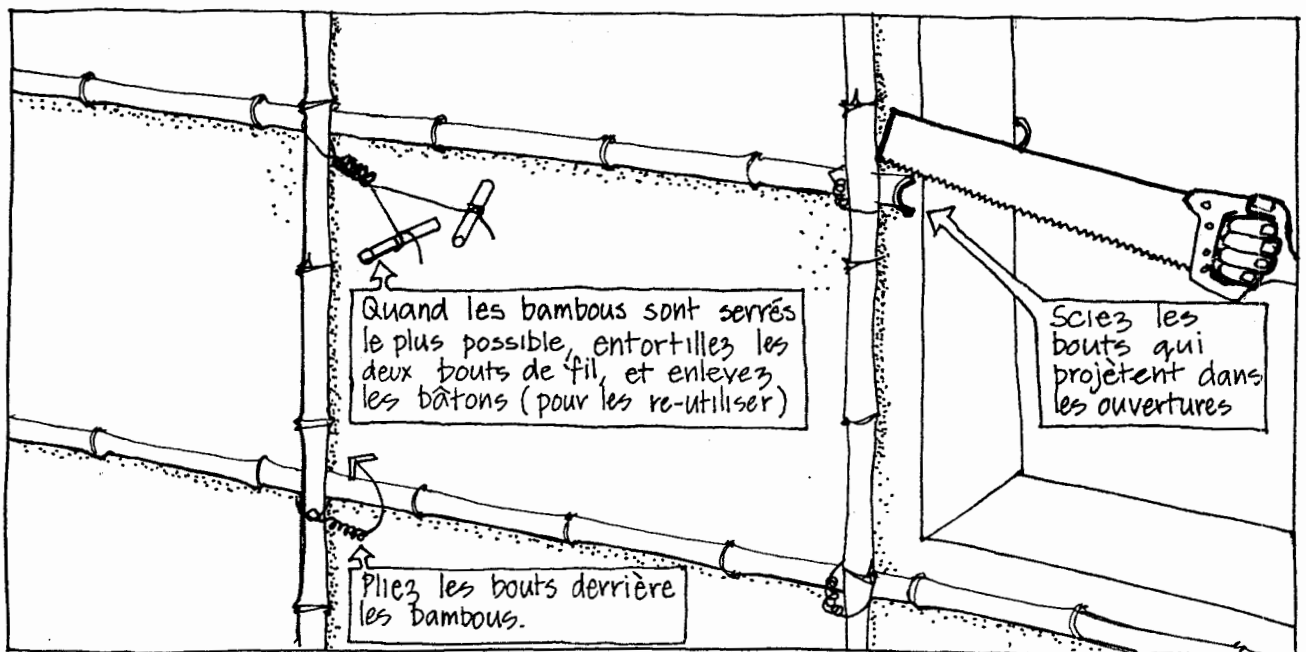
FIG. 34.

STICKS REMOVED FOR REUSE. WIRE END PUSHED BEHIND FRAME.

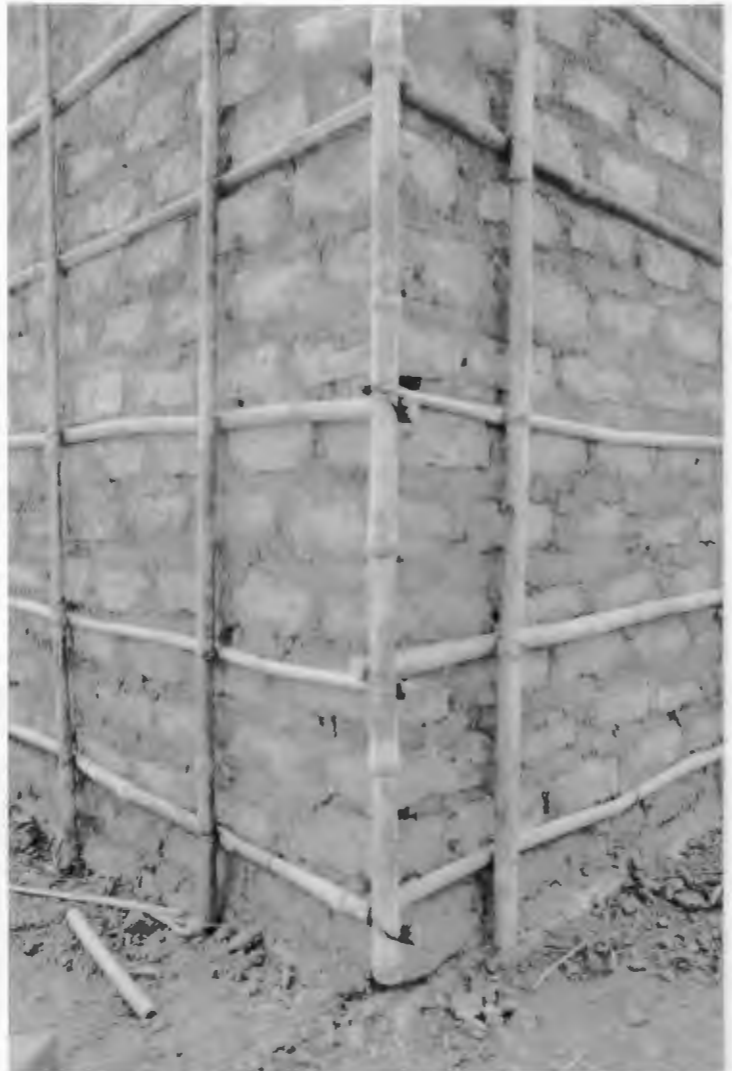
FIG. 35. ILLUSTRATION FROM THE MANUAL.

DETAIL OF VERTICAL BAMBOO POSITION AT EXTERNAL CORNERS ON RECTANGULAR HOUSE BUILT WITH LOCAL MATERIALS.

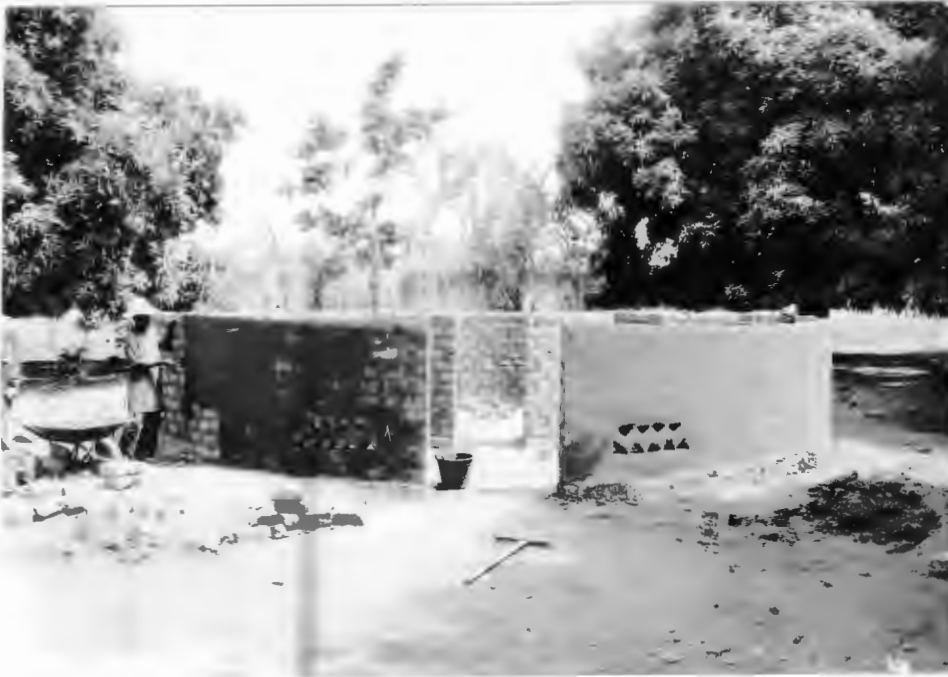
A). ROUND HOUSE OUTER WALL BEING PLASTERED (AT MADINA GUILLEDJI).
