**The Introduction of
earthquake resistant building techniques
in Koumbia,
North West Guinea**

Final Report

**John Norton
Development Workshop**

September 1985

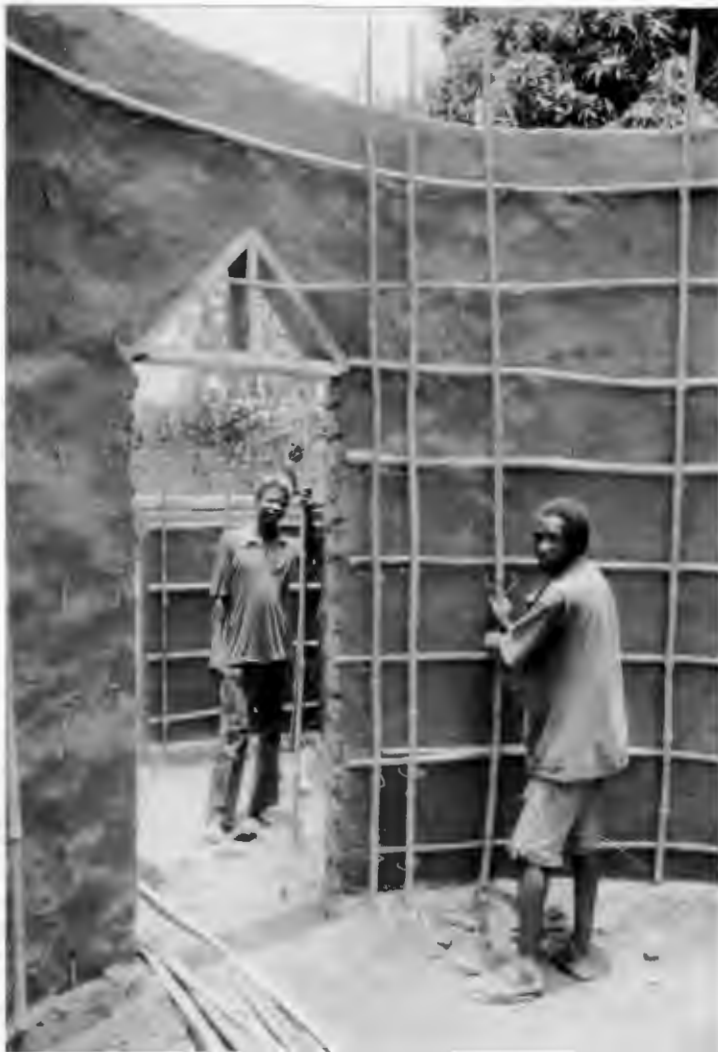
B). VERTICAL BAMBOOS
BEING PLACED

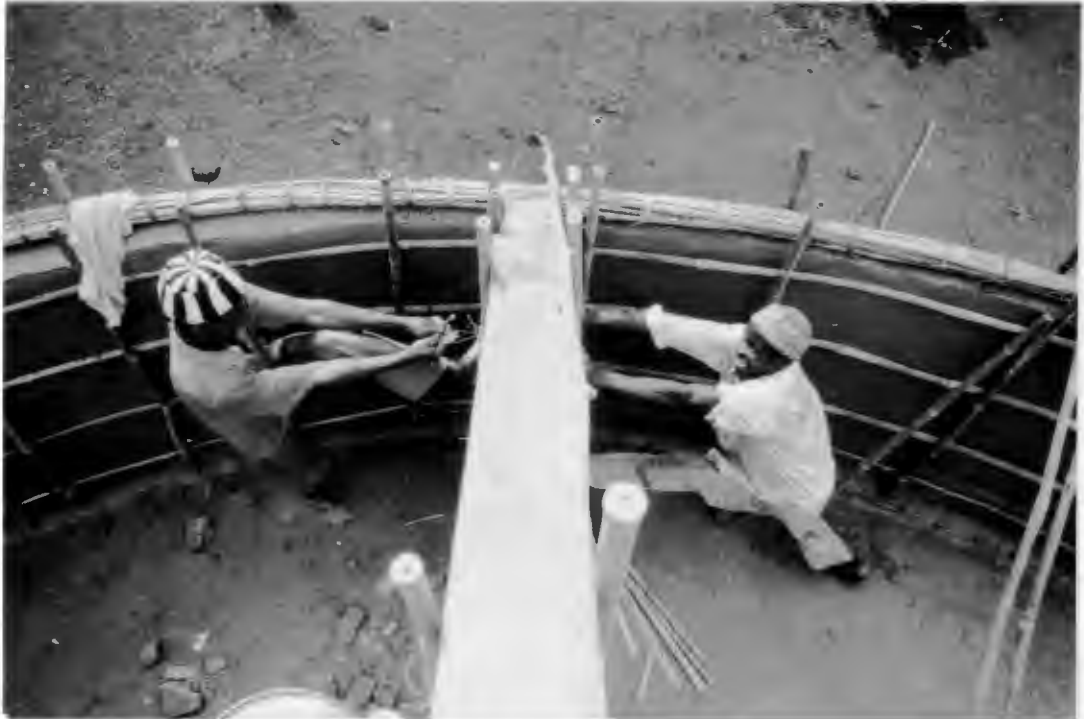
C). PUSHING THE FRAMES AGAINST THE WALL. VIEW LOOKING DOWN.

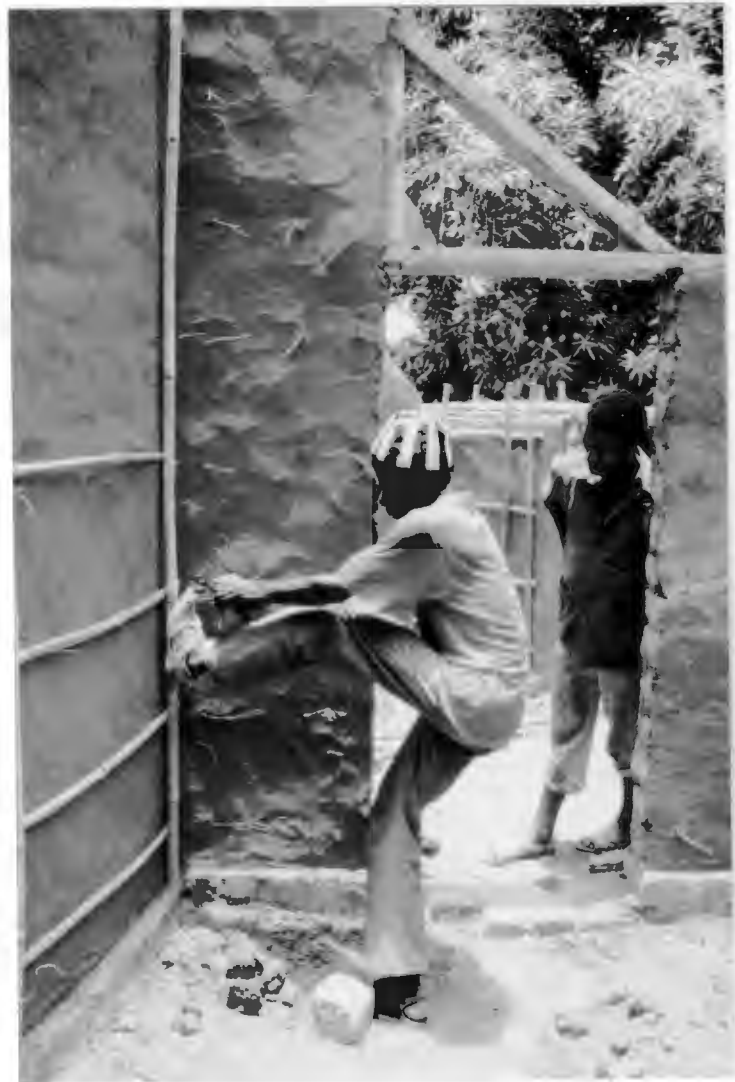
D).
TIGHTENING WIRES,
BEGINNING AT THE
MIDDLE OF THE
VERTICAL BAMBOO.

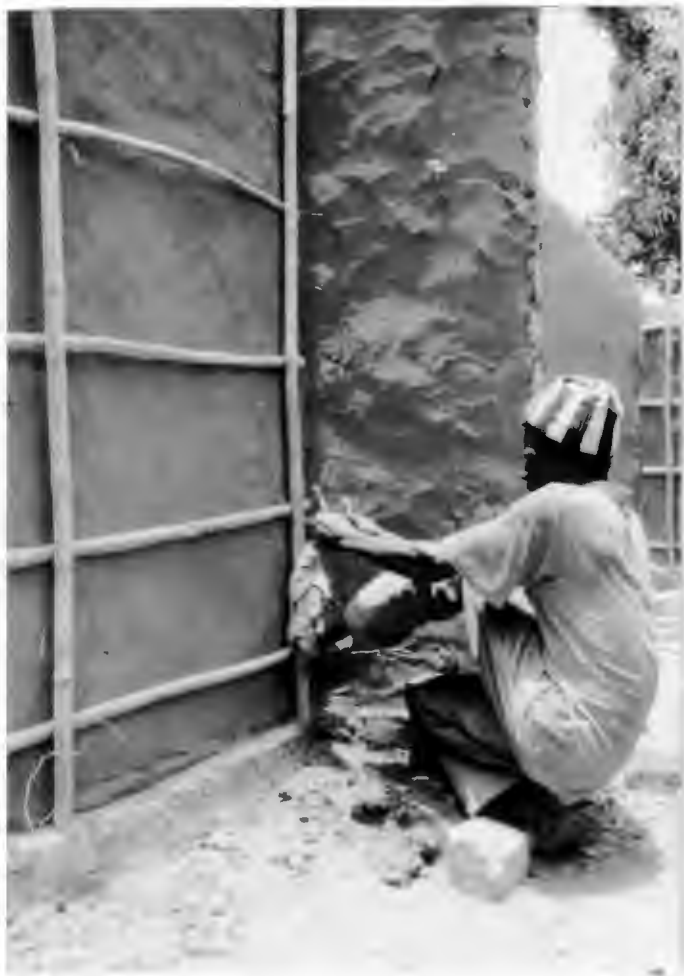
E). PULLING WIRES TIGHT

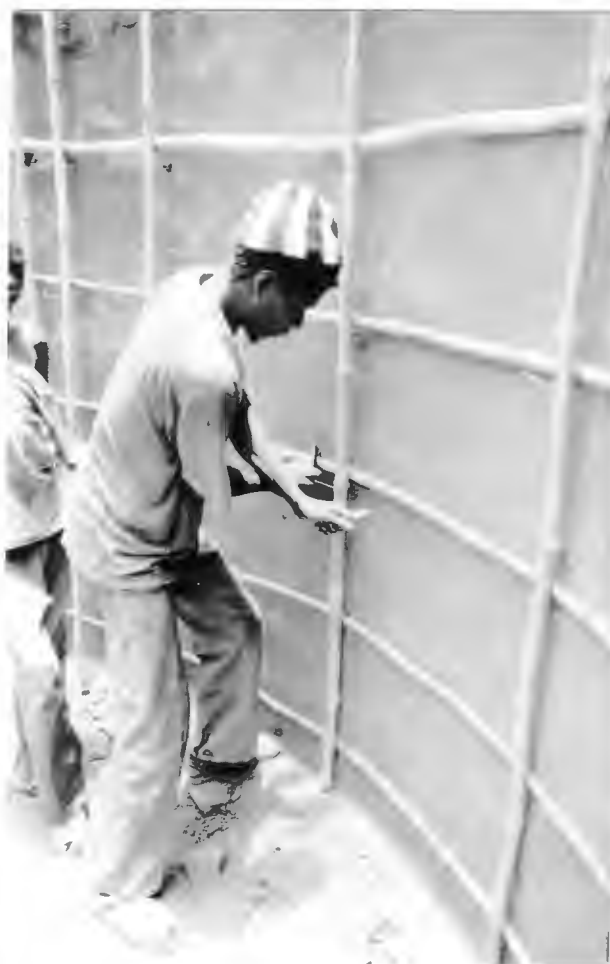
F). BINDING THE WIRES
USING STICKS

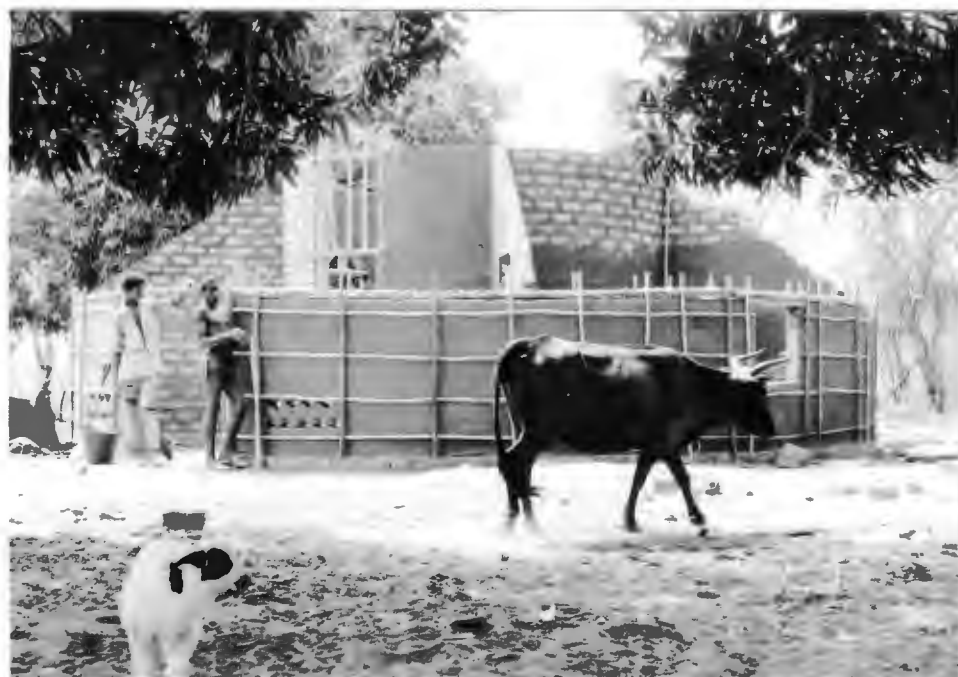
G). OUTER WALL FRAMING IN PLACE. INNER RING WALL BEING PLASTERED.
(MADINA GUILLEDJI.)

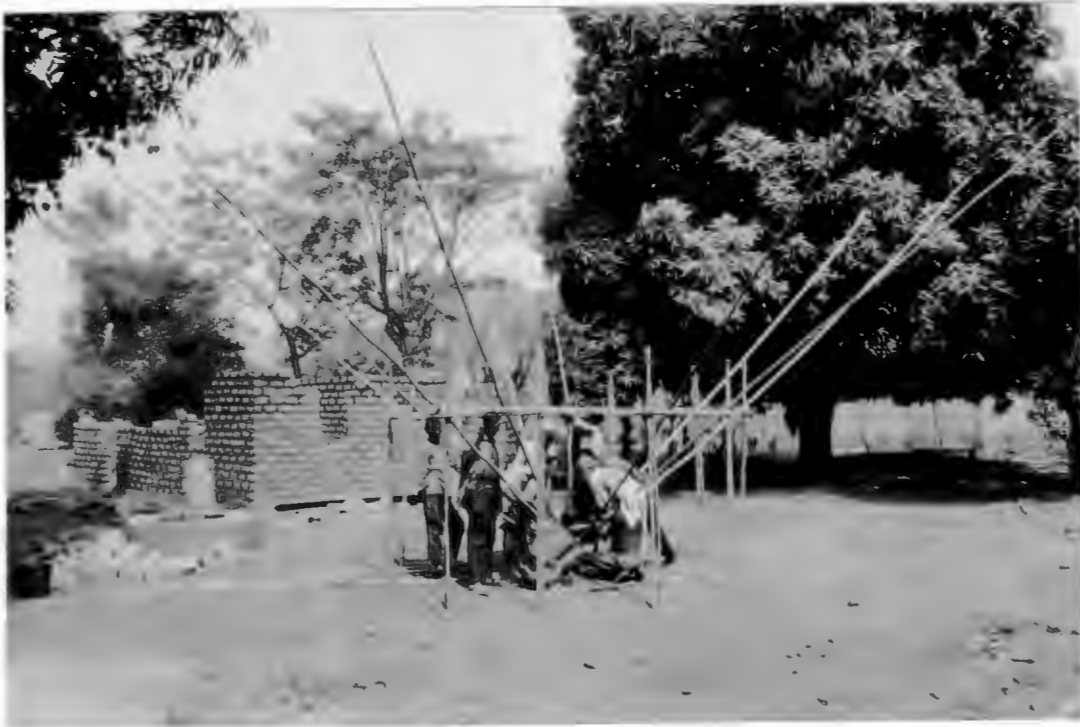
FIG. 36. ROUND HOUSE ROOF FRAME BEING PREPARED ON SUPPORTING FRAMEWORK...

(iii) Roof: For the round house the roof frame is assembled upside down on the ground, using a supporting framework (Fig.36) erected beside the building. When the upper part of the cone of bamboos has been tied together, the whole roof frame is picked up, turned over, and placed on top of the house. (Fig.37) Additional horizontal rings are added, one ring every 30 to 40 centimetres up the slope of the roof. Each ring uses a small bundle of 4 to 8 split bamboos. (Fig.38)

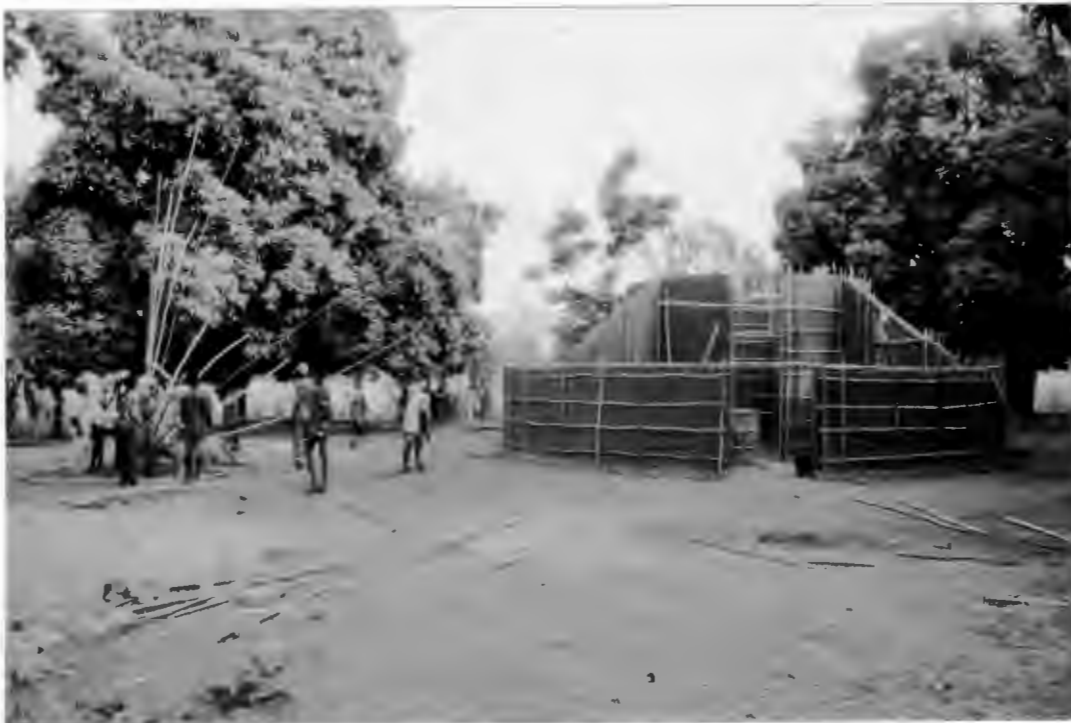
... ROOF FRAME TURNED ON ITS SIDE, READY FOR PLACING OVER THE FINISHED WALLS OF THE HOUSE.

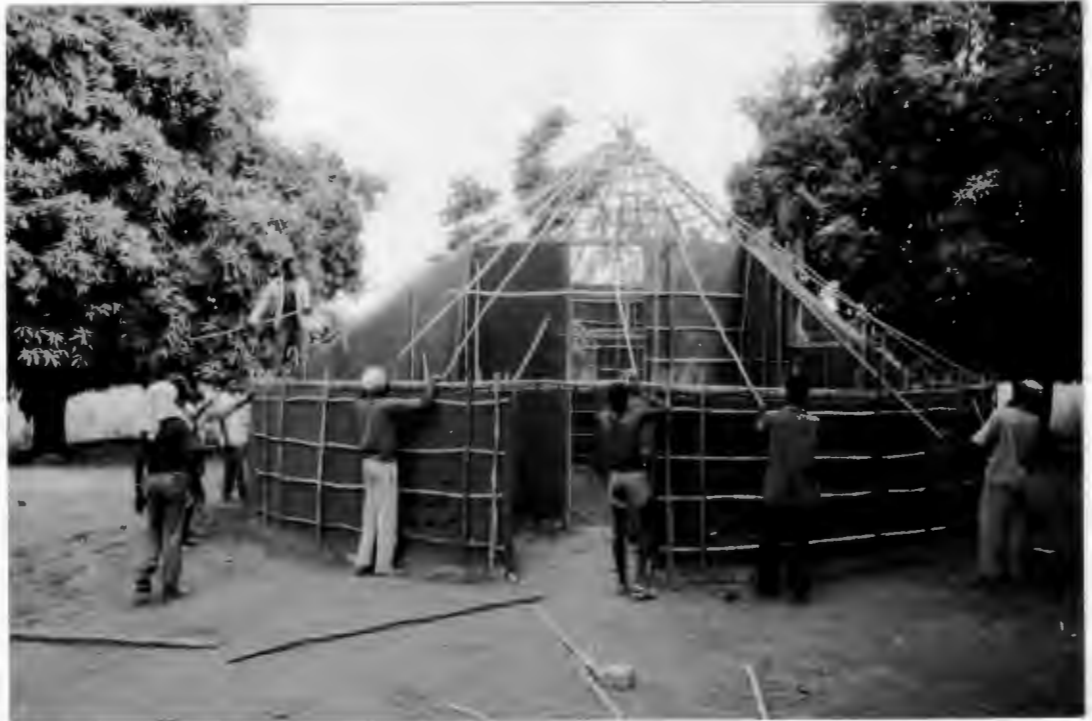
FIG. 37.

ROOF FRAME IN POSITION ON WALLS. ROUND HOUSE.

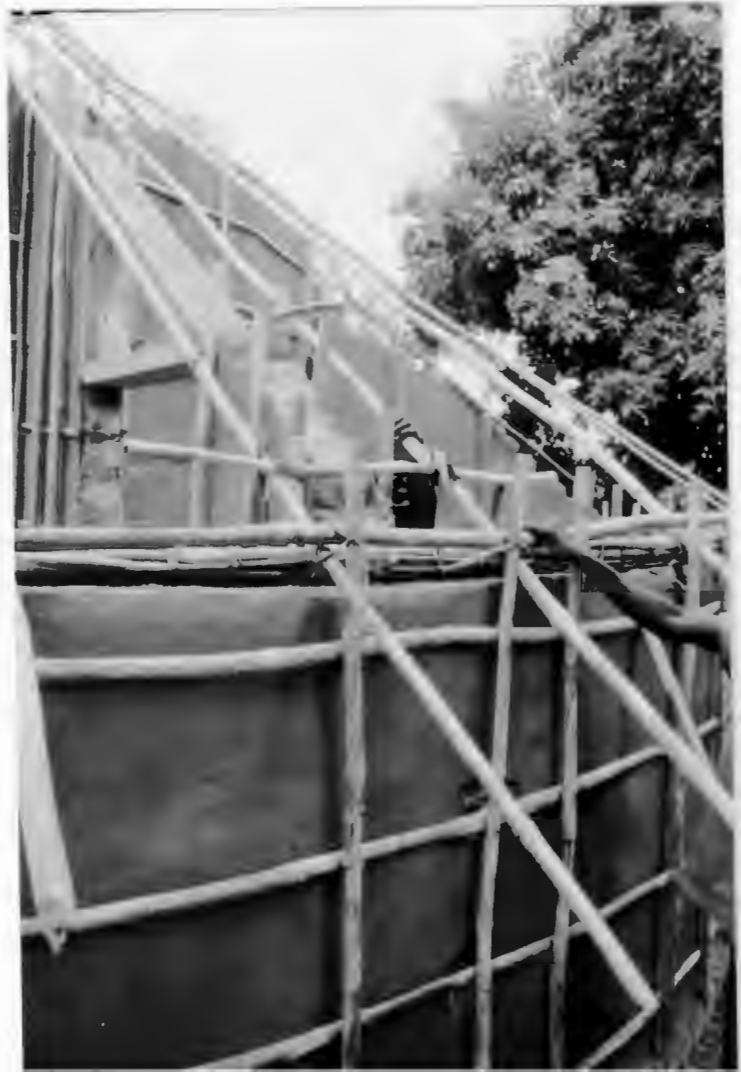
ROOF FRAME ATTACHED
TO WALL FRAME.

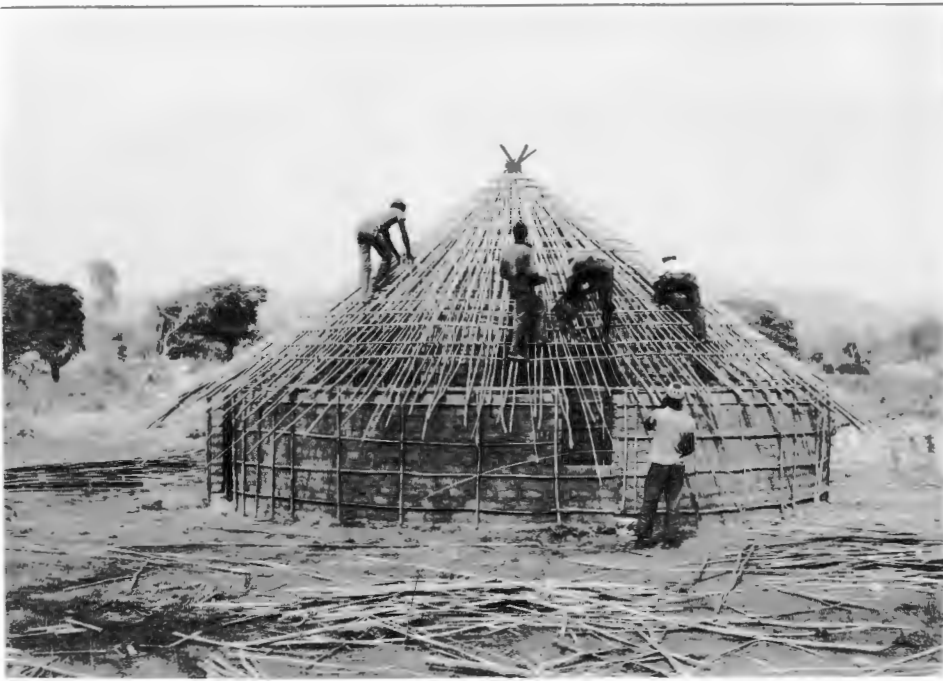
FIG. 38. ADDITIONAL HORIZONTAL BAMBOO RINGS BEING PLACED ON ROOF FRAME

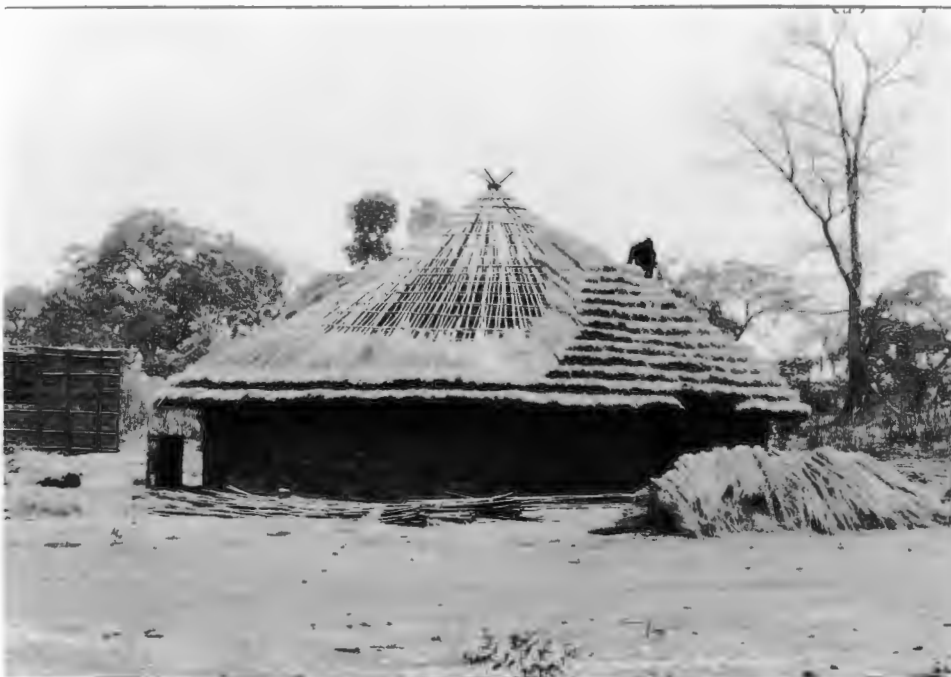
FIG. 39. THATCHING THE ROOF

The thatch is then laid on top of the framework, secured with bark strips, with each layer starting about 30 centimetres up from the layer below. (Fig.39)

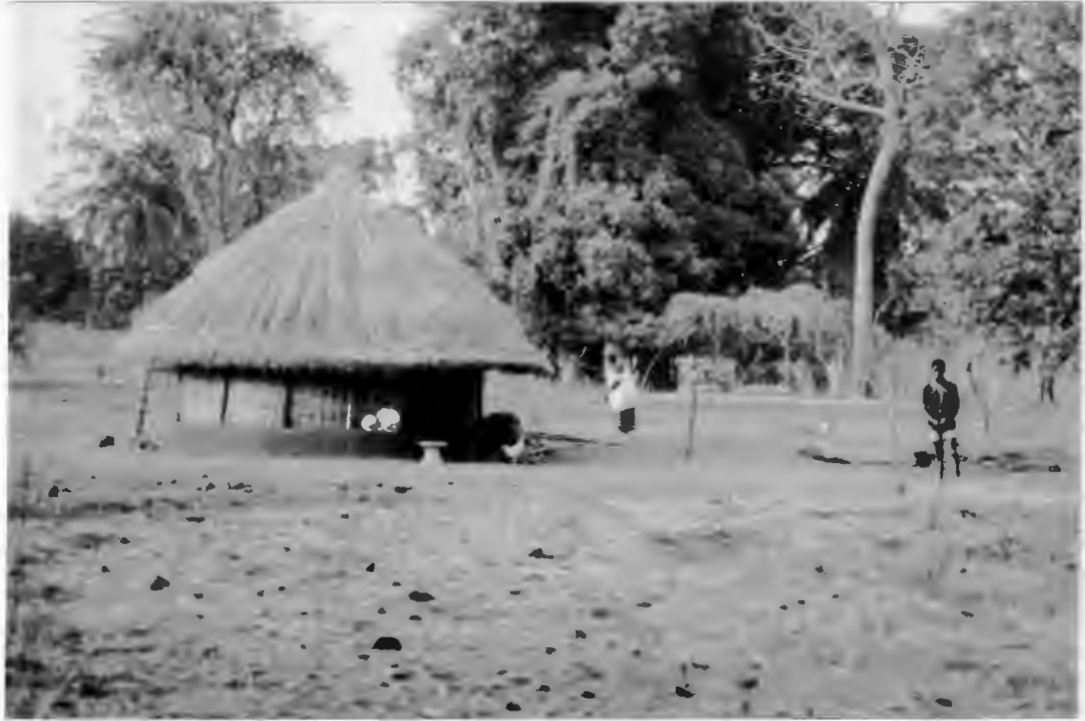
TEMPORARY ROUND HOUSES WITH BAMBOO MATTING WALLS.

Some people have repaired their round houses by taking down the mud walls to a maximum height of 0.75 - 1 metre and putting bamboo matting higher up.

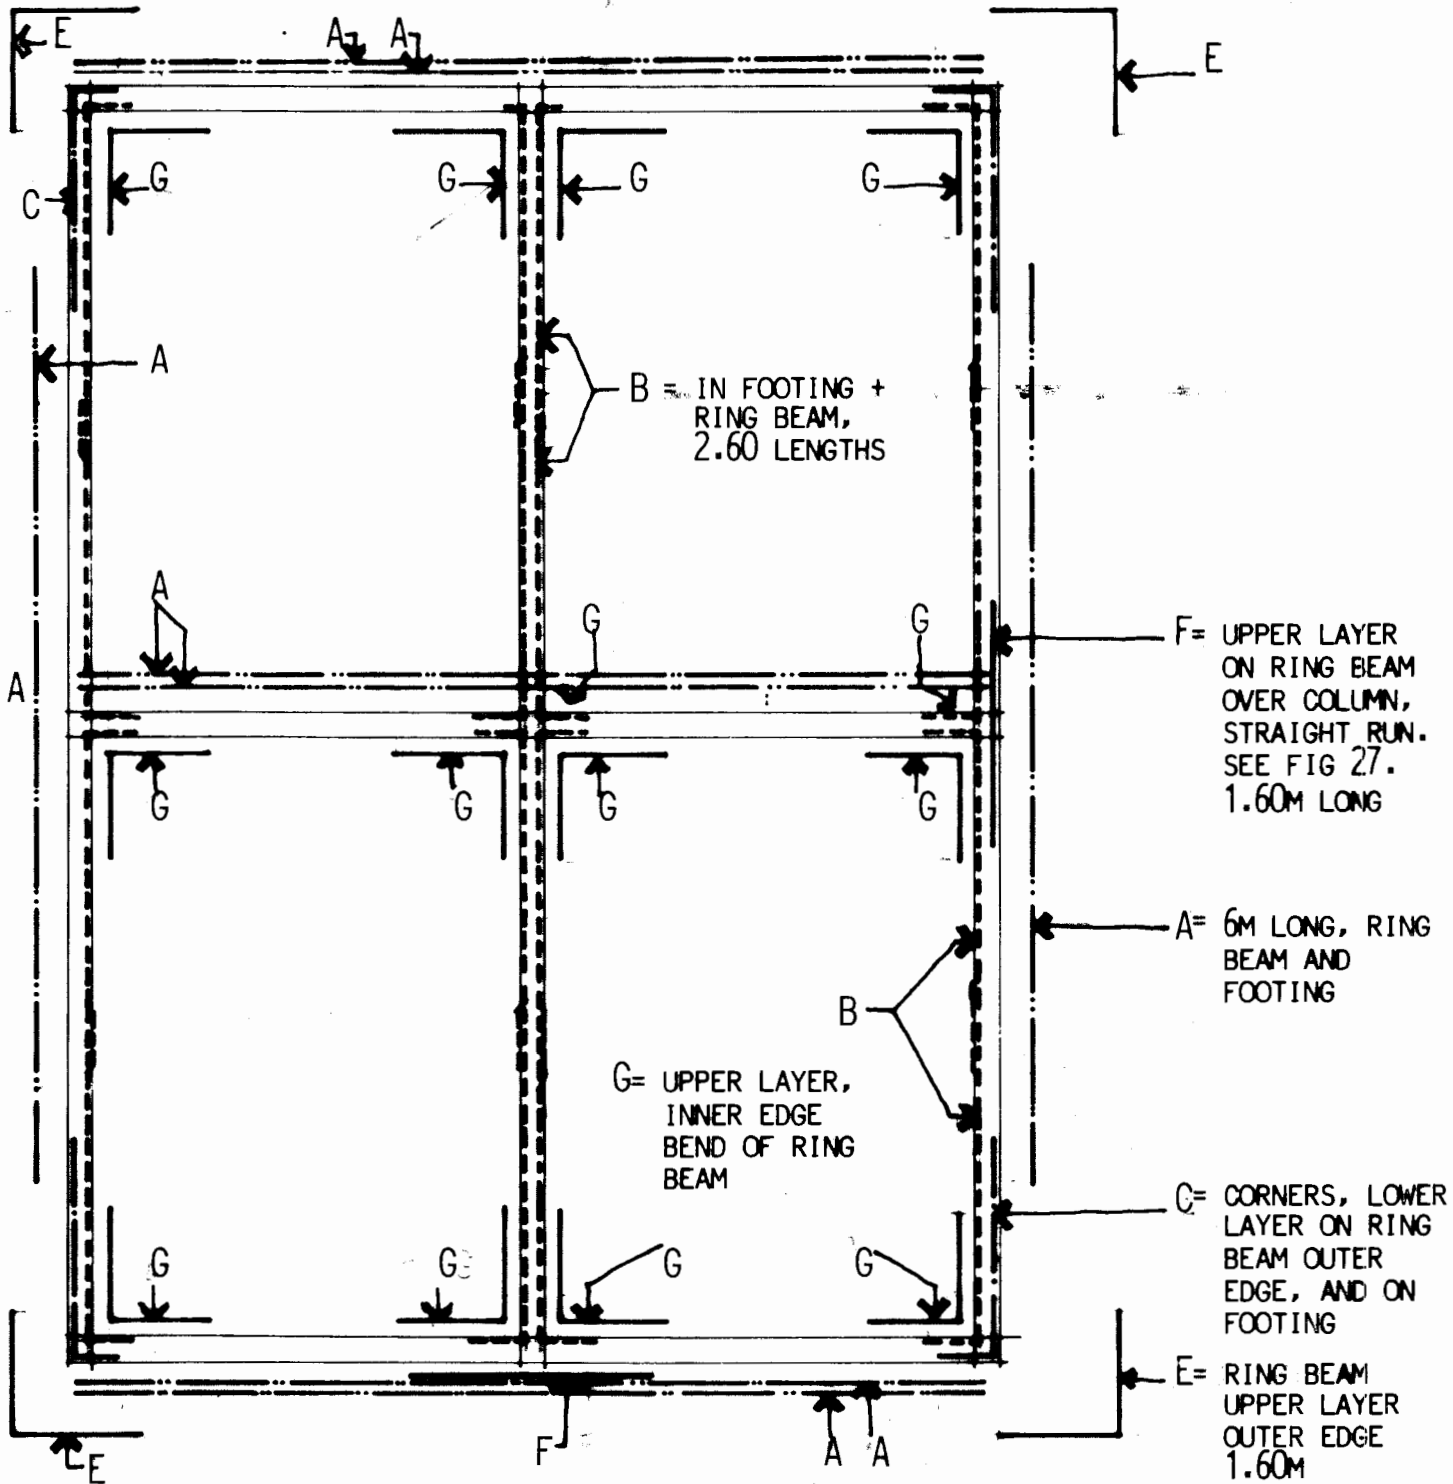
FIG. 40. REBAR LENGTHS AND POSITIONS, RELATED TO QUANTITIES LIST. DEMONSTRATION RECTANGULAR HOUSE WITH DURABLE MATERIALS.

ITEM	QUANTITY	LENGTH	N ^o OF BARS	DESCRIPTION	
A	16	6.00m	16	Horizontal bars	
B	32	2.60m	end of column bars		
C	8	2.00m	2	Corners	
D	36	3.35m	36	Column bars	
E	4	1.60m	}	Upper layer, ring beam, outside corner	
F	4	1.60m		6	Upper layer on ring beam, straight run
G	16	1.40m			Upper layer, inner bend of ring beam
