**A STRATEGY FOR DEVELOPING
INDIGENOUS BUILDING
IN EARTHQUAKE REGIONS**

**TIMBER REINFORCING
FOR EARTHQUAKE RESISTANCE**

**CASE STUDIES OF THE
BANDAR ABBAS (1977) AND THE ZARAND
(1978) EARTHQUAKES**

Development Workshop

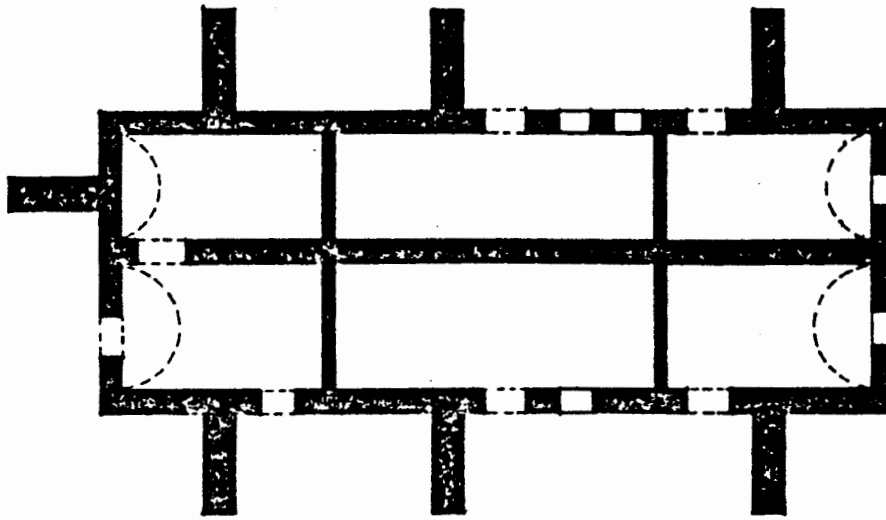
WORKSHOP BUILDING SOUTH OF SAR BAGH
Stone walls in lime mortar and fired brick
vaults. External buttresses assisted building
to withstand major earthquake damage.

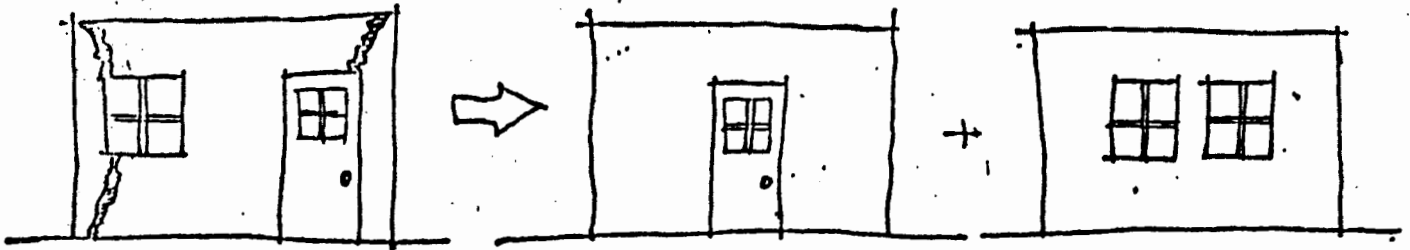
Because of stress concentration, openings should be avoided near corners of buildings.

Therefore it is better to position openings centrally on the walls.

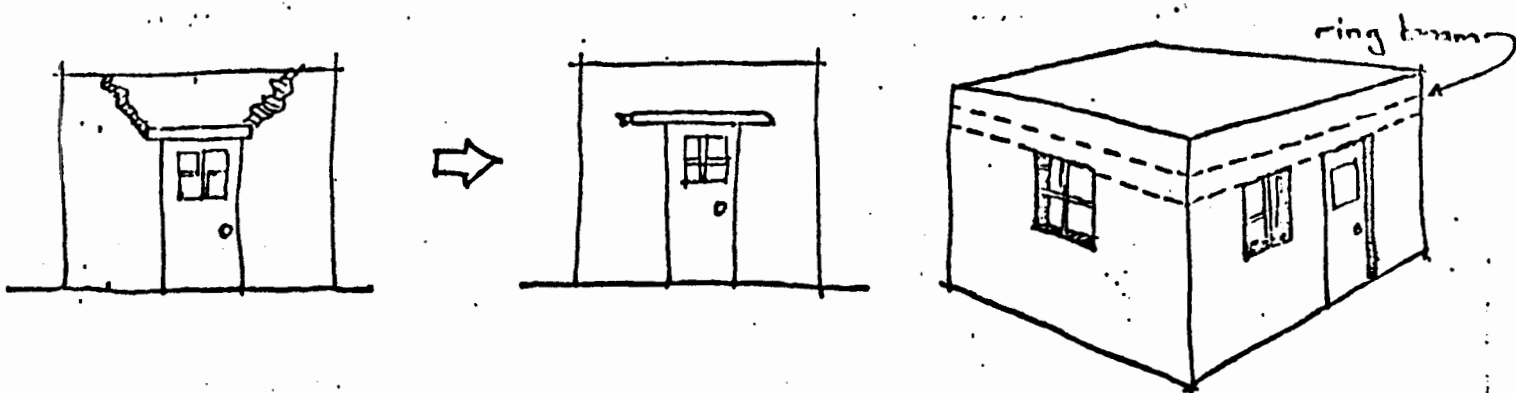
Cracking and failure often occurs above door and window openings. These areas can be strengthened by extending lintels deep into walls or by using continuous reinforced ring beams as a common lintel above all openings, with extra reinforcing at corners.

Such ring beams serve a double function in tying walls together to prevent movement which could cause roof collapse.

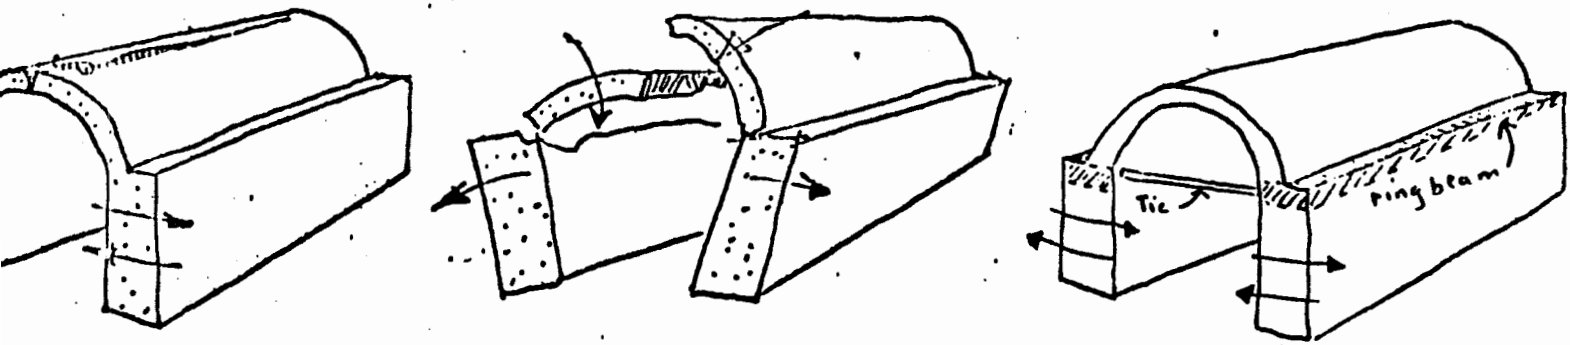
Vaults are much more susceptible to earthquake damage than domes. Any movement of walls upon which the vault rests will cause cracking in and failure of the roof.

A tie rod connecting the two side walls, which should have a continuous ring beam at the base of the vaults, will resist earthquake damage.

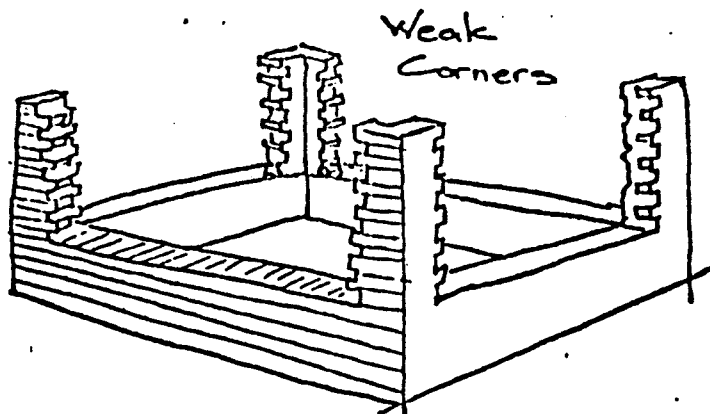
Bonding Corners: it is common practice in Iran to build up corners before infilling the wall. This is done to simplify the problems of lining up and levelling. This practice produces badly bonded and weak corners.

Since corners are critical stress areas, this practice should be discontinued. Brick courses should be laid continuously and wall building should progress evenly.
